APSHAWA MAIN DAM

APSHAWA AUXILIARY DAM

PHASE I INSPECTION REPORT

NATIONAL DAM SAFETY PROGRAM

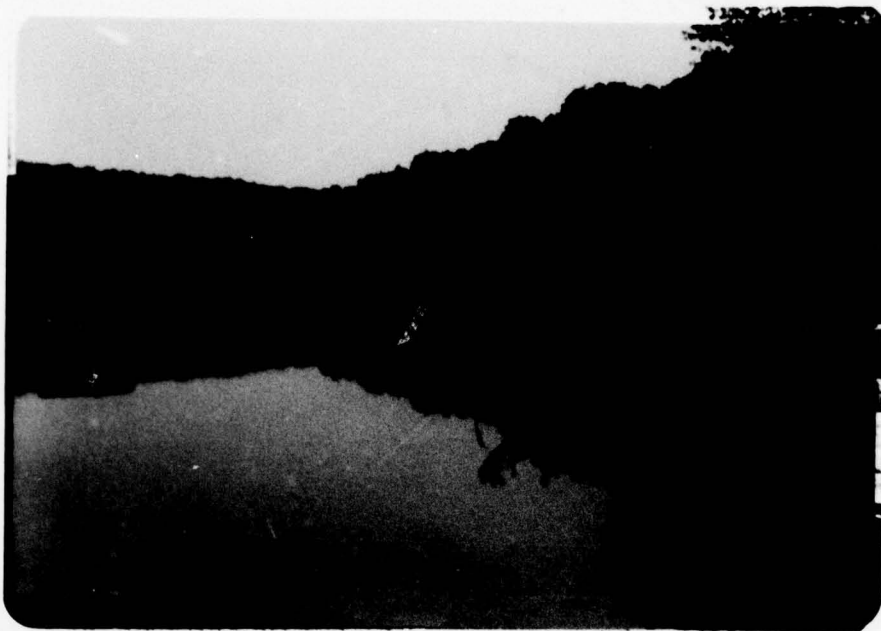
Outlet gate house and
left side of spillway.

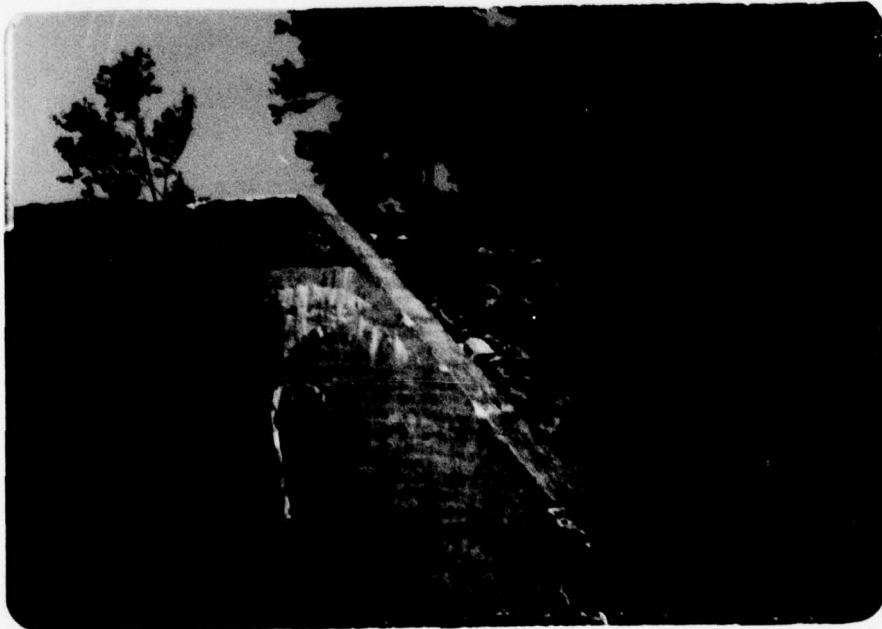
Spillway left sidewall.
Note disturbance of riprap.

3. The rip-rap and the top of the main dam near the left side wall of the spillway and upstream rip-rap should be repaired. This will require replacement of missing rip-rap and should be done very soon.

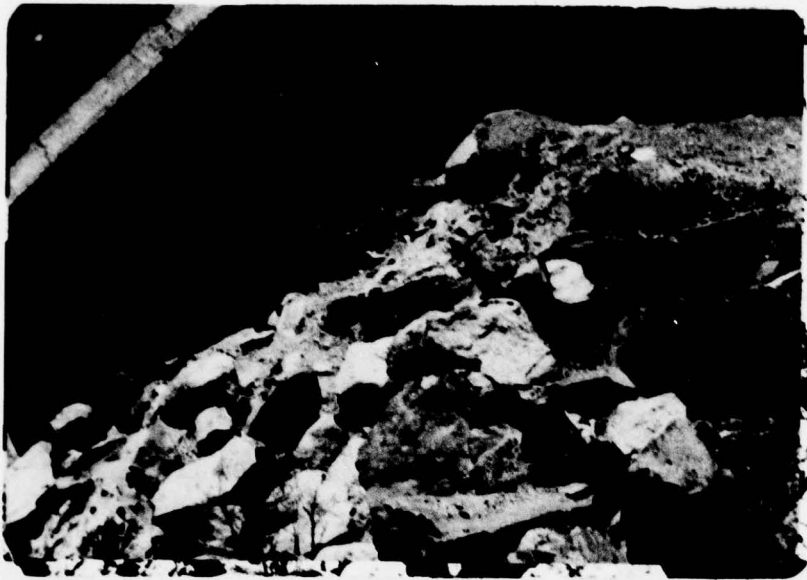
No signs of movement or settlement were observed on the embankments except on the section near the left spillway side wall. In this area, and for a length of a few feet, there are traces of erosion and possibly overtopping. This erosion goes down approximately three feet below the crest and the downstream face of the upper part of the rock fill has fallen down. It does not appear likely that this damage was caused entirely by overtopping and may be a consequence of vandalism or a lack of maintenance. The damage may have been increased by erosion and overtopping.

Erosion and removal of riprap 19 June 1978
at spillway and left sidewall
abutment.

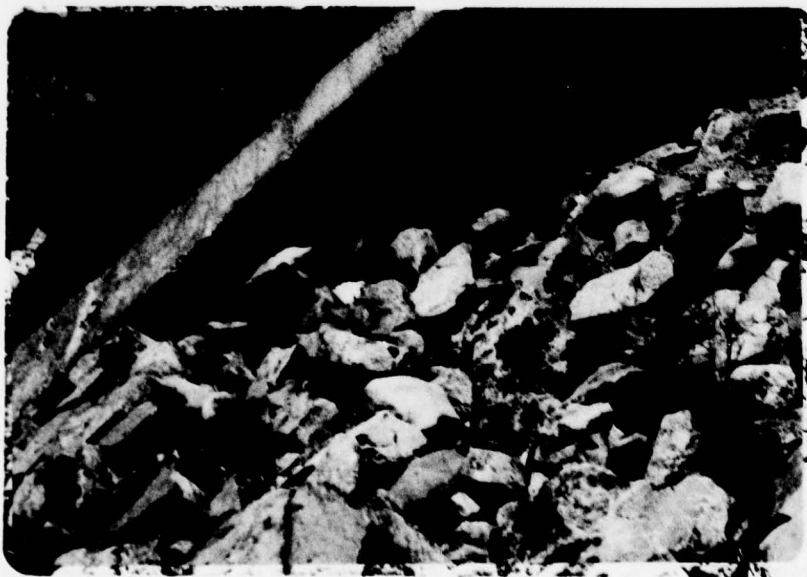
Erosion of riprap at spillway 19 June 1978
and left sidewall abutment.

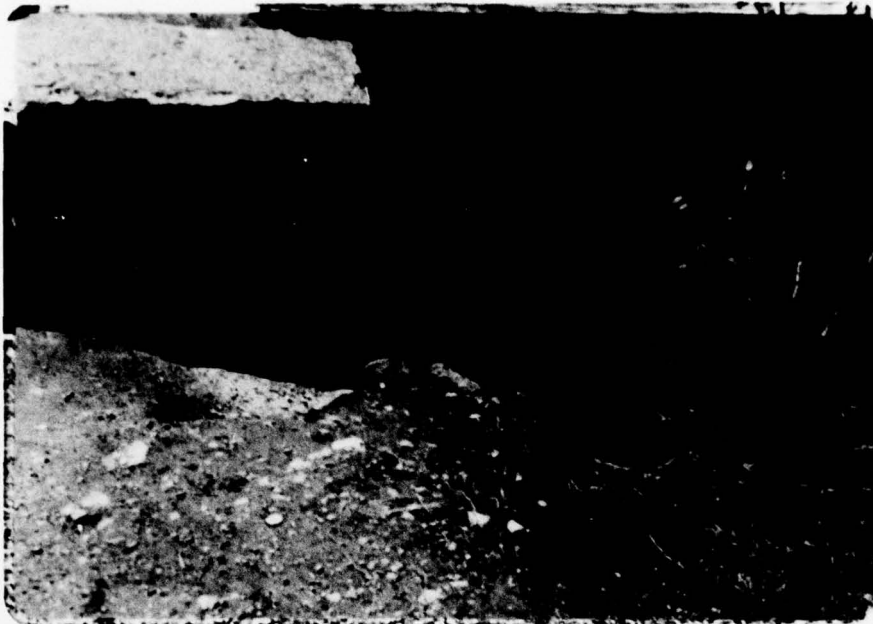
Erosion at spillway
left sidewall.

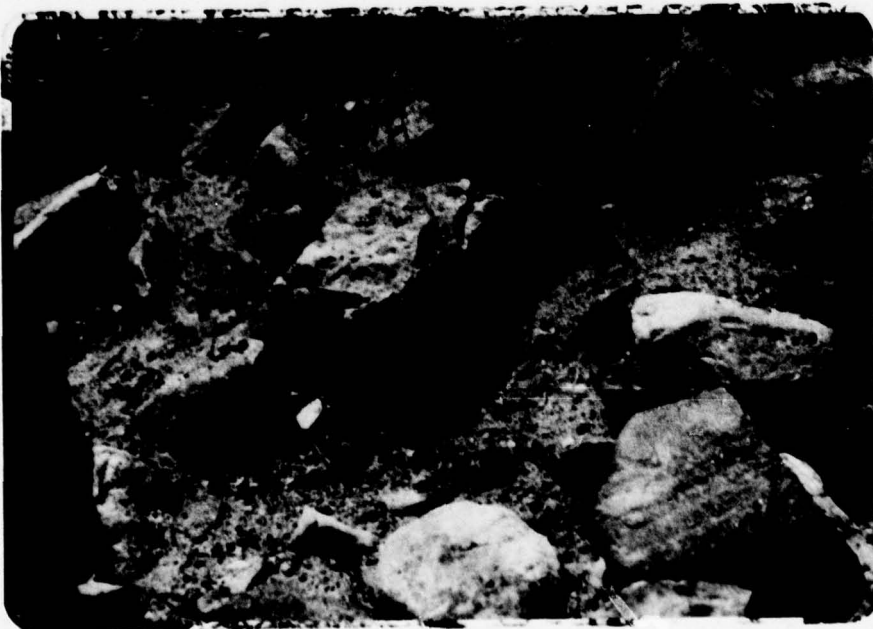
Erosion of riprap and earth at
left spillway sidewall abutment.

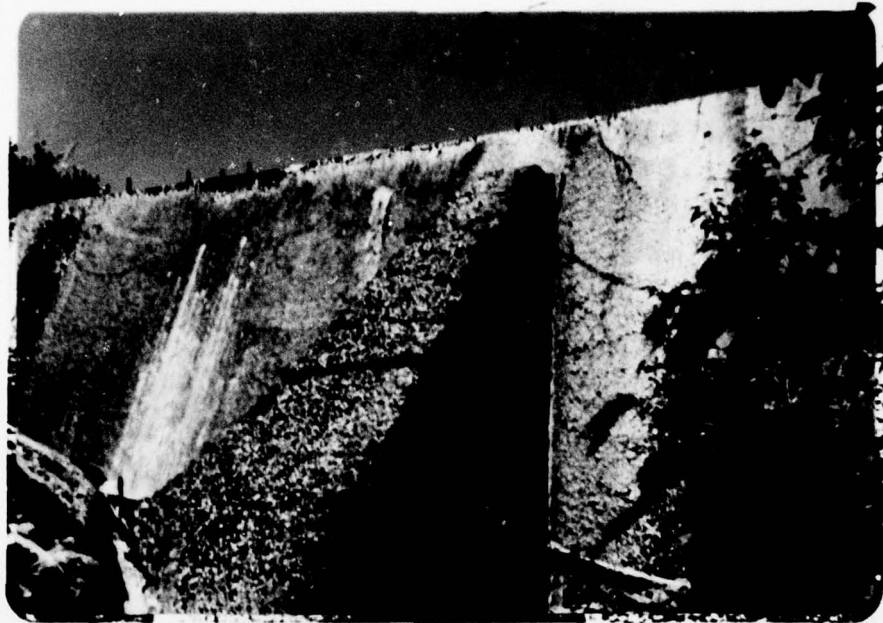
Central buttress pier at
downstream face of spillway.

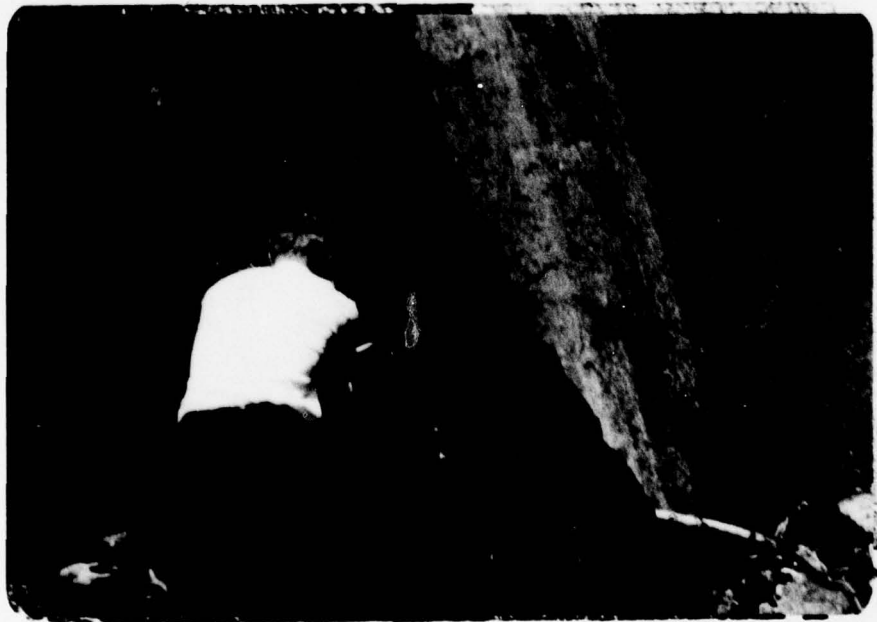
Weathering at central pier of spillway
along interface of concrete lifts.
Horizontal surface cracks in sidewalls.

Central pier at spillway.
Note horizontal grooves where
concrete lifts were placed.

2. Deterioration of the spillway concrete should be repaired and measures taken to minimize further concrete deterioration. This should be done in the future.

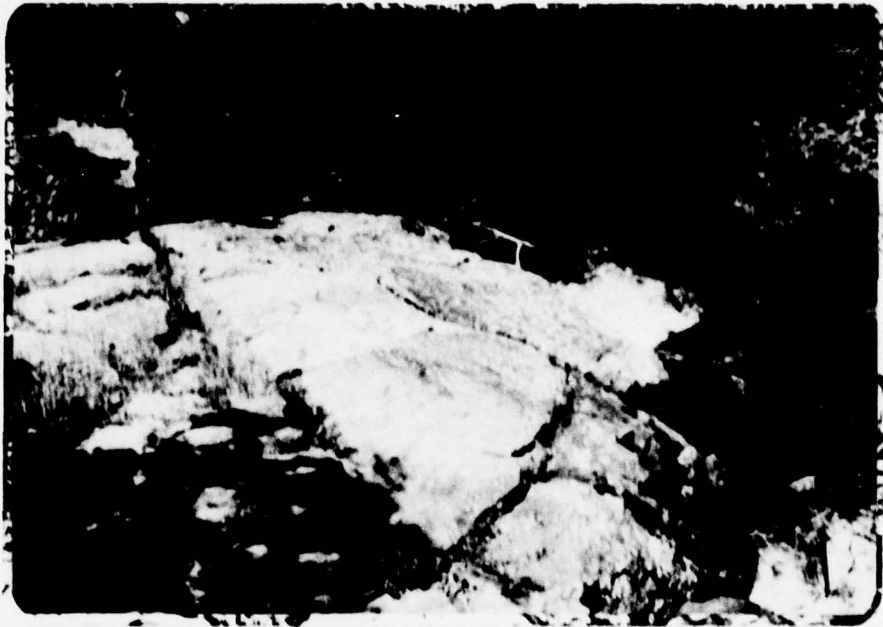
Foundation rock at base of
central pier at downstream
face of spillway.

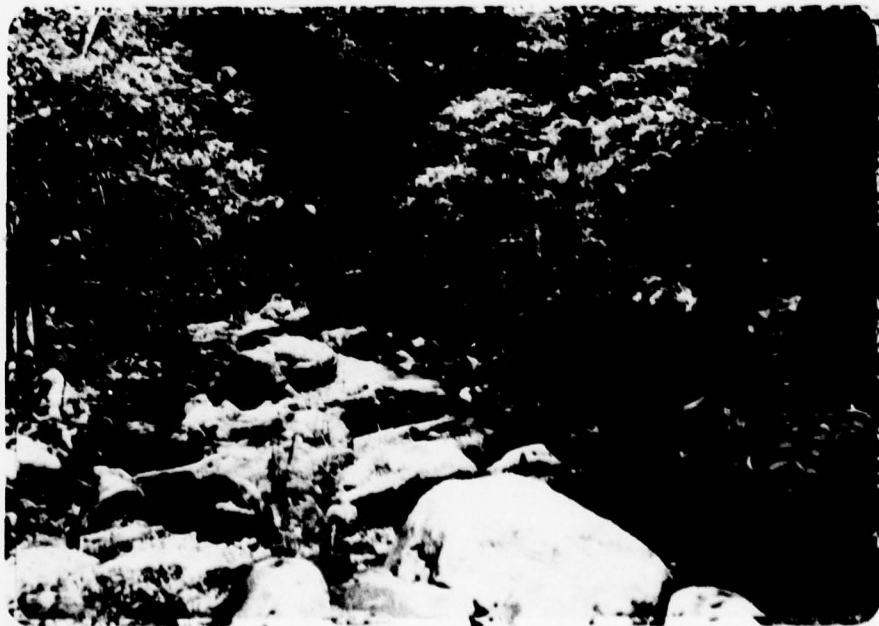
Spillway discharge channel
looking downstream.
