GREEN SWAMP NO. 3

PHASE I INSPECTION REPORT

NATIONAL DAM SAFETY PROGRAM

NJ 00211

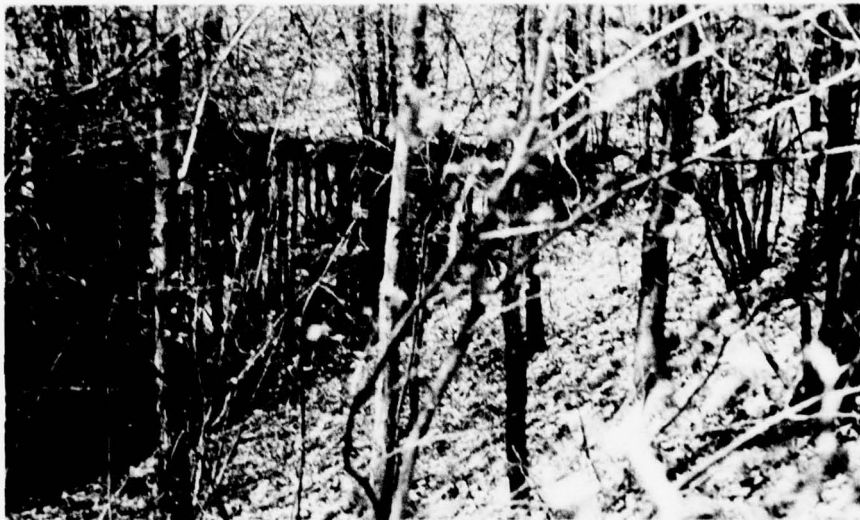
The small swamp occupies a part of the downstream slope, apparently formed because of a natural poor drainage condition at the downstream valley bottom. The water level in the swamp was about 4.7 feet below the reservoir pool level at the time of inspection. The swamp is believed to be fed by the local surface drainage and springs, although the actual source of the water must be determined. There are some doubts on the foundation watertightness because of the fact that foundation grouting was not

6.1.1 Visual Observations: The existence of the small swamp with a water level which is higher than the toe of the downstream embankment has raised the phreatic surface within the downstream embankment. The high phreatic surface and poor toe drainage condition presents a potential safety hazard due to long term slope instability which would require further in-depth studies and analyses.

VISUAL EXAMINATION OF	OBSERVATIONS	REMARKS OR RECOMMENDATIONS
ANY NOTICEABLE SEEPAGE	Dam No. 3 - No seepage noticed; however, directly against the toe of the downstream slope is a 45-foot wide pool of stagnant, dark brown water, 8 to 9 inches deep at the edge with an exit which at 250 feet south of the dam flows at about 5 gpm. This water seems to be trapped in a depression in the rock. Some of this flowing water may be attributed to surface water.	Remove fallen trees which impede flow of water, and deepen pool exit drain to keep the water off the toe of the dam is downstream.
STAFF GAGE AND RECORDER	Dam No. 2A - None.	
DRAINS	Not Applicable	
	Not Applicable

DOWNSTREAM SLOPE WITH POOL OF WATER

a. Within six months of the date of approval of this report, the pool of water saturating the downstream toe should be drained and an engineering study initiated to determine the source of this water. The poor drainage of this area should be corrected.

7.2.1 Alternatives: In order to drain the swamp at Green Swamp Dam No. 3, the invert of the natural drainage swale could be lowered, or a newer, shorter route chosen (which would include a considerable amount of rock drilling and blasting). An alternate is to drill holes from the downhill side to permit drainage. A subsequent visual inspection of the swamp area should be made when the swamp is drained.

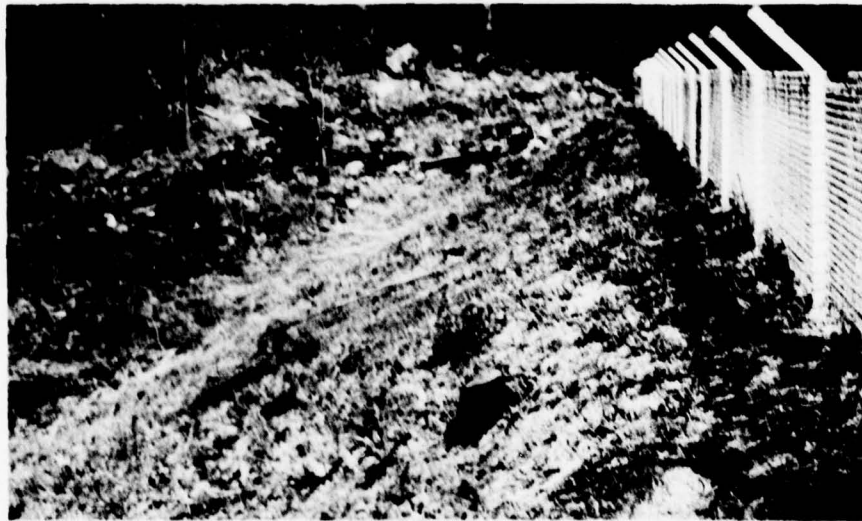
3.1.2 Dam: Some slight sloughing along the downstream slope was observed; the material exposed is mainly silty sand and small gravel. A large size burrow hole was seen on the upper part of the downstream slope, 2-1/2 feet below the crest. The crest of the dam is covered with tufts of grass; shrubs and trees up to 6 inches in diameter cover the upstream slope; trees up to 11 inches in diameter were observed on the downstream slope. A pool of stagnant water is ponded against the downstream slope, to elevation 298 feet. A water depth of 8-9 inches was measured along the perimeter of the pond. At a distance of 250 feet downstream from the pool, water is flowing at an estimated 2-5 gpm with the reservoir water elevation at 302.4 feet.

DOWNSTREAM SLOPE LOOKING WEST

7.2.2 Operational and Maintenance Procedures: Clearing of large trees and stumps and prevention of tree growth on the embankment should be performed within the next two years. All burrows in the embankment should be backfilled with select compacted granular material. The cleaned ground surface should be redressed with top soil and seeded with select grass.
