RARITAN RIVER BASIN

DAVIDSONS MILL POND DAM

PHASE I INSPECTION REPORT
NATIONAL DAM SAFETY PROGRAM

NJ 00516

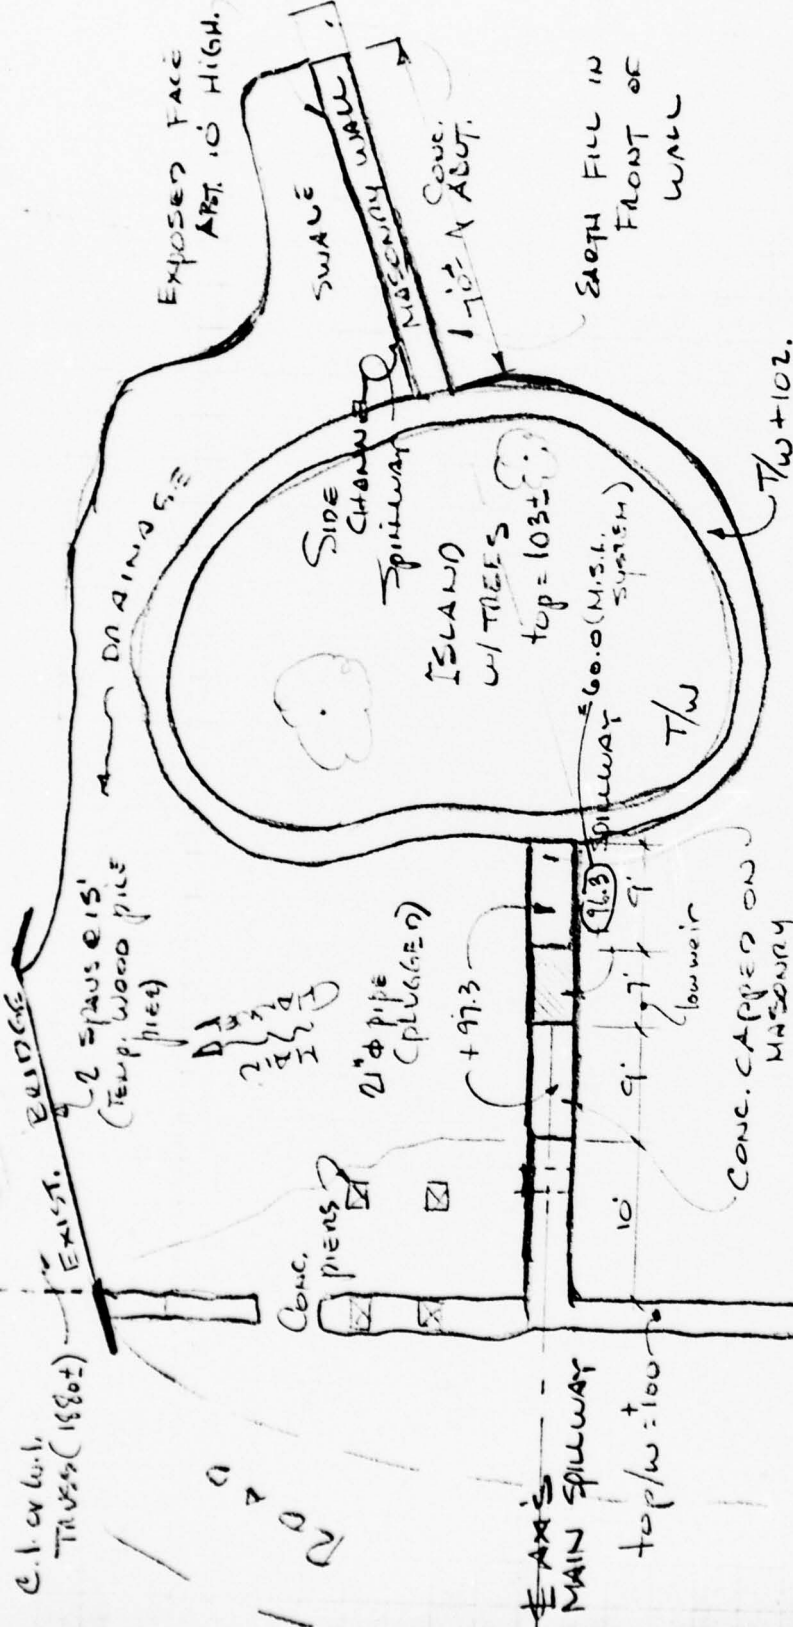
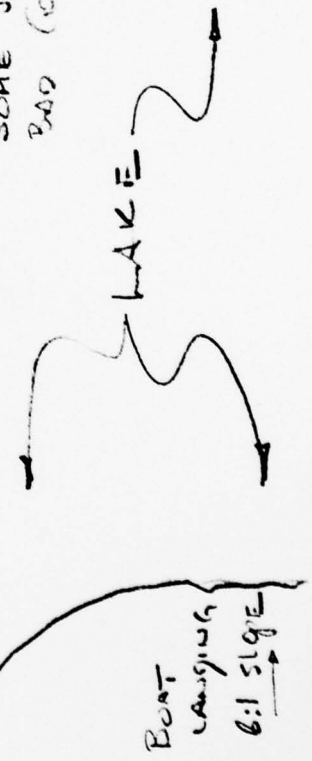
FIGURE 2

NOTE: ALL WALLS - APPROX. 2'
 RANDOM ASHLAR MASONRY.
 SOME JOINTS MORTARED.
 BAD CONDITION.

- 1) Place riprap at the toe of the east auxiliary side channel.
- 2) Extend the wall at the west abutment in a southerly direction to protect the left abutment and road.
- 3) Repoint mortared joints.

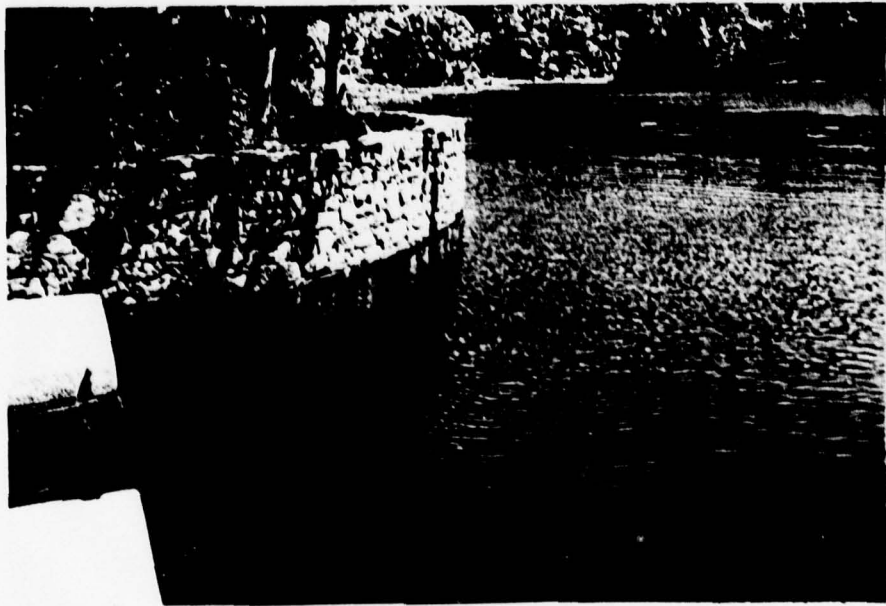
View of pond

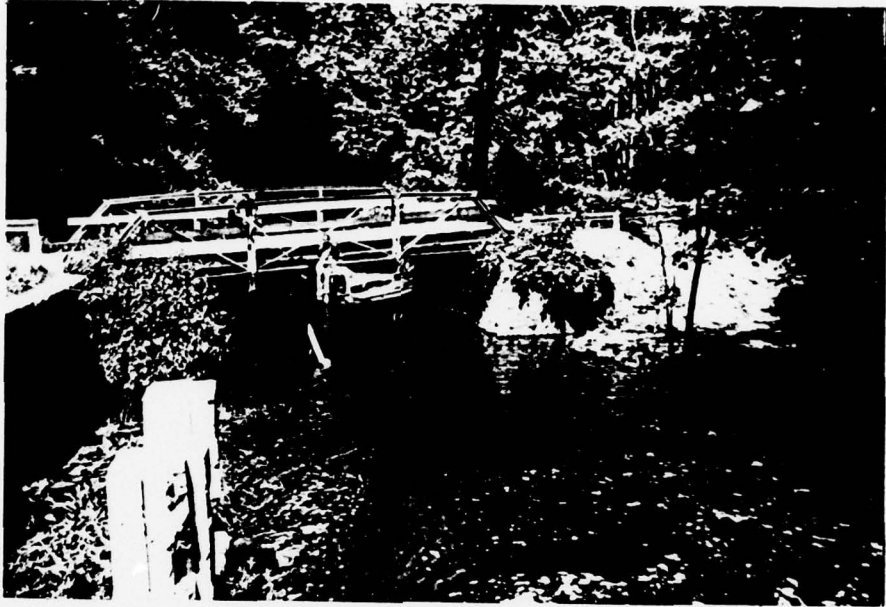
Downstream of Spillway

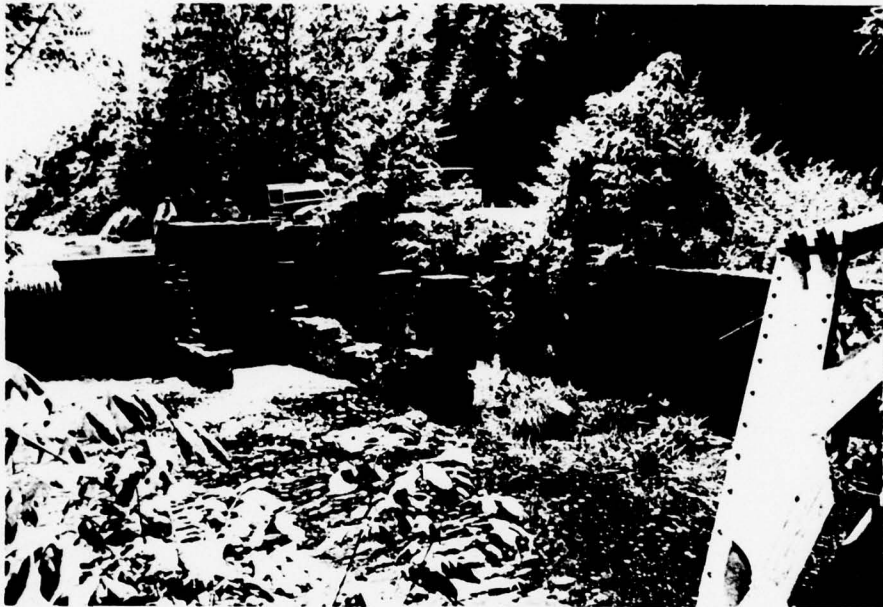
Old power channel

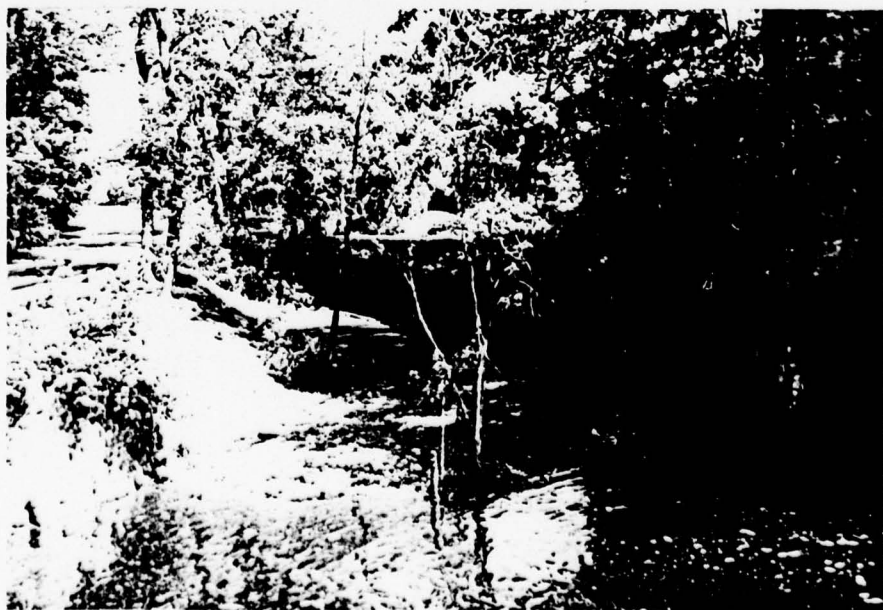
Downstream of Spillway

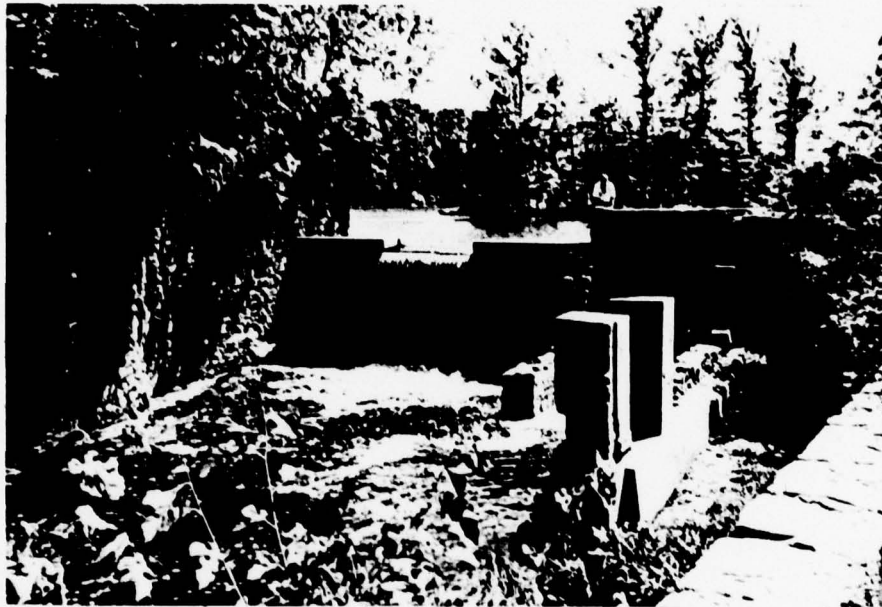
Downstream view of Spillway

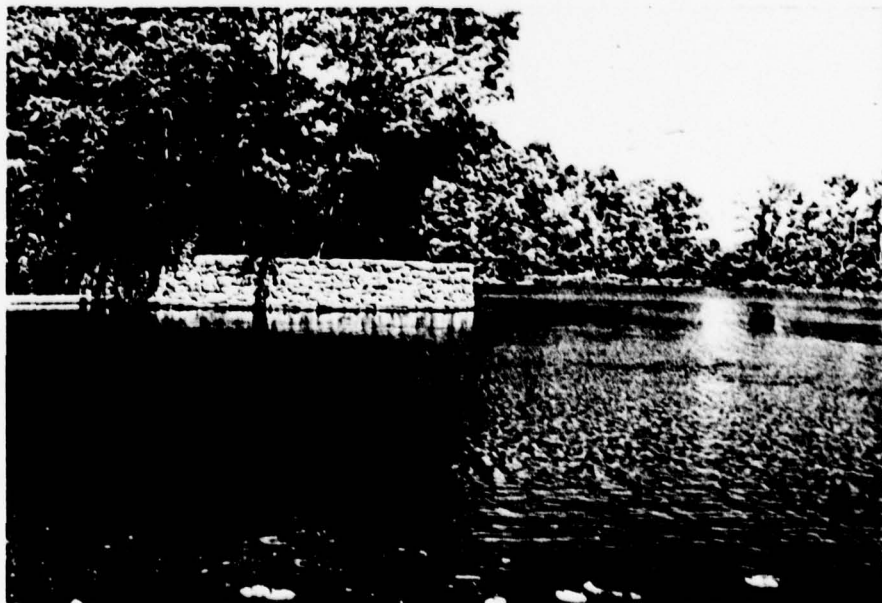
VISUAL EXAMINATION OF	OBSERVATIONS	REMARKS OR RECOMMENDATIONS
SLOPES	Very flat	
SEDIMENTATION	Appears to be heavily silted up. Silted much worse in upper end of reservoir.

View of Pond
