WESTONS MILLS ARCH DAM

PHASE I INSPECTION REPORT
NATIONAL DAM SAFETY PROGRAM

NJ 00382

WESTONS MILLS ARCH DAM (NJ00382)

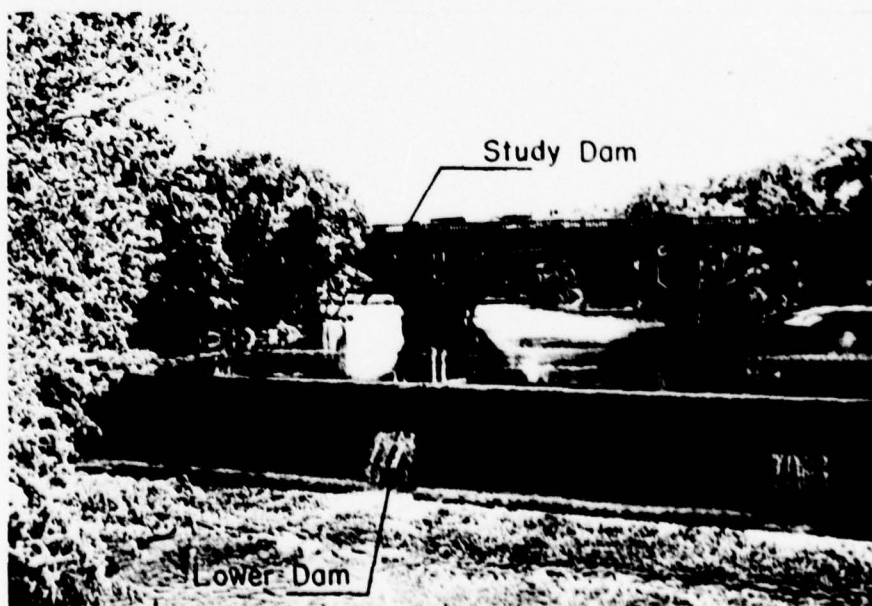
It is believed that the safety of this dam would be substantially decreased if the Lower Dam were to fail. This is due principally to the short 600 foot distance between them which maintains a tailwater on the study dam during overtopping flood conditions.

Dam downstream of study dam
