BENNETTS MILLS DAM

PHASE I INSPECTION REPORT

NATIONAL DAM SAFETY PROGRAM

NJ00088

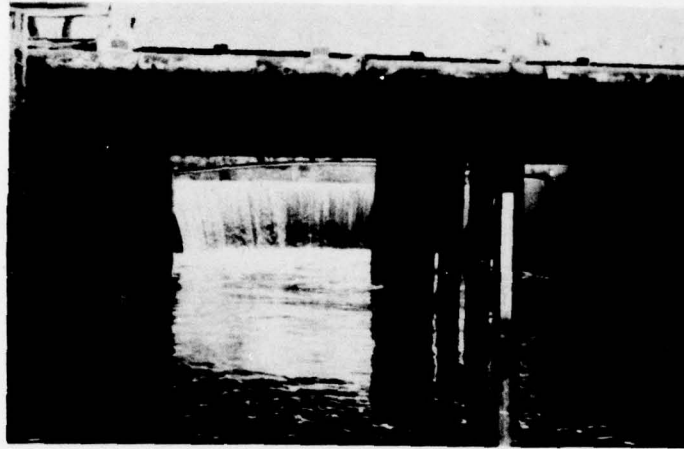
Photo 5 - Downstream view of the timber substructure of the bridge crossing the South Branch of the Metedeconk River; the spillway structure is in the background

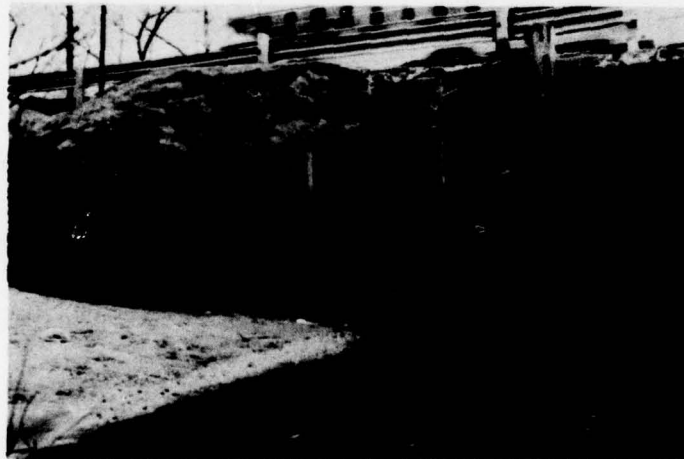
Considerable erosion was observed behind the downstream side of the right bridge abutment wingwall and to a lesser extent behind the left bridge abutment wingwall. No riprap erosion protection was observed in these areas. Asphalt erosion protection did not appear adequate.

Photo 6 - View of the right downstream timber bridge wingwall and wingwall extension; the asphalt earth embankment protection has eroded

VERTICAL AND HORIZONTAL ALIGNMENT OF THE CREST	The roadway embankment is built on a curve and on an upward slope from right to left, no obvious misalignments or settlements are visible.	Protect areas behind downstream wingwalls with stone or asphalt paving.
RIPRAP FAILURES	Asphaltic abutment protection at downstream bridge abutment slopes has failed and is undercut on right side, serviceable but deteriorating on left side.	Repave with asphalt material or place slope protection.

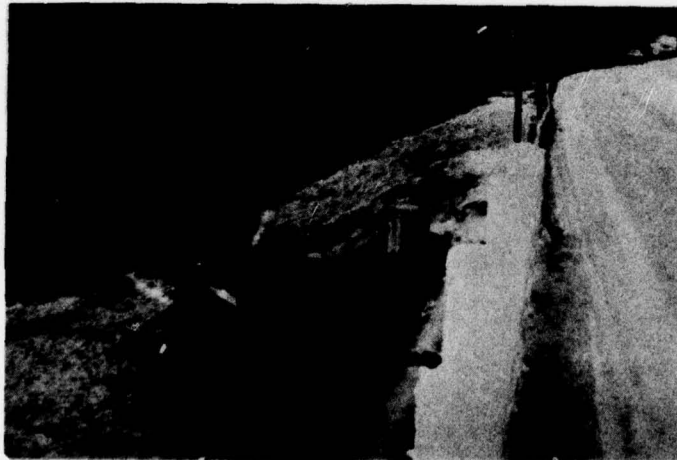
Photo 8 - View of the downstream roadway embankment slope looking toward the right abutment; the water impounding part of the roadway embankment ends approximately at the end of the guardrail

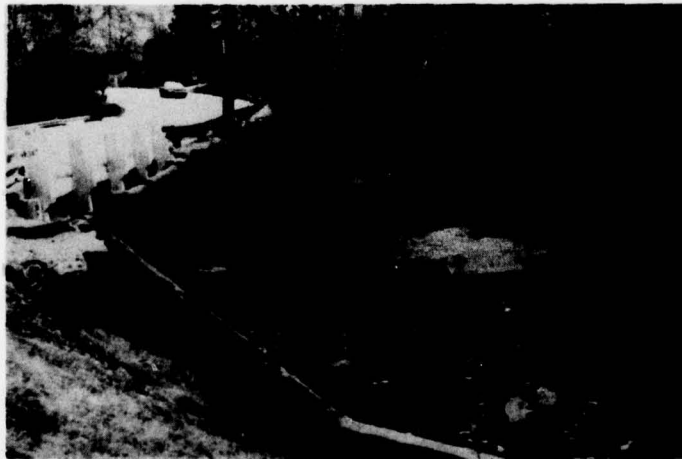
Photo 10 - Downstream face of the left timber bridge wingwall and the roadway embankment slope

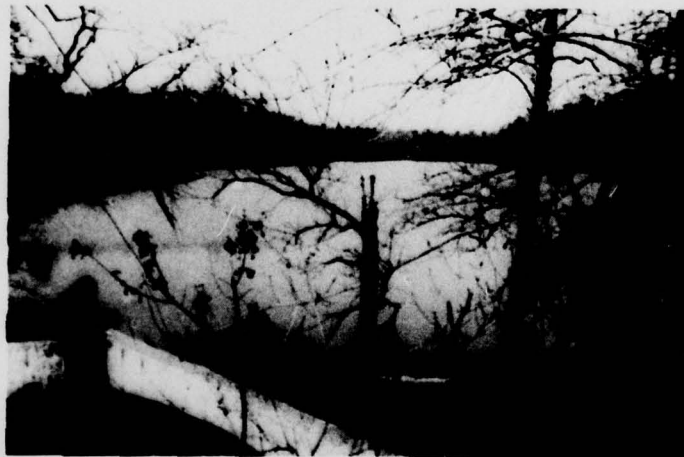
Photo 12 - View of the reservoir, looking upstream from the roadway
