PASSAIC RIVER BASIN

GREEN SWAMP NO. 2

PHASE I INSPECTION REPORT

NATIONAL DAM SAFETY PROGRAM

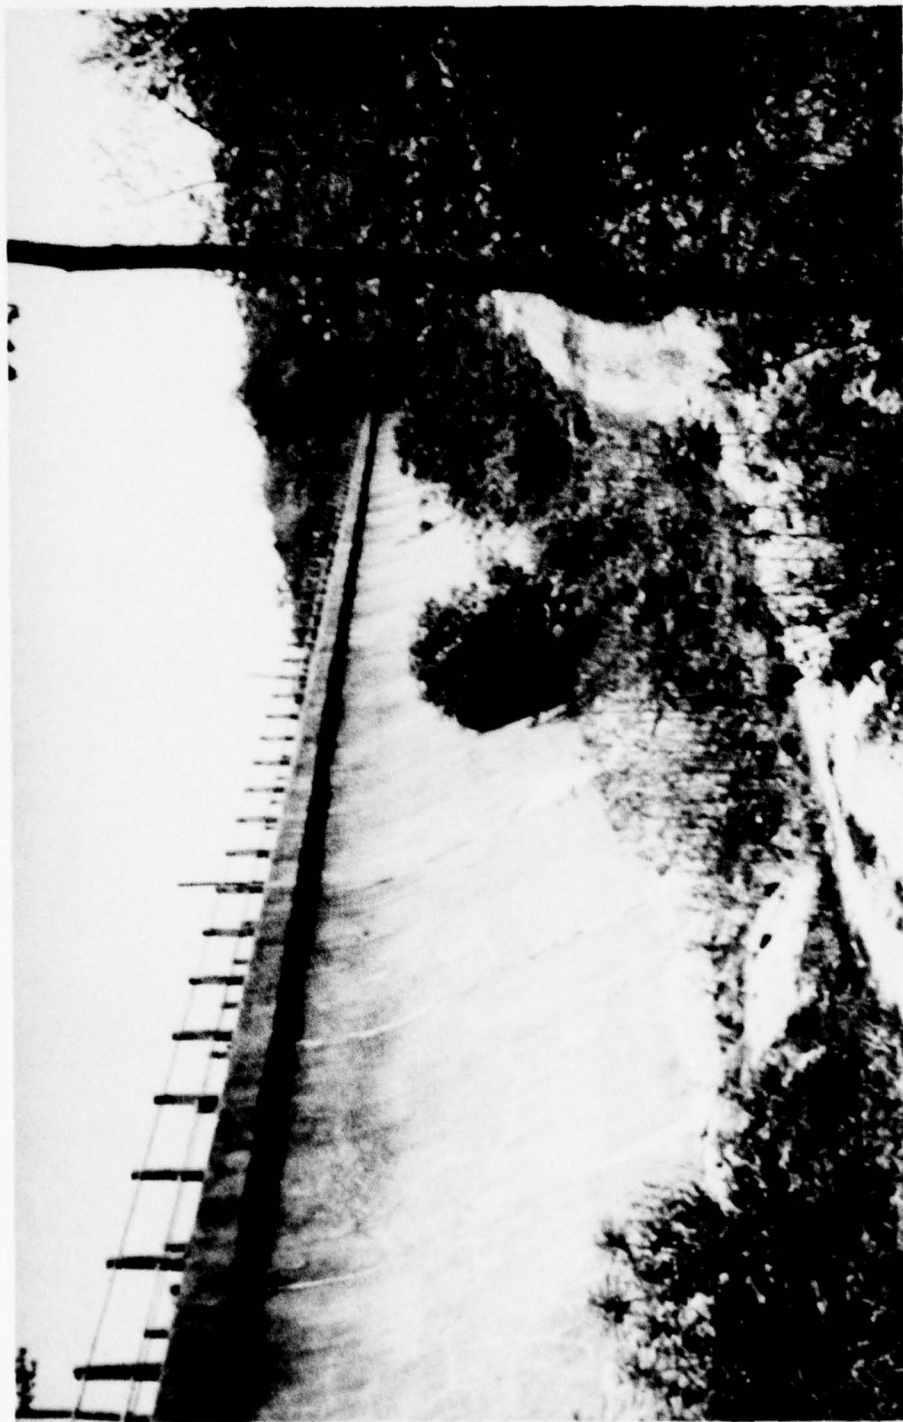
OVERVIEW PHOTO - GREEN SWAMP 2
(DOWNSTREAM VIEW OF DAM LOOKING EAST)

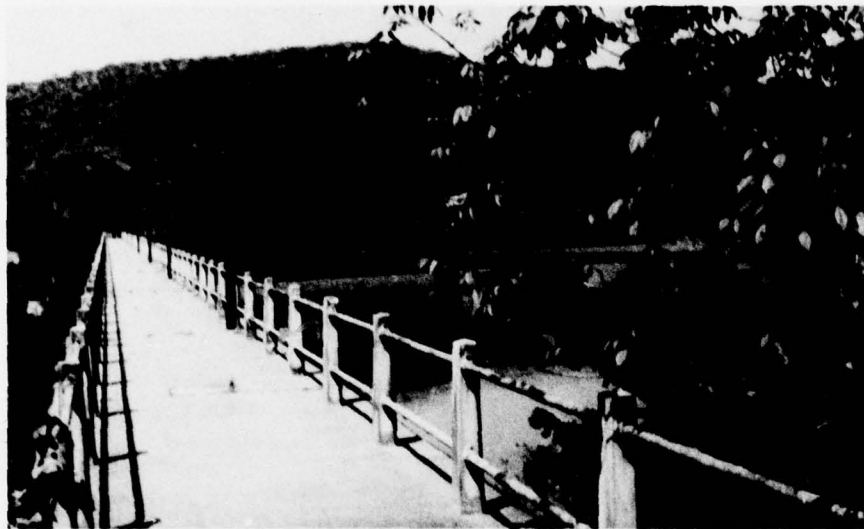
TOP OF DAM LOOKING TOWARDS RIGHT ABUTMENT

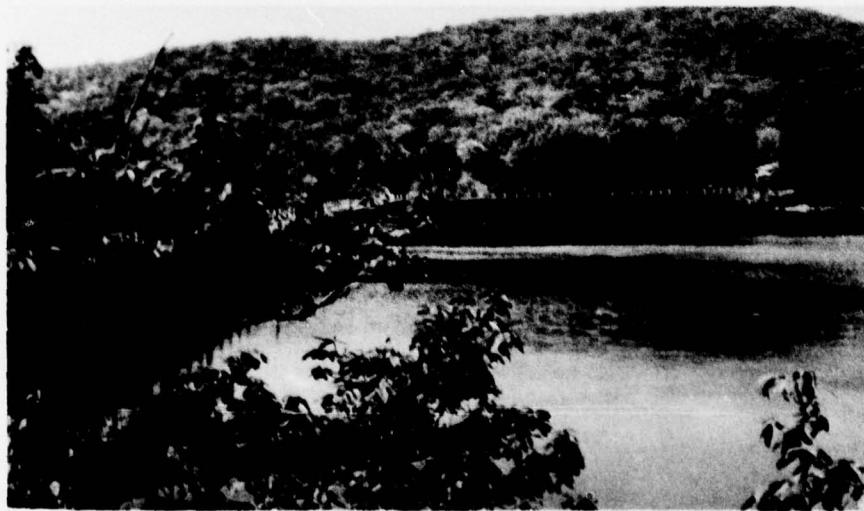
UPSTREAM VIEW
