# LAKE LEFFERTS DAM

## PHASE I INSPECTION REPORT NATIONAL DAM SAFETY PROGRAM

NJ 00089

JULY 1978

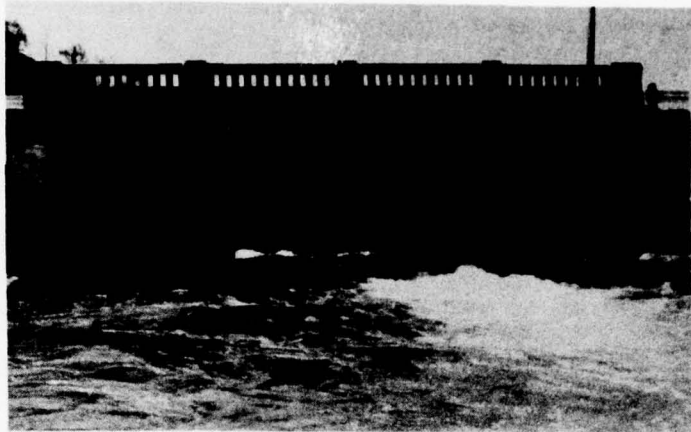
Photo 3 - View of the downstream face of the spillway bridge over Matawan Creek; the concrete spillway is in back; the right low level outlet is fully open; discharging water strikes the left bridge abutment before continuing downstream; Matawan Creek is tidal and the picture was taken near high tide

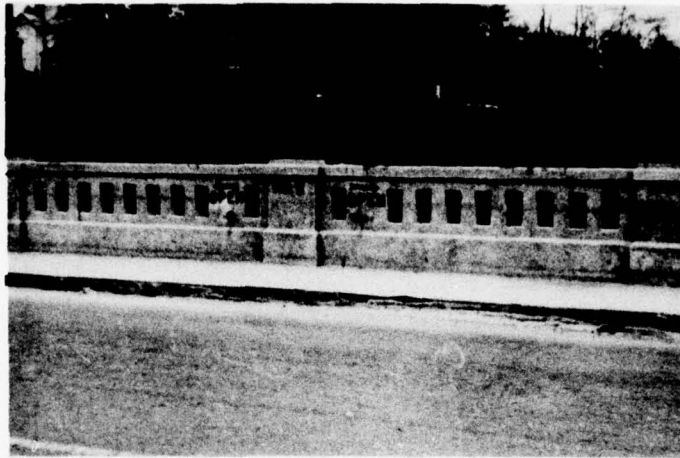
universal joint (Hooke's type) to an extension shaft. The extension shafts allow the sluice gates to be operated from the surface of the roadway which bridges the spillway. The universal joint on the 24-inch valve is worn and is quite loose. In addition, the support guide for the extension shaft has broken loose from the concrete spillway. In its present condition, this gate cannot be operated with any reliability. These items should be replaced. The other operator and extension shaft for the 30-inch diameter valve is in good condition.

Photo 5 - View of the upstream spillway bridge railing, where the low level outlet gate crank extensions pass through

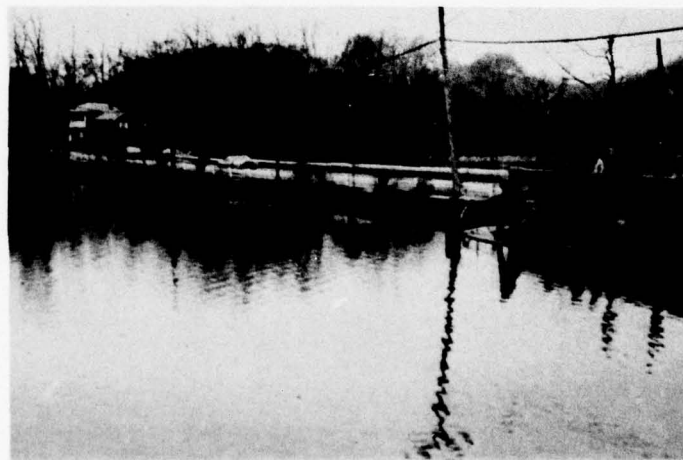
There is no evidence of leakage or seepage at this time. The upstream timber bulkhead sheeting is in good condition, for the portion visible above the lake level.

Photo 6 - Upstream view of the left abutment embankment and upstream timber sheeting

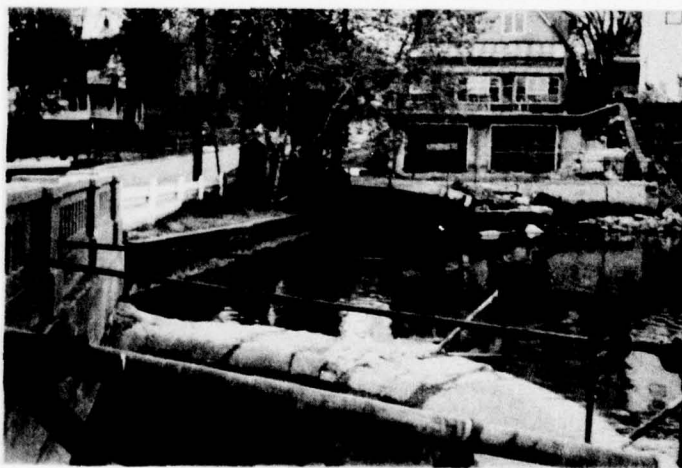
Photo 8 - View of the right upstream face of the embank-  
ment and right abutment

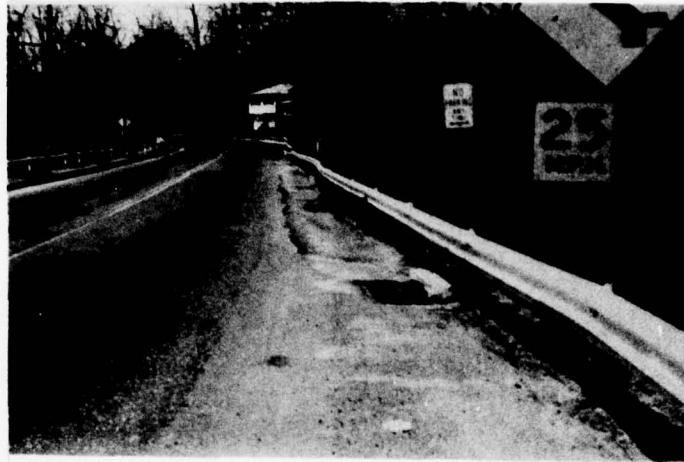
VISUAL EXAMINATION OF	OBSERVATIONS	REMARKS OR RECOMMENDATIONS
SURFACE CRACKS	Top of roadway embankment impounding Lake Lefferts is called Ravine Drive. Black top paving show a crack parallel to dam axis at a point where downstream face of retained embankment has moved from 6 to 12 inches downstream.	Monitor roadway cracking with a semi-annual inspection.
UNUSUAL MOVEMENT OR CRACKING AT OR BEYOND THE TOE	The timber pile supported downstream face of the left embankment has moved from 6 to 12 inches downstream, deflecting the vertical timber piles and punching down the batter piles. Area of movement is 125 to 200 feet to left of bridge.	Monitor deflections at half yearly intervals.
SLOUGHING OR EROSION OF EMBANKMENT AND ABUTMENT SLOPES	The area downstream of the left abutment timber pile supported embankment face is poorly graded, and retains normal drainage. Erosion at base of wall is believed to be due to roadway embankment overtoppings. Timber retaining walls are all in good condition.	Regrade downstream area of left embankment to drain water away from base of retaining wall.

Photo 9 - View of the roadway forming the dam crest, looking toward the left abutment; the guardrail on the downstream face has moved with the timber pile supported downstream retaining wall; the roadway paving has cracks paralleling the dam axis, also indicating downstream movement

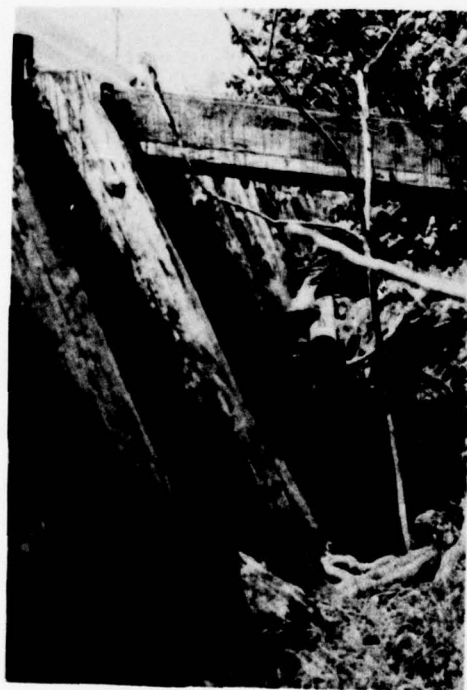
Photo 12 - Close-up of the downstream timber pile supported retaining wall; the wood structure visible at the top of the wall is a roadway drainage trough

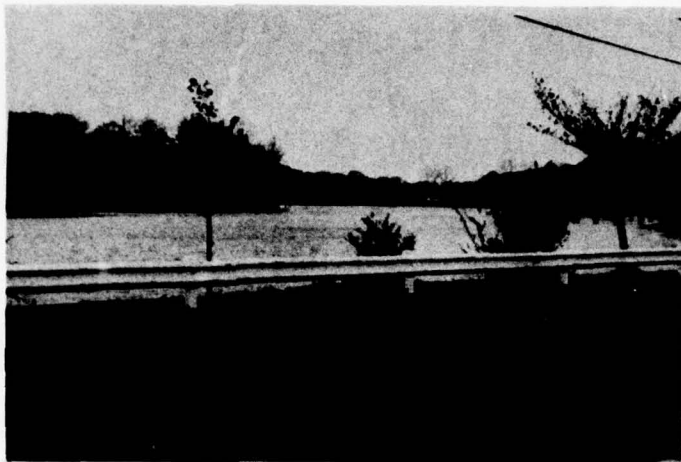
Photo 17 - View of Lake Lefferts, looking upstream from the roadway embankment

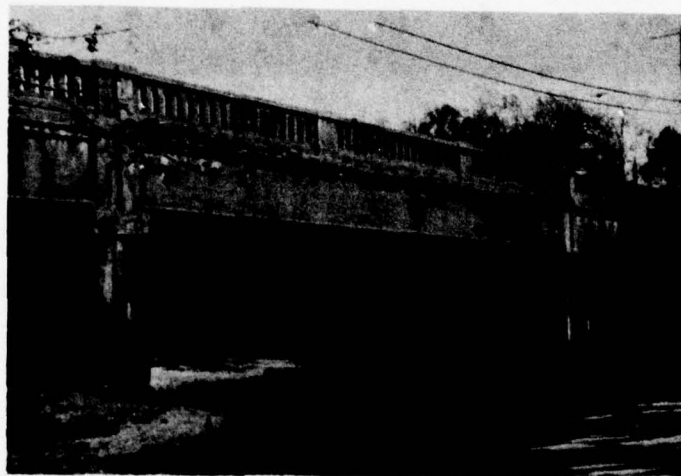
Photo 18 - State Route 34 crossing Lake Lefferts. 2,500 ft. upstream of dam embankment at Ravine Drive
