PASSAIC RIVER BASIN

**LIONSHEAD LAKE DAM**

**PHASE I INSPECTION REPORT**

**NATIONAL DAM SAFETY PROGRAM**

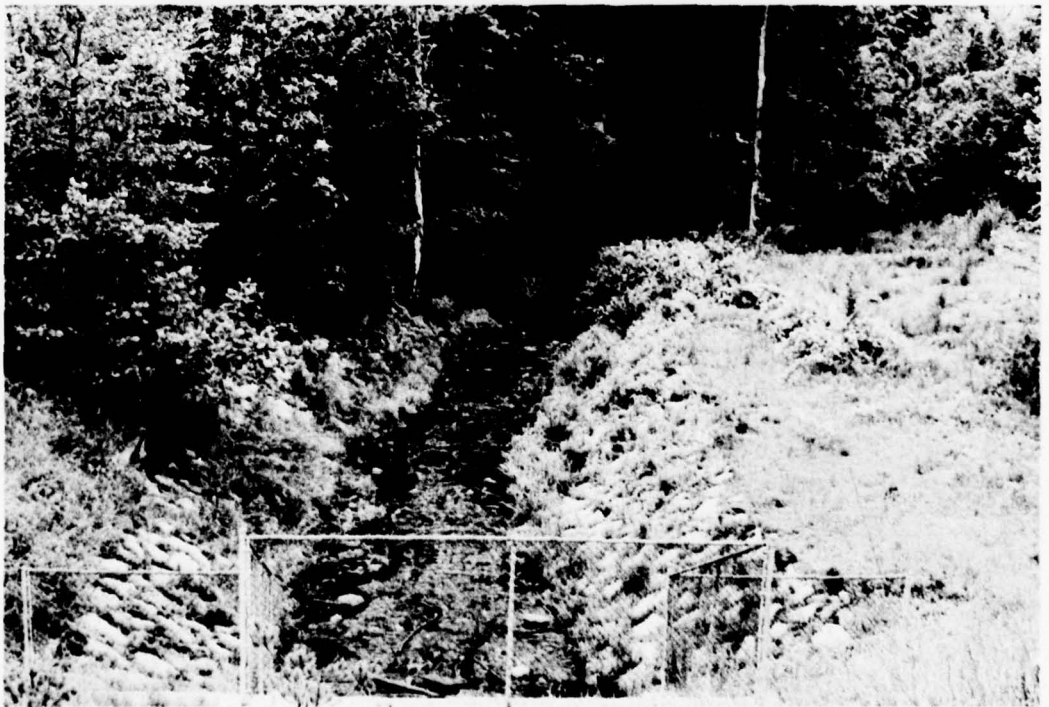
**PHOTO 6**

Photo 6 - View Downstream (North) Along Outlet Channel From Crest of Downstream Slope of Dam (Culvert Outlet Headwall at Bottom Center of Photo. Riprap on Stream Banks Extends 85 Feet Downstream From Culvert Outlet. The Riprap Lines the Slopes to a Height of Five Feet Above the Streambed Level.) - 13 June 1978
