FARRINGTON DAM

PHASE I INSPECTION REPORT NATIONAL DAM SAFETY PROGRAM

NJ 00383

JULY 1978

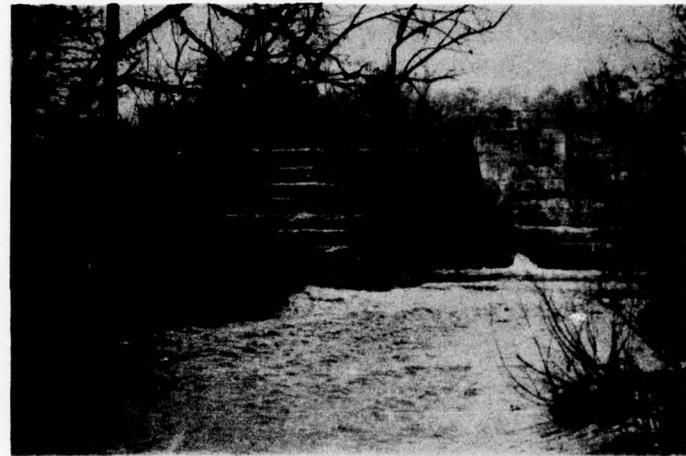
Photo 1 - Downstream face of the dam showing part of the spillway and part of the left non-overflow abutment section; the low level outlet is visible on the right at tailwater level; the downstream channel is partly blocked off by the tree grown peninsula visible on the left of the picture

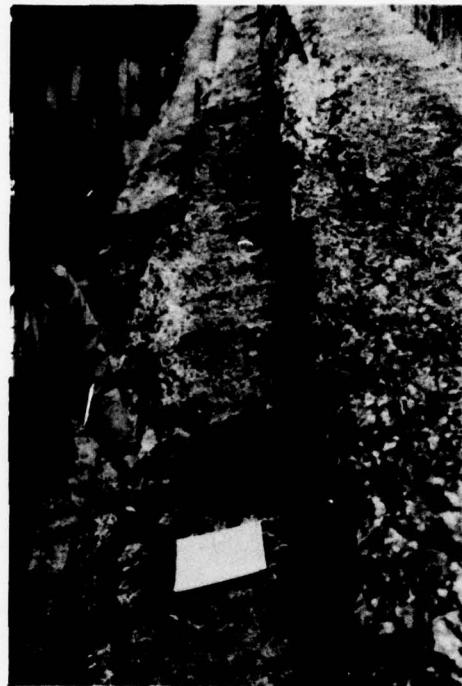
The overlay concrete obscures the original monolith joints and they are hard to discern on the downstream face. It is hard to ascertain where the overlay concrete facing was jointed, because of the severe deterioration of the surface. One monolith joint in the base concrete was found on the downstream face, in a spalled condition beneath the deteriorated overlay facing. Two monolith joints were observed on the back face of the dam, one each in the middle of the non-overflow sections adjoining the central spillway. These joints are also severely spalled. The only construction drawings available do not show any monolith jointing. No construction joints are visible except on the back face of the dam where two cracked horizontal construction joints are visible very close to the top of dam.

Photo 5 - Detail of the deteriorated downstream face concrete overlaying a monolith or construction joint in the original concrete placement

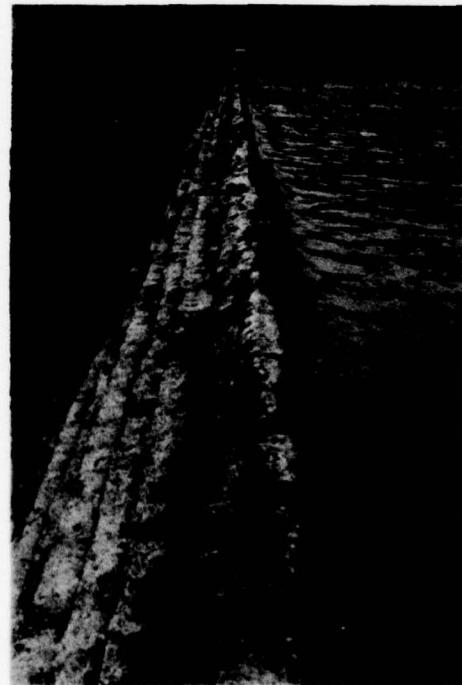
The spillway crest, also apparently repaired, is in slightly better condition than the remainder of the dam face, although also severely eroded. In places, such as adjacent to the left non-overflow section the spillway crest repair concrete, it is completely missing for a distance

Photo 6 - View across the spillway crest of the dam, looking toward the right abutment, showing the deteriorated crest

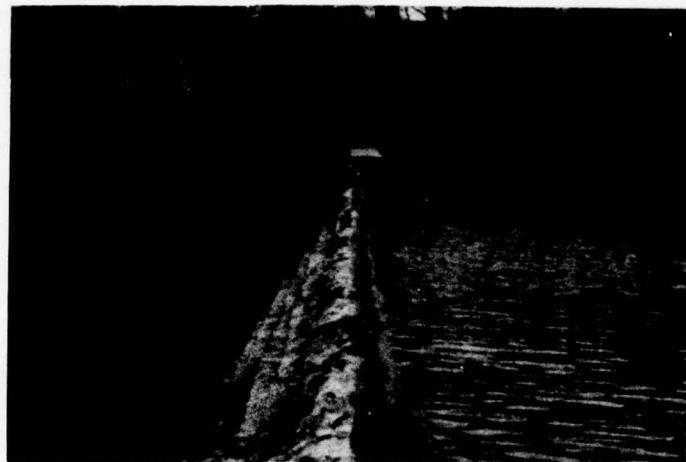
Photo 7 - Detail of the spillway crest at the right non-overflow abutment section

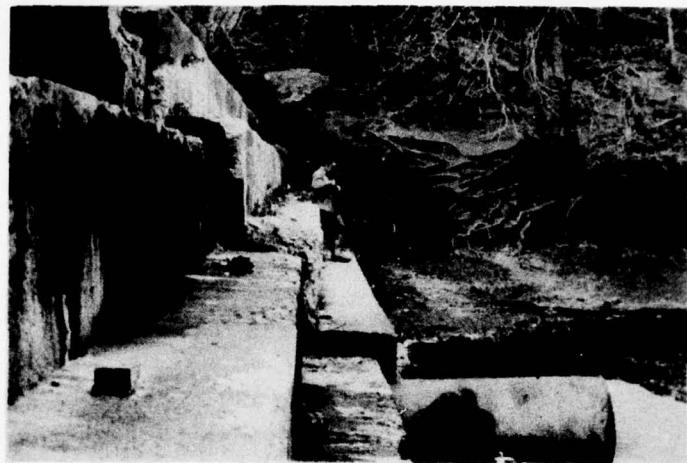
Photo 9 - View of the lower left abutment area downstream
of the dam

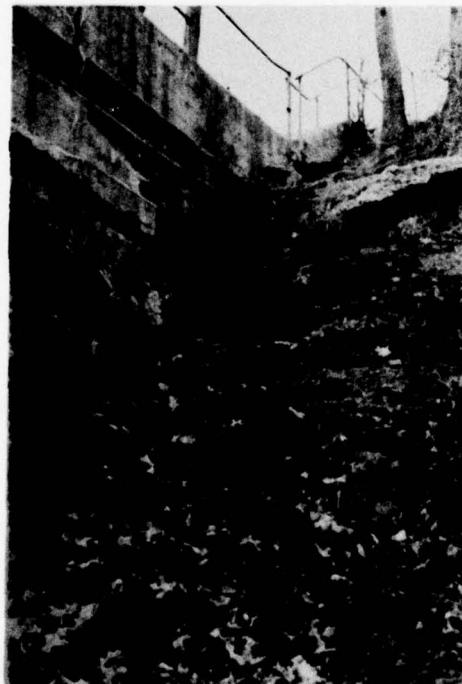
Seepage was observed coming out high up on the left abutment's downstream face, approximately at the reservoir level and estimated at one gallon per minute.

Photo 10 - View of the upper left
abutment area downstream
of the dam showing the
the general area of see-
page at the top of the
dam

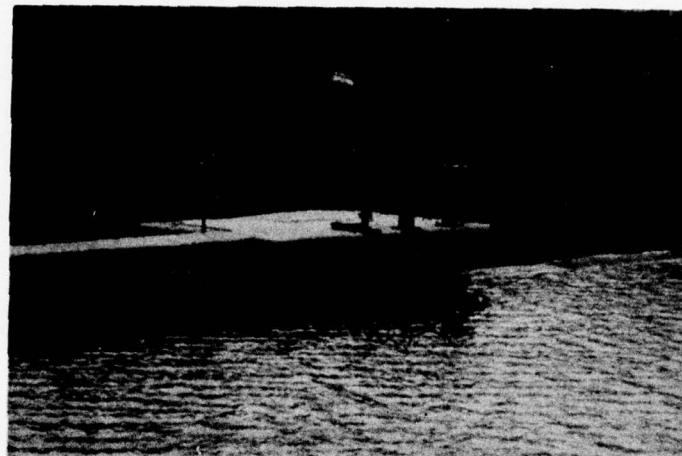
Photo 11 - View of the upstream face of the dam at the left abutment showing the spillway and the outlet works gate operating stands

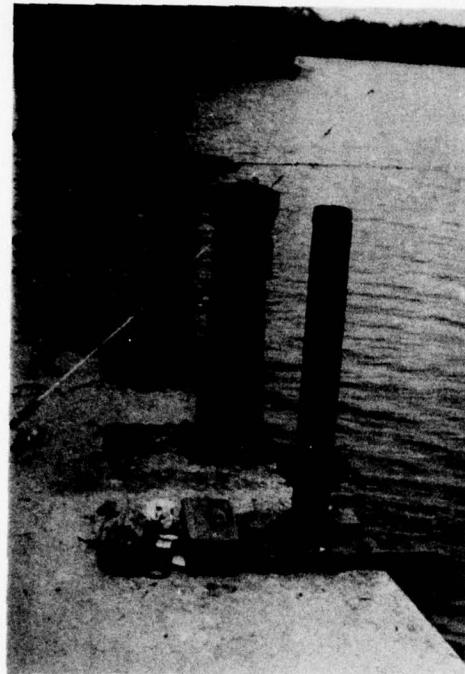
In summary, Gate 3 is operable and in good condition; Gate 1 is inoperable; however, the desirability of repair is debatable since the centerline elevation of this intake is only two feet below the crest of the spillway. Gate 2 has been unused for years and may be inoperable. Without this gate, the reservoir can be drawn no lower than approximately elevation 37.0, which is the invert elevation of the mid-level outlet Gate 3.

Gate No. 1 (high level) has a missing operating stand and is inoperable. Gate No. 2 has not been operated in years and is assumed to be inoperable. Gate No. 3 (mid-level) is operable.

Photo 13 - Close-up of the outlet works gate operating stands; only the far stand, controlling the middle gate is readily operable

The rehabilitation of the deteriorated dam spillway crest and facing would be part of such a plan. The low and high level outlet gates should be brought up to full operational capacity within six months.

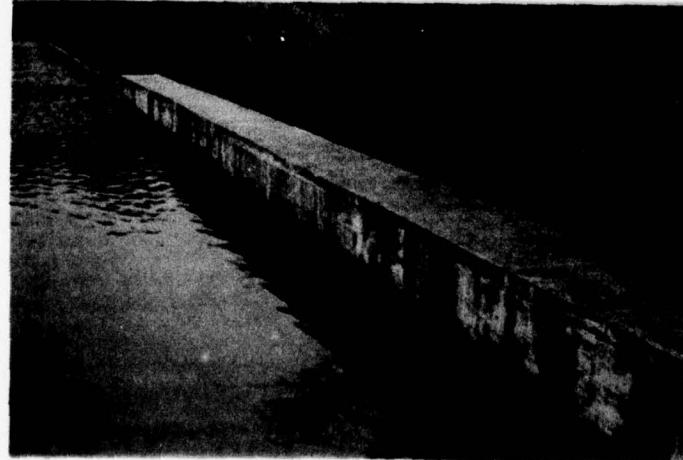
Photo 14 - Upstream view of the right abutment non-overflow abutment section
