DELAWARE RIVER BASIN

# EVANS POND DAM

## PHASE I INSPECTION REPORT

## NATIONAL DAM SAFETY PROGRAM

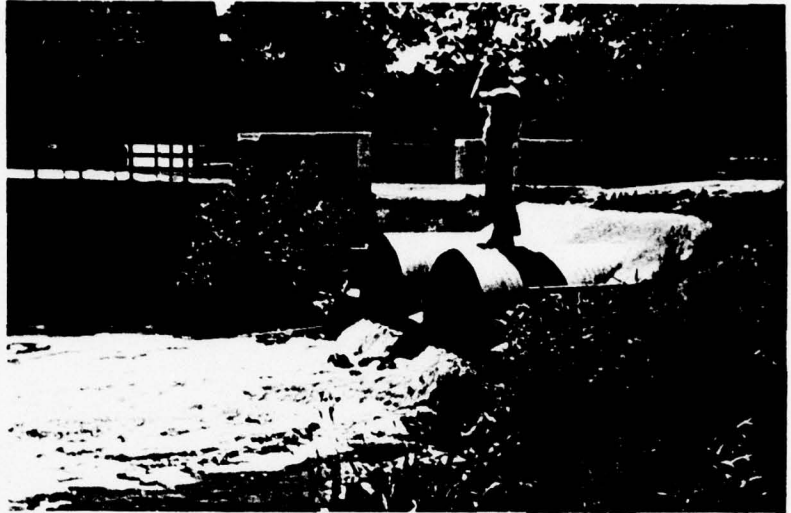
The surface and slopes of the embankment appear to be in fair condition. Some minor erosion has occurred at various spots and the recently installed sluice pipes exhibit outlet velocities that could cause scour during periods of high flow. No evidence of seepage or significant settlement were observed but at the time of inspection the backwater elevation from the Wallworth dam downstream limited the exposed height of embankment to about 3.5 feet. It appears the upstream face is heavily silted up and the toe of the downstream face is continually submerged.

Discharge of Sluices  
June 1978

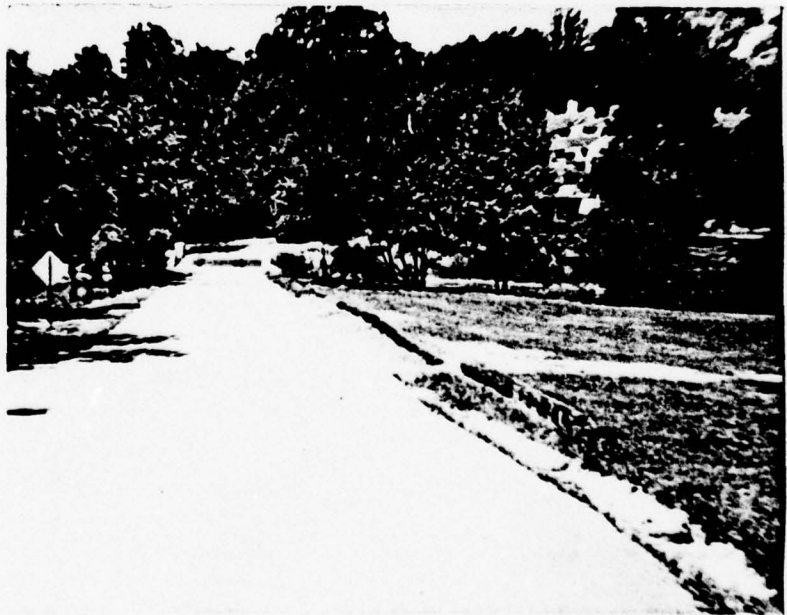
View West towards bridge  
June 1978
