LANGAN ENGINEERING ASSOCIATES INC CLIFTON NJ  
NATIONAL DAM SAFETY PROGRAM. UNTERMEYER DAM (NJ00253), PASSAIC --ETC(U)  
JUL 78 D J LEARY

REPORT DOCUMENTATION PAGE		READ INSTRUCTIONS BEFORE COMPLETING FORM
1. REPORT NUMBER NJ00253	2. GOVT ACCESSION NO.	3. RECIPIENT'S CATALOG NUMBER
4. TITLE (and Subtitle) Phase I Inspection Report National Dam Safety Program Untermeyer Lake Dam Morris County, N.J.	5. TYPE OF REPORT & PERIOD COVERED 90 FINAL Rept. 13

PHASE 1 REPORT  
NATIONAL DAM SAFETY PROGRAM

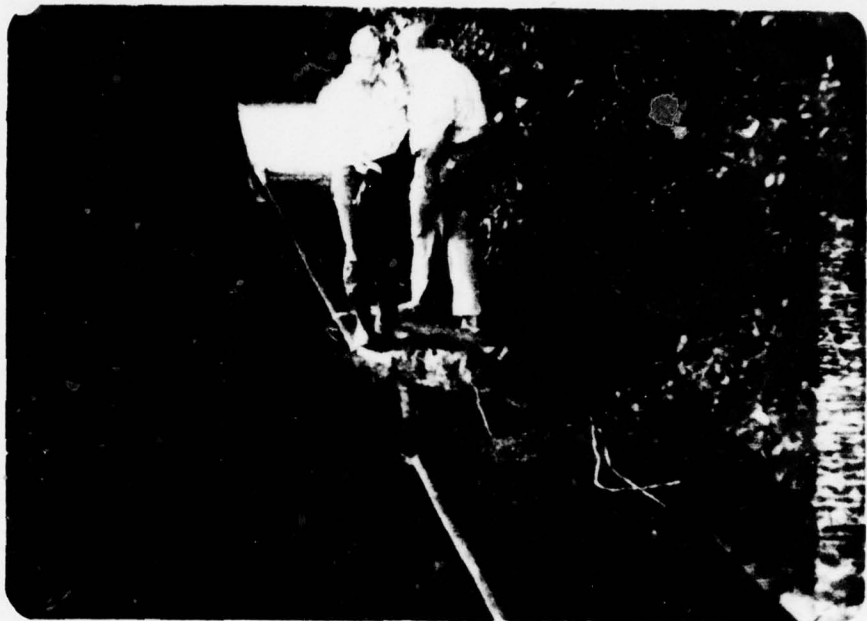
30 June 78 (Evening)

NJDEP personnel atop masonry spillway, beside partially deepened notch (18-inches) in the spillway wall of UNTERMEYER Dam. (Notch later extended to depth of 4-feet from top of spillway.)

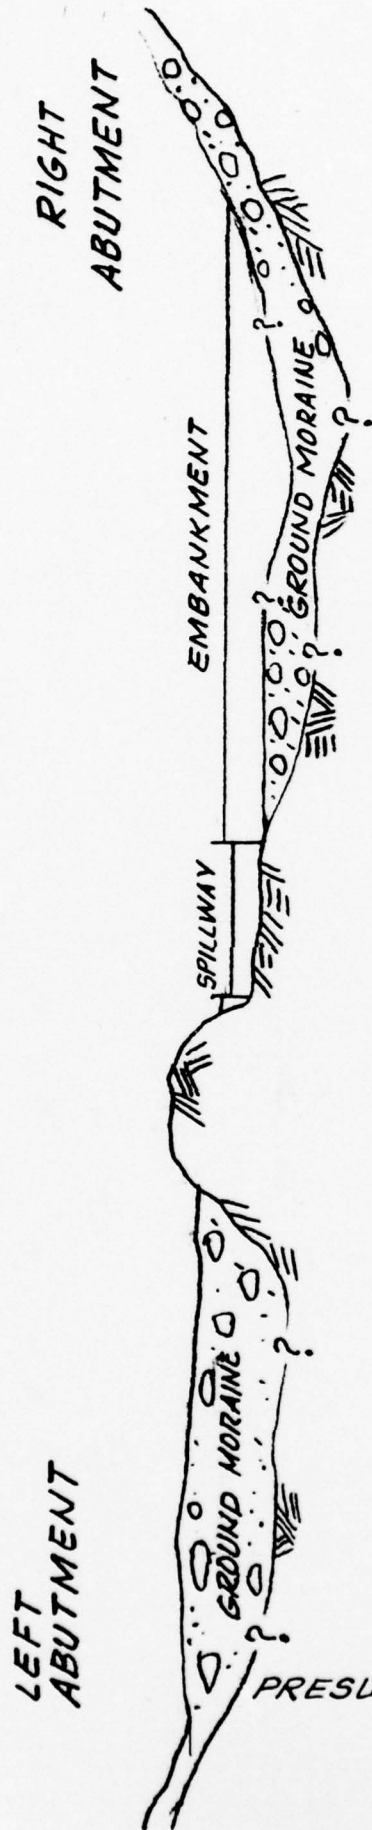
Fig 4

This dam was constructed in a stream valley which contained a large bare knob of bedrock in the approximate center of the valley. The spillway was constructed on the bedrock knob and what appears to be a random fill embankment was constructed between the spillway and the right abutment to the south. Boulders up to 3 ft in diameter were observed in the embankment. The original stream bed is located approximately half-way between the spillway and the right abutment. It appears that while the spillway has been constructed on rock, the major portion of the embankment has been built on ground moraine and alluvium. Rounded boulders up to 12 ft in diameter were seen in the old stream bed.

DIAGRAMMATIC SKETCH  
 UNTERMAYER DAM  
 (NO SCALE)

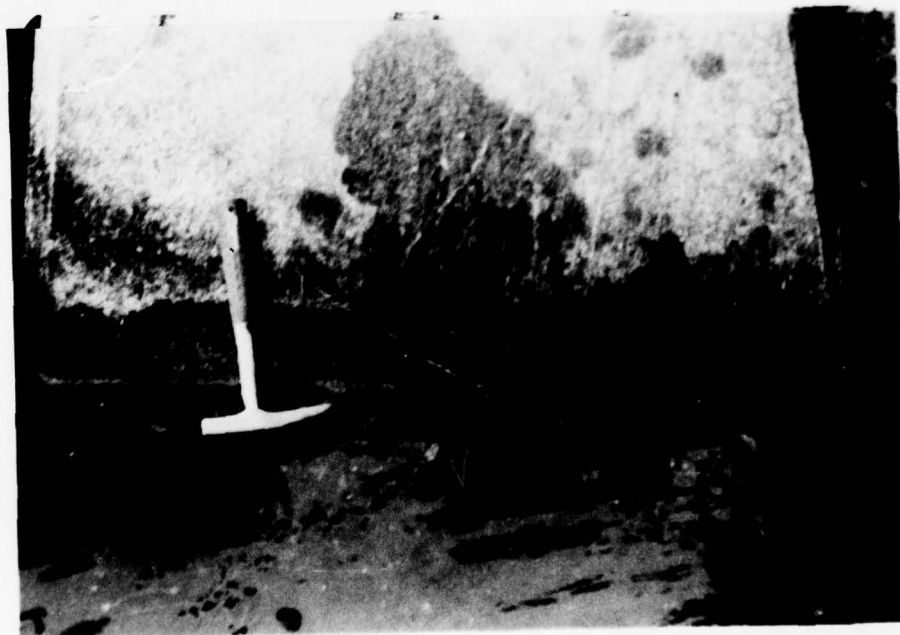
Crack in concrete spillway 8 June 1978  
crest

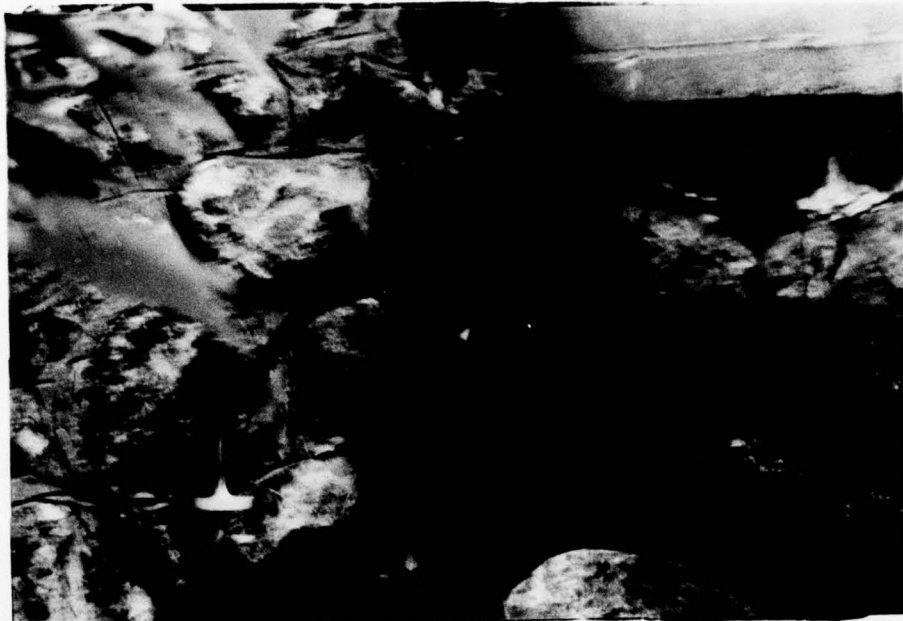
Rock falling from masonry at  
downstream corner of spillway  
and right abutment.

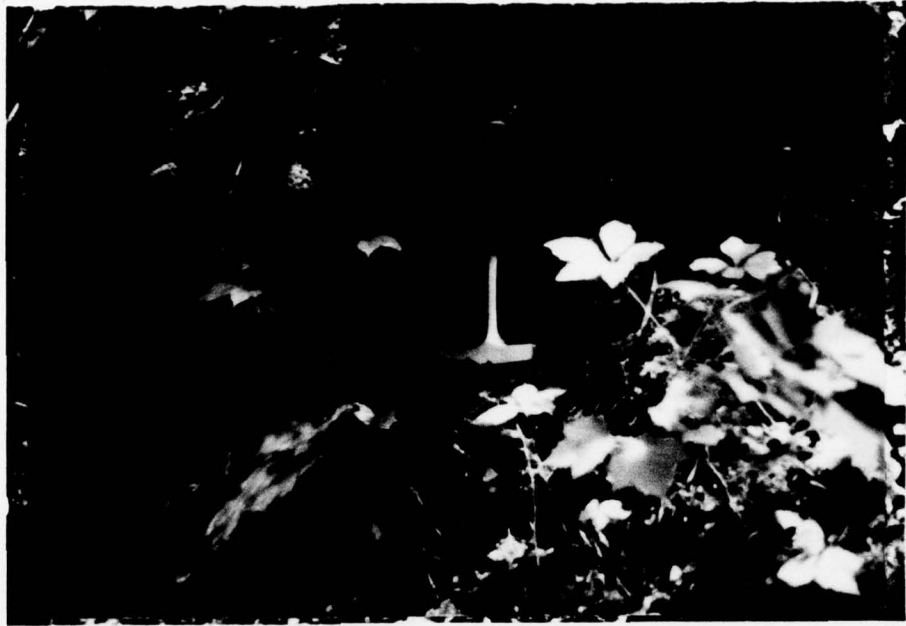
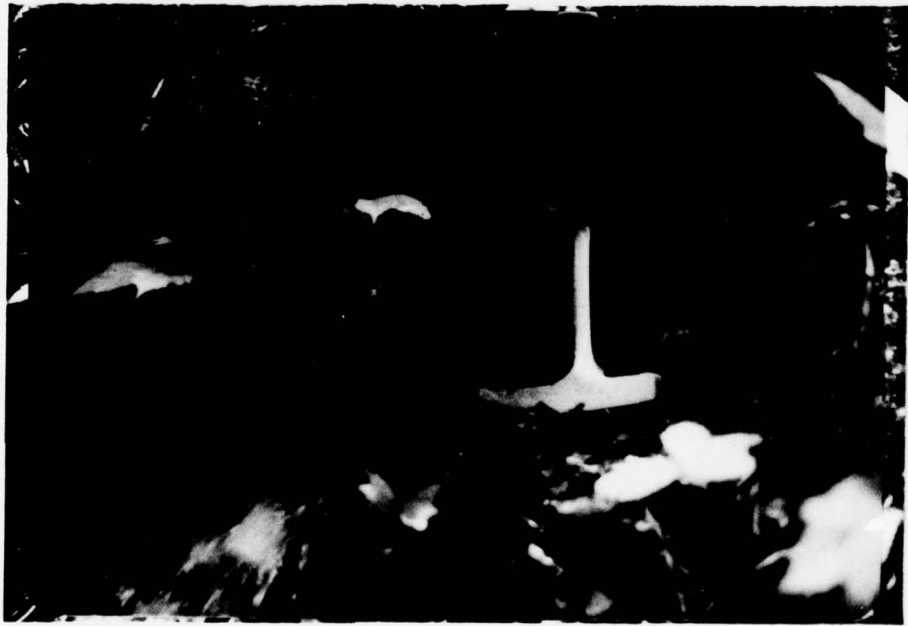
On 29 June a leak was observed on the downstream face of the earth embankment. Leakage was occurring at about 15 gpm from a single source located 4 ft below the crest and 110 ft from the spillway. The water was clear. In addition, the downstream face of the embankment in the area of the leak was wet and spongy. Mr. W. Rogers of the N.J. D.E.P. Division of Water Resources, Bureau of Flood Plain Management was informed of the conditions and their critical nature with respect to the stability of the embankment. Subsequent inspection and action were taken by the D.E.P., Corps of Engineers, and the Owner. Sketches showing the observed conditions are included in Appendix 3. Lowering of the lake was started about 6 p.m. on 30 June and the leak in the embankment had stopped when the lake water level had lowered about six inches.

Leak at downstream face  
of embankment.
