**JERSEY CITY RESERVOIR  
NO.3 DAM**

**PHASE I INSPECTION REPORT  
NATIONAL DAM SAFETY PROGRAM**

NJ 00524

**AUGUST 1978**

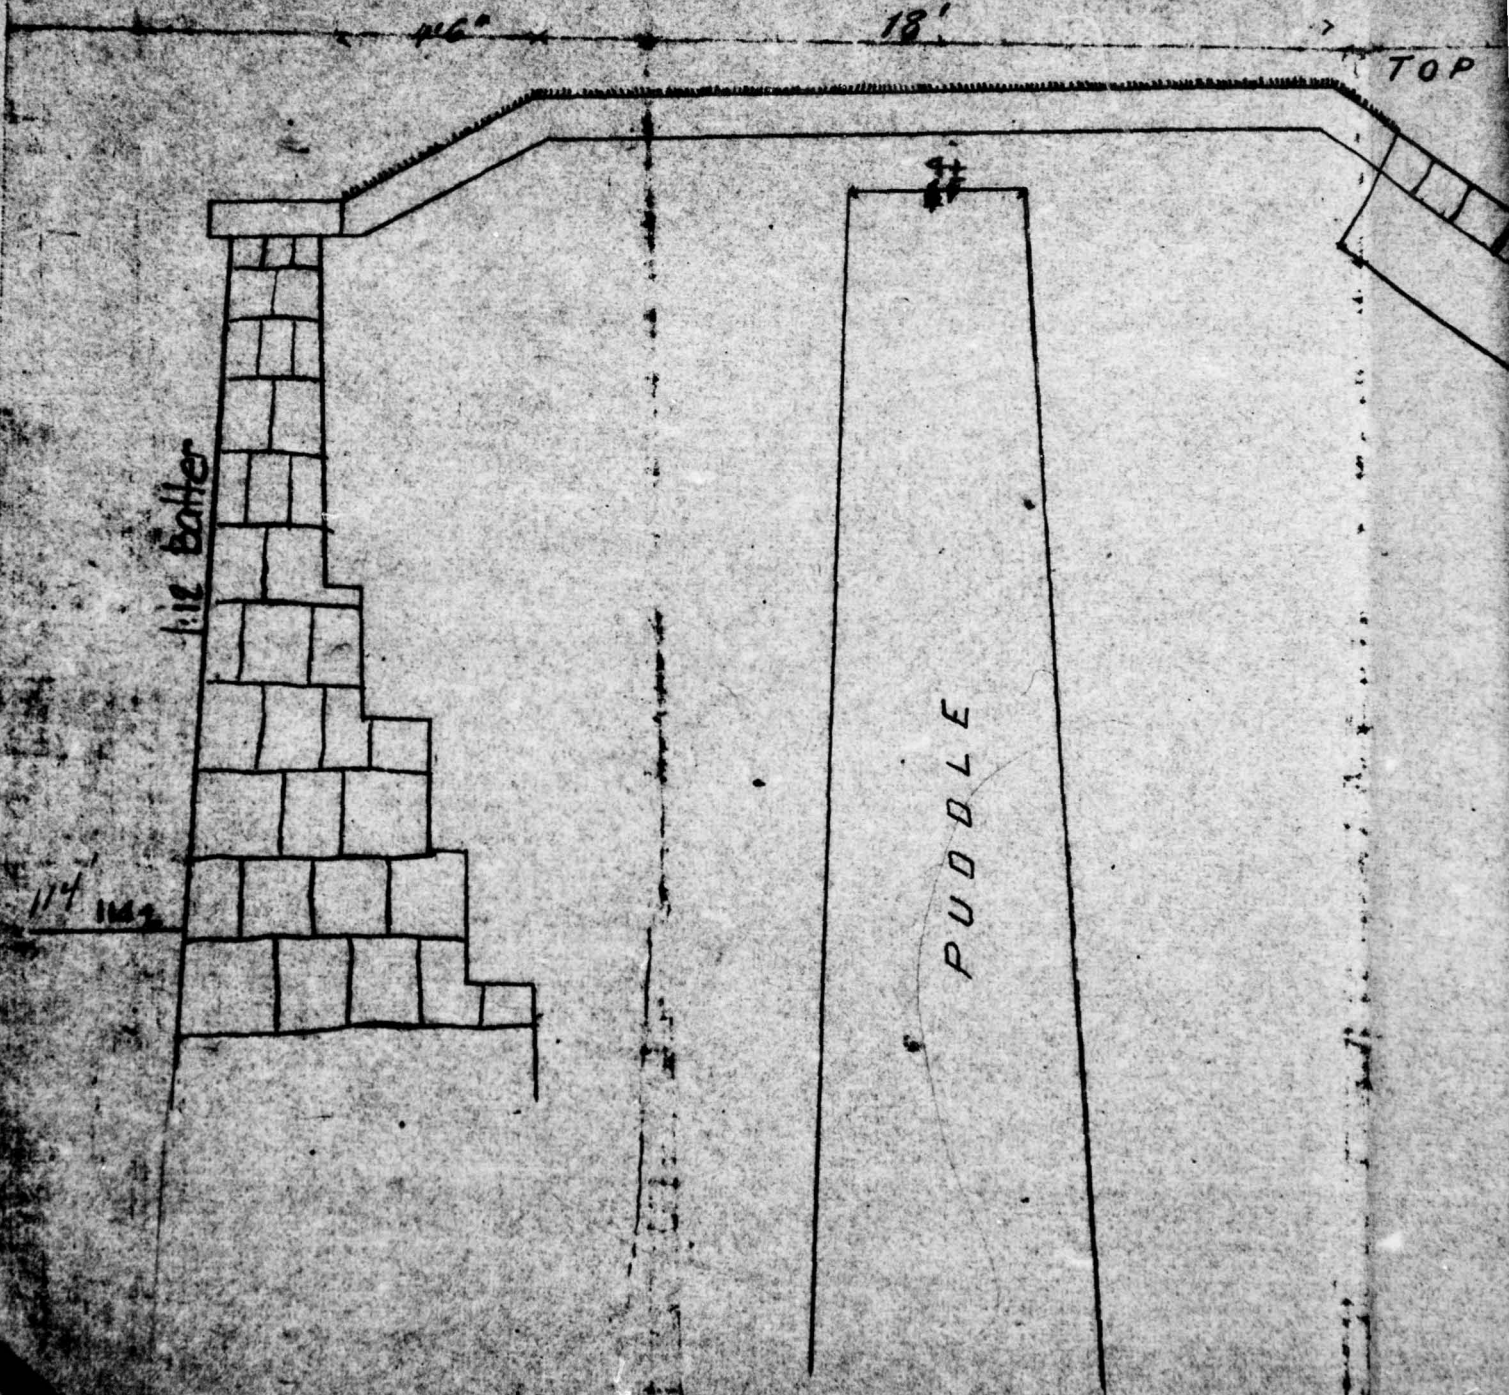
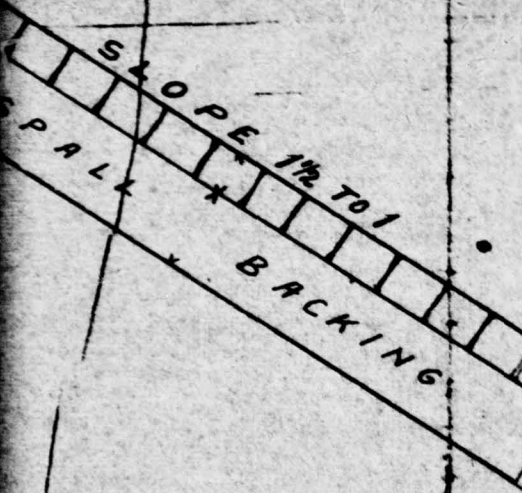
Figure 3

Review of the one structural (see Figure 3) and two construction drawings indicates that the design appears to have been consistent with the prevailing state-of-the-art at the time of construction. The design and construction of the reservoir has obviously withstood the test of time and field inspections indicate that the reservoir was well built and the walls appear to date, to be structurally sound. However, the available data is considered inadequate for design review and further investigations are required to ascertain the physical conditions and assess the structural stability of the entire perimeter wall system.

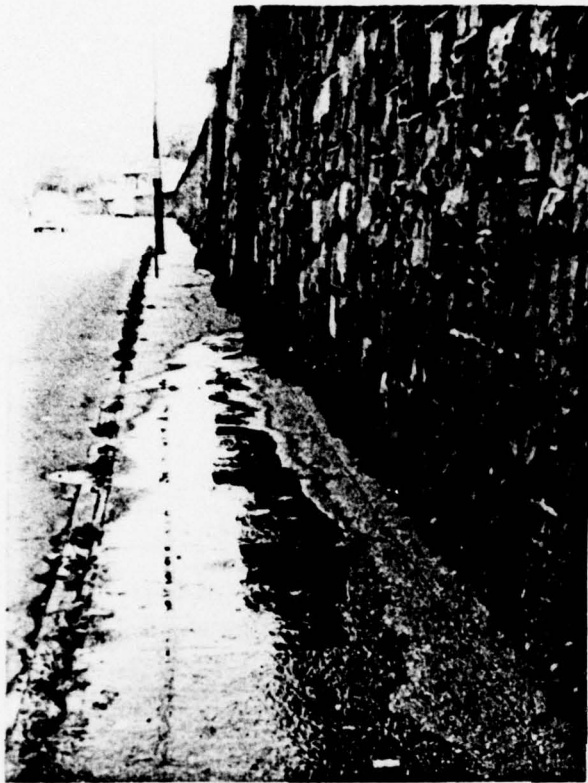
The exterior walls of the Reservoir appear to be in fair condition. Alignment and plumbness of the walls are quite true and only superficial mortar cracking was noted. A slight leak or seepage was observed one foot above the sidewalk level near the southwest corner of the west wall on Summit Avenue. Communication with City personnel on duty indicates the leak is approximately at elevation 123 MSL and has existed unchanged for several years. The reservoir was reportedly lowered some 5 years ago and an inspection of the riprap surface near the leak was performed by personnel of the engineering department of Jersey City. No corrective action has been taken since that inspection. Copies of the inspection report were not located in the City records.

Minor seepage was noted at the base of the west wall on Summit Avenue which confirmed the existence of a leak in the vicinity. Water level in the reservoir at the time of the inspection was at elevation 121.5, about 1.5 feet below the reported elevation of the leak. Thus, no assessment could be made with respect to the magnitude of the leak at normal pool elevation although reputedly, it is minor in nature.

LEAK AT WEST WALL

Jersey City Reservoir No. 3. Further investigation and evaluation of the leak and riprap settlement at the west wall is recommended and some form of corrective action such as grouting or repositioning of the riprap should be undertaken based on the results of the investigation. It is further recommended that the City of Jersey City evaluate their own requirements for an internal alarm system to alert operators of a possible or impending failure. A system of this nature may take the form of an automatic water level recorder with an alarm system to indicate rapid changes in water elevation. In conjunction with an operator's alarm is the requirement for a community warning system to alert residents in the surrounding area of hazardous conditions. This system may take the form of public address devices in conjunction with sirens or roving patrol cars. Both alert systems should be tested at regular intervals and a program should be undertaken to inform nearby residents as to the significance of the alert system.
