# BARBOUR MILL DAM

PHASE I INSPECTION REPORT

NATIONAL DAM SAFETY PROGRAM

NJ 00237

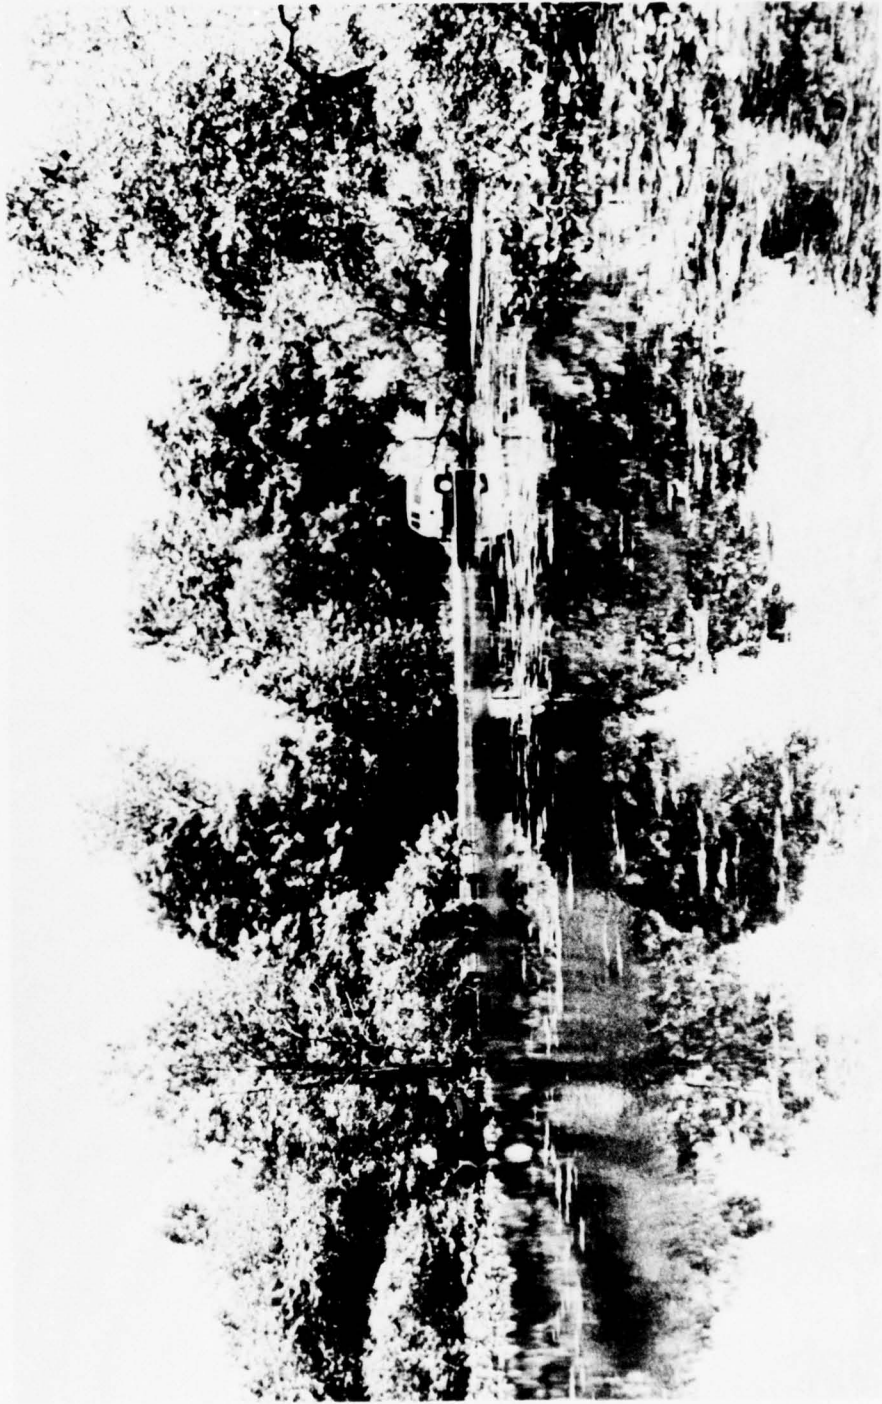
OVERALL VIEW OF DAM

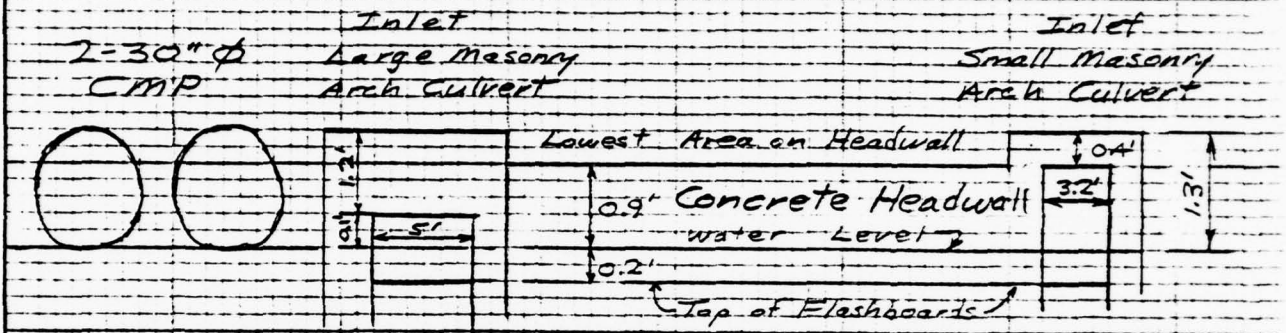
UPSTREAM ELEVATION

Low Point on Embankment = 0.9' Free board as at Headwall = is approx 35' left of 30"  $\phi$  CMP.

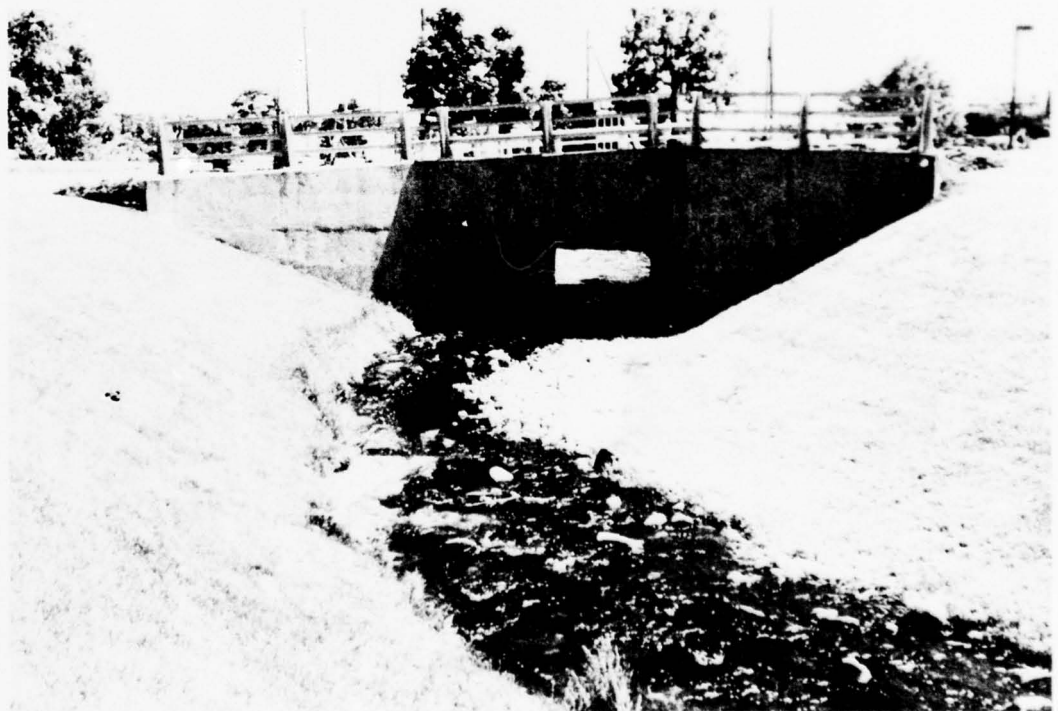
PHOTO 12

- Photo 12 - View South Along Downstream Channel Showing Bridge to Surburban Savings and Loan Parking Area. Bridge, Which Spans Box Culvert Twelve Feet Wide by Five Feet High; Is Located Approximately 400 Feet Downstream From Dam - 10 June 1978.
