SYLVA LAKE DAM

PHASE I INSPECTION REPORT  
NATIONAL DAM SAFETY PROGRAM

NJ 00391

AUGUST 1978

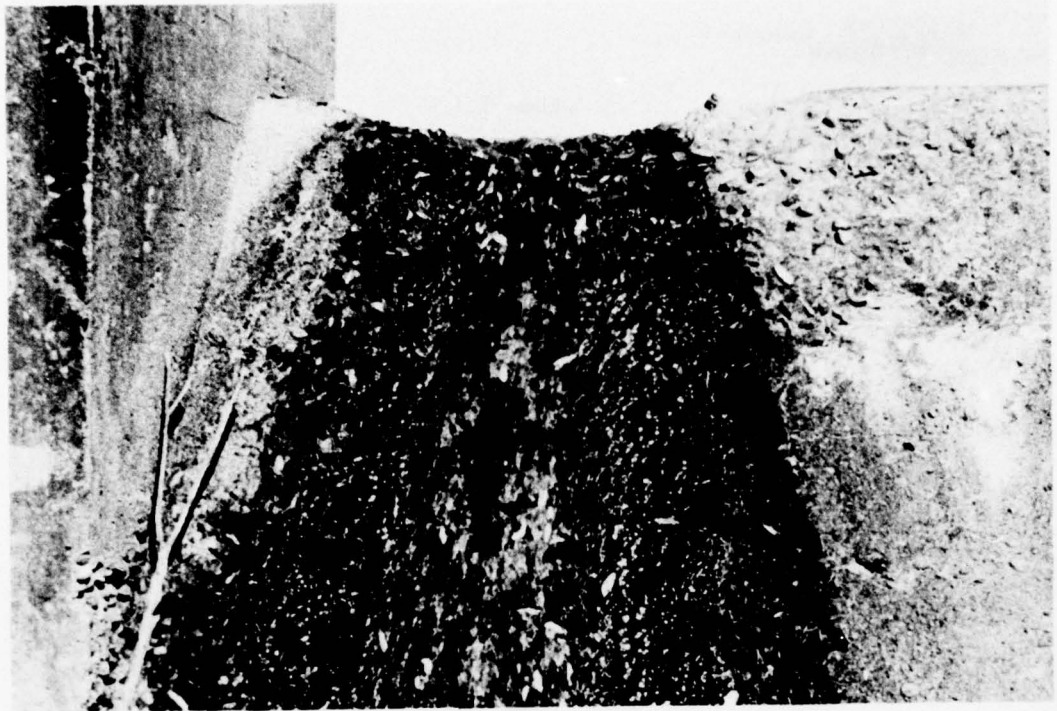
PHOTO 7

Photo 7 - Close-Up of Spillway Adjacent to Right Abutment Showing Badly Spalled Concrete - 24 June 1978.

(1) Extensive repairs should be made to all spalled and deteriorated concrete on the spillway weir, downstream face of the spillway, spillway wing walls, and discharge channel apron.

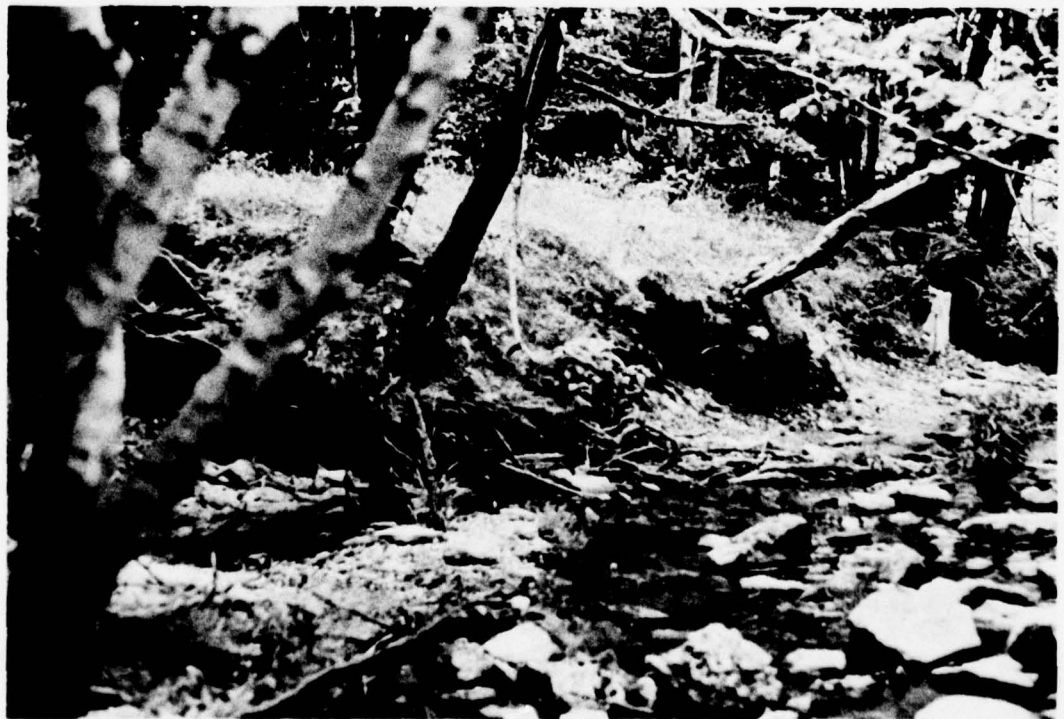
PHOTO 12

- Photo 12 - Picture of Downstream Channel Looking Downstream  
(Note Erosion and Undercutting of Bank Causing  
Collapse of Tree Root Systems) - 24 June 1978.
- Photo 13 - Picture of Very Slight Clear Seepage (Less Than One  
G.P.M.) From Contact of Dense Sand and Gravel With  
Little Silt (Above) With Underlying Very Stiff Gray  
Silt Exposed Just Above Stream Level on Right Bank  
About 100 Feet Downstream From Dam - 24 June 1978.
- Photo 14 - View of Upper End of Lake Sylva Showing Aquatic  
Growth Resulting From Heavy Siltation of Lake -  
24 June 1978.

(3) Improve outlet channel conditions by removing deposition, trees and debris. The left stream bank should be cleared, shaped and stabilized with properly designed riprap to withstand high stream flows. The scour hole at the end of the spillway apron should be repaired to avoid further damage.
