# COOPER RIVER PARKWAY

PHASE I INSPECTION REPORT  
NATIONAL DAM SAFETY PROGRAM

NJ 00393

AUGUST 1978

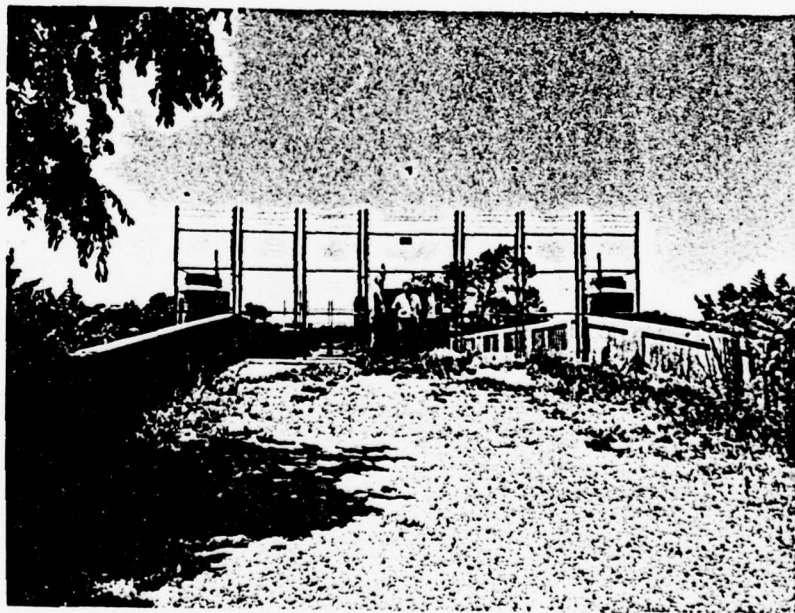
Some concrete spalling and deterioration was observed at the concrete abutments and wing-walls. The railing, equipment housings and superstructure are in acceptable condition.

East Abutment  
June 1978

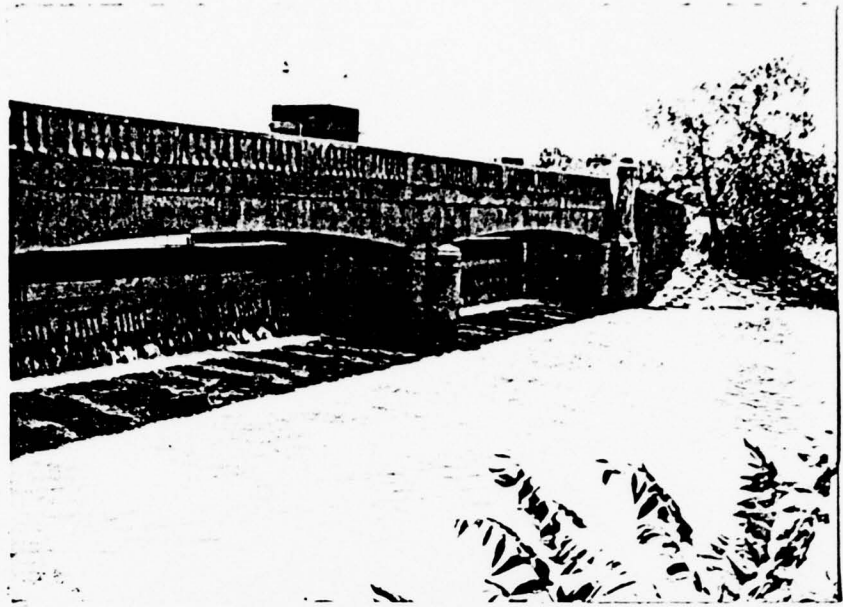
Downstream view of Sluiceways  
June 1978

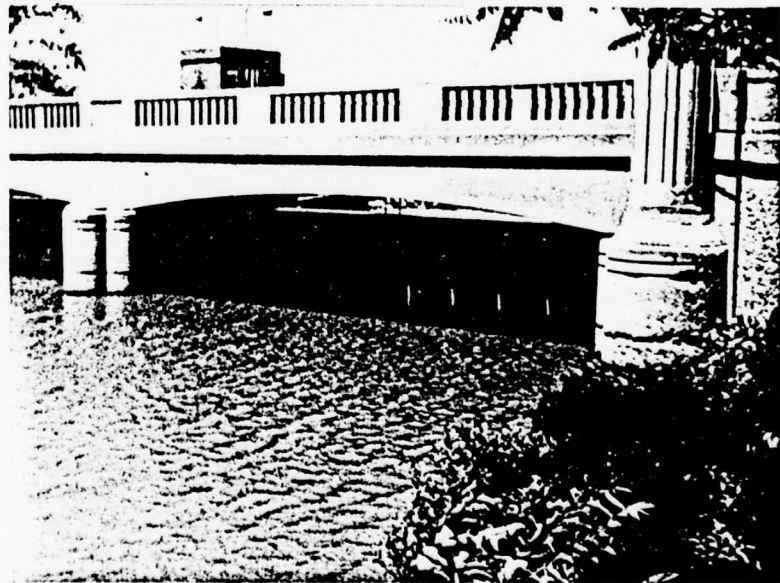
Upstream of Sluiceways and East Abutment  
June 1978

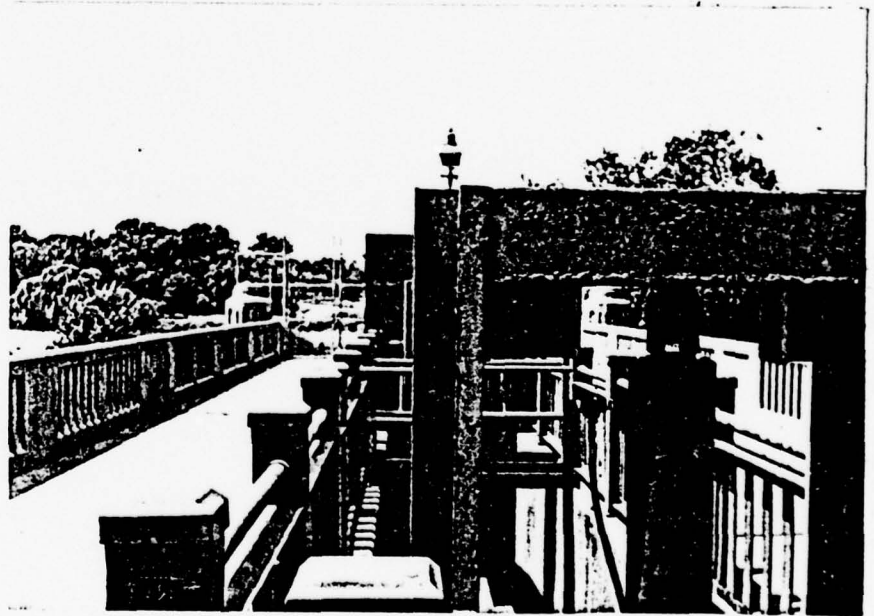
Initially, the tide gates were raised and lowered by screwlift hoists, which permitted the gates to be raised to their full height. The screw stems were attached to davit arms near the bottom of the gates. Difficulties were experienced in operating the gates with the hoisting mechanism originally installed, so in 1975, the screw hoists were replaced by hydraulic piston hoists. They are operated either separately or simultaneously. The hydraulic piston hoists are attached to lifting frames anchored to the bridge, and the gates can be raised only a maximum of approximately 4 feet. A crosswalk was also installed over the gate slot on the bridge deck, which limits the lift height to which

Lifting Apparatus  
July 1978

It is recommended that within three years from the date of approval of this report, the owner review the hoisting arrangement to see if modifications could be made to permit a greater gate opening, both with regard to obtaining added release capacity and for permitting access to the lower end of the gate for inspection and maintenance.
