REPORT NADC 76220-60

DISASSEMBLY INSPECTION AND OVERHAUL

X-22A GEAR REDUCTION AND PROPELLER ASSEMBLIES

HAMILTON STANDARD DIVISION OF UNITED TECHNOLOGIES CORPORATION WINDSOR LOCKS, CONNECTICUT 06096

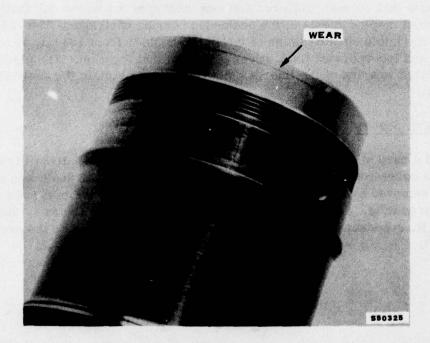
The barrel tailshaft exhibited a band of wear from contact with its corresponding P/N 582555-2 shaft seal. The wear depth was superficial and was removed by lapping without significantly reducing the thickness of the chrome surface coating. See Figure 11 for typical appearance - Figure 4, the Gear Reduction - L.H. subassembly drawing, for orientation of the barrel in the assembly.

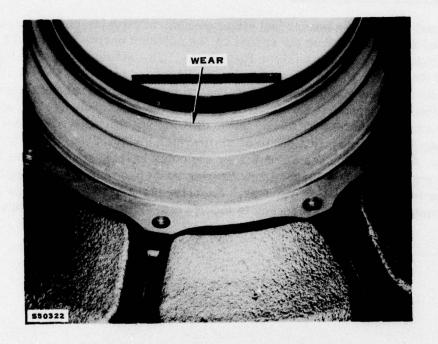
Figure 12. Front Housing Bearing Liner

The magnesium front gear reduction housing incorporates a hardened steel bearing liner. The shoulder of the liner, which supports the P/N 592154 tapered roller preload bearing, had a wear pattern of concentric circular rings that were apparently caused by rotation of the bearing outer race. The depth of wear was approximately 0.001 inch. See Figure 12 for typical appearance - Figure 4, the Gear Reduction -L.H. subassembly drawing, for orientation of the liner in the assembly. The analytical evaluation of the rotation problem produced two design changes. The first change involved preloading as that is the mechanism whereby bearing race rotation is prohibited. In the original design preload was accomplished by means of a laminated shim whose thickness is established by relating the actual stack-up dimensions of the affected bearing cartridge parts; i.e., P/N's 592154, 592044, 592043, and 592067 to the P/N 592048 housing to achieve a 0.001-0.003 inch axial interference. It was found that the tolerances on thickness and parallelism of the P/N 592069 laminated shim could produce a widely varying clamping force with a resulting poor distribution across the P/N 592067 retaining plate. The redesign supersedes the laminated shim with a P/N SK94932 solid shim. The solid shim has a thickness tolerance of 0.0005 inches vs. 0.002 inches for the laminated shim. In addition, the original design housing liner tolerance on parallel surfaces of 0.001 inch was reduced to 0.0005 inch. These closer tolerances result in a clamping force of more uniform distribution without exceeding the stress limit of the retaining plate. The second design change was made on the basis that normal propeller moment loading of the barrel tailshaft could cause small radial displacements of the preloaded bearing cartridge. The redesign reduced the permissible surface finish of the liner shoulder from 125 micro-inch to 32 micro-inch and incorporated flash silver plating at that location. The plating is intended to prevent wearing of the liner shoulder and thus maintain the desired clamping force.

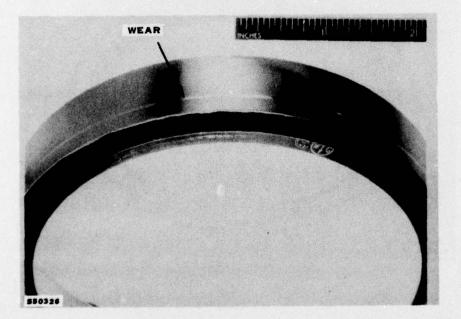
Figure 13. Seal Sleeve

The sleeve had a band of wear similar to the P/N 592014-2 barrel tailshaft from contact with its corresponding P/N 582555-5 shaft seal. The wear depth was superficial and was removed by lapping without significantly reducing the thickness of the chrome surface coating. See Figure 13 for typical appearance - Figure 4, the Gear Reduction - L.H. subassembly drawing, for orientation of the sleeve on the propeller barrel tailshaft.

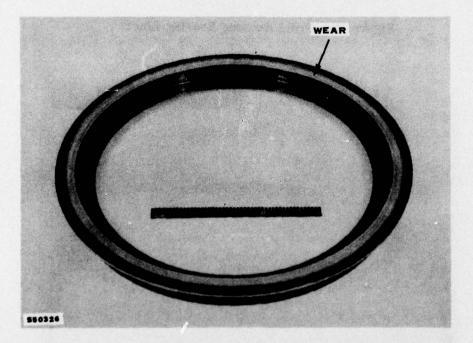
Figure 14. Outer Bearing Spacer

The parallel end faces of the spacer had slight concentric circular ring wear patterns which indicated rotation of either the spacer or the adjacent parts. See Figure 14 for typical appearance - Figure 4, the Gear Reduction - L.H. subassembly drawing, for orientation of the spacer within the assembly. This spacer is part of the bearing cartridge stack-up discussed under P/N 592048 and the design changes are expected to prevent rotation of the spacer. Corrective action for the spacer involved grinding the end faces, to remove the wear patterns, to the drawing specification of surface finish and parallelism and incorporation of silver plating (per HS519, Type 1, Grade B) to prevent wear. As a consequence of reworking the outer bearing spacer it was also necessary to regrind the P/N 592038 inner bearing spacer to maintain the required preload on the two tapered roller bearings. Experimental engineering change E121785, dated 18 November 1977, was processed to incorporate silver plate in all future parts.

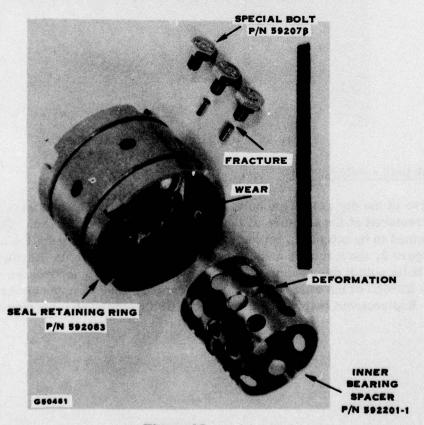
Figure 15.

The ring was scored and worn on the inside diameter due to the tumbling action of a dog point that had separated from a failed P/N 592078 special bolt which will be discussed later. See Figure 15 for documentation of the distress and Figure 2, the Actuator and Transfer Bearing subassembly drawing, for orientation of the ring in the assembly. No evidence of cracks or deformation were present. Although the ring was considered structurally and functionally acceptable, a replacement ring, which was obtained from the Calspan spares, was used for improved appearance.

All three of the dog point type bolts that restrain the P/N 592083 seal retaining ring were fractured at the juncture of the dog point and the bolt thread. The fracture was determined to be fatigue in nature. See Figure 15 for documentation of the fractures and Figure 2, the Actuator and Transfer Bearing subassembly drawing, for orientation of the bolts within the assembly. These bolts were not in accordance with experimental change E28635 which was published on 2 February 1968 to improve the strength in this area. Replacement bolts were drawn from HS inventory and incorporated at reassembly.

The spacer was deformed from the tumbling action of the fractured dog point discussed earlier. See Figure 15 for documentation of the deformation and Figure 2, the Actuator and Transfer Bearing subassembly drawing, for orientation of the spacer in the assembly. A replacement spacer was obtained from the Calspan spares and incorporated at reassembly.

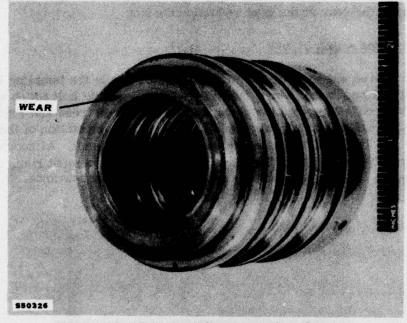
Figure 16. Rotating Fluid Transfer Sleeve

Two sleeves are employed in each assembly and both had slight bands of concentric circular wear rings on their sealing faces. See Figure 16 for typical appearance – Figure 2, the Actuator and Transfer Bearing subassembly drawing, for orientation of the two sleeves in the assembly. In order not to compromise the sealing effectiveness of new mating P/N 592080 face seals, the end sealing faces were relapped to drawing specification of three helium light bands maximum for flatness.

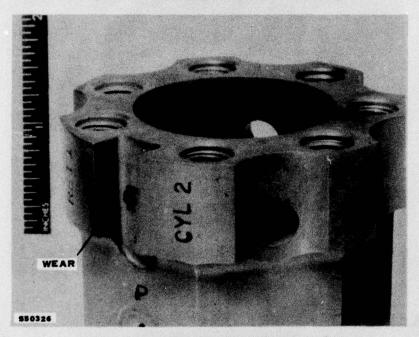
Figure 17. Housing Anti-Rotation Slot

The anti-rotation slot in the aluminum housing showed significant wear. See Figure 17 for typical appearance - Figure 2, the Actuator and Transfer Bearing subassembly drawing, for orientation of the housing at the aft end of the assembly. This wear was similar to that revealed by three housings for which a repair was developed when sent to HS in 1975. The repair procedure, which involved incorporation of a steel-dovetail-insert that is bonded and pinned, was repeated for this housing.

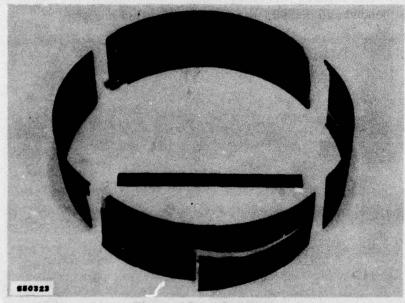
Figure 18. Afterbody

The afterbody, normally a two piece construction, was fractured into multiple pieces. See Figure 18 for documentation of the fractures and Figure 1, the Gear Reduction and Propeller assembly drawing, for orientation of the afterbody on the propeller. No information was available as to the incident causing the fractures. A replacement afterbody was obtained from the Calspan spares and incorporated at reassembly.

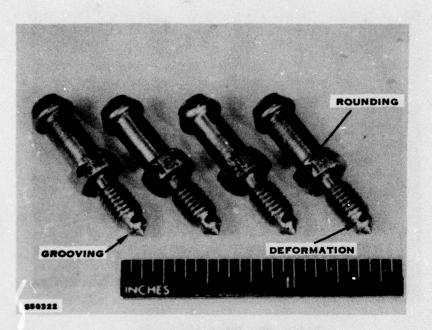
Figure 19. Bleed Screws

The four needle pointed screws were heavily grooved and the bleed orifice diameters distorted from contact with their mating P/N 582570 bleed screw extensions. The wrenching hexagons were rounded from apparent overtorque. See Figure 19 for documentation of the damage and Figure 2, the Actuator and Transfer Bearing subassembly drawing, for orientation of the four screws at the front of the assembly. Observation of a specified installation torque of 15-20 inch pounds should prevent a re-occurrance of this problem. New screws were manufactured and incorporated at reassembly. During remanufacture a tolerance condition was discovered which could place the bleed hole in close proximity to the conical sealing seat causing the potential for leakage. Experimental engineering change E121802 was published on 9 January 1978 to eliminate the possibility of this occuring in these and future parts.

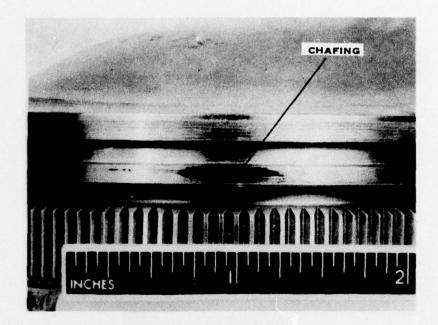
Figure 20. Trunnion Lands

The outside diameter of the trunnion incorporates two lands, one on either side of a seal groove, which control the radial position of the trunnion within the P/N 592006 propeller blade shank. The inboard land, which is directly exposed to the propeller operating fluid, was free of chafing while the outboard land which cannot be lubricated, was slightly chafed. See Figure 20 for typical condition - Figure 1, the Gear Reduction and Propeller assembly drawing, for orientation of the trunnion within the propeller blade. The bore of each propeller blade was also slightly chafed from contact with the trunnion. On the basis that only one land is required for the positioning function, the outboard land diameter was reduced from 3.9398-3.9402 to 3.936-3.938 inch by experimental engineering change E121785, dated 18 November 1977, to prevent contact with the blade shank bore. The slight chafing in the blade shank bore was polished prior to reassembly.

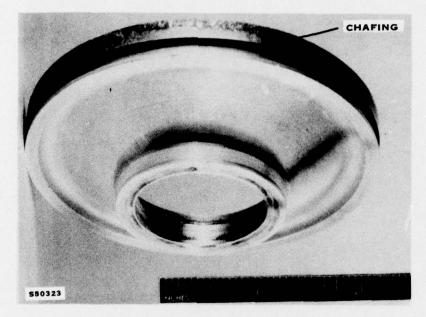
Figure 21. Piston Rod Support

Evidence of chafing was present on the outside diameter of the support from contact with the interfacing P/N 592014-2 propeller barrel bore. See Figure 21 for typical appearance - Figures 1 and 2, the Gear Reduction and Propeller and Actuator and Transfer Bearing, assembly and subassembly drawings, for orientation of the support within the propeller barrel. This condition suggested that the oil level in the propeller barrel was not adequate to cover the interfacing surfaces. The propeller barrel bore was polished and the outside diameter of the support was reworked to 3.6205 inch minimum and then electrofilmed (per HS 248, Class 40, Type A2). An experimental engineering change E121785, dated 18 November 1977, was published to incorporate the electrofilm in all future parts.

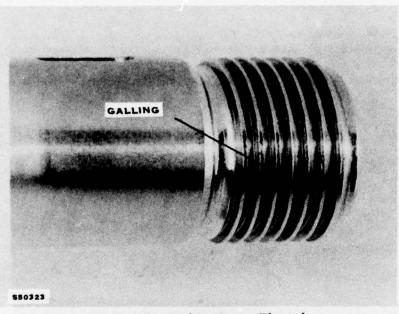
Figure 22. Rod Buttress Thread

The rod incorporates a buttress type thread which was galled from contact with the interfacing P/N 583150 retaining nut. See Figure 22 for typical appearance - Figure 2, the Actuator and Transfer Bearing subassembly drawing for orientation of the rod within the assembly. The thread was reworked to the low limit of drawing specification to remove the majority of the galling and a light coating of a special high temperature anti-seize lubricant known as Silver Goop applied prior to reinstalling the retaining nut. This current technology coating is in use on the HS F-16 Environmental Control System and is obtainable from the Crawford Fitting Company of Cleveland, Ohio.

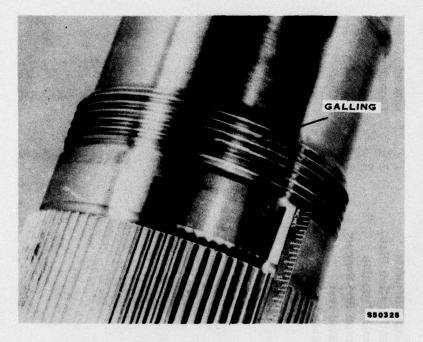
Figure 24. Barrel Buttress Thread

The barrel tailshaft external buttress type thread was severely galled. See Figure 24 for documentation of the galling and Figure 3, the Gear Reduction - R.H. subassembly drawing, for orientation of the barrel within the assembly. This damage appeared to be due to pickup of foreign material during the previous installation of the interfacing P/N 582526 retaining nut. A replacement barrel was obtained from the four residual assemblies and a light coating of the anti-seize lubricant called Silver Goop was applied to the threads at reassembly. Experimental engineering change E-21785, dated 12 November 1977, was processed to incorporate the lubricant.

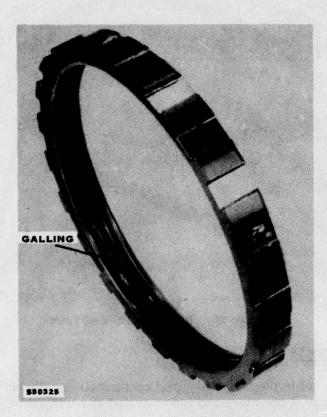
Figure 25. Retaining Nut

The nut internal buttress type thread was severely galled from contact with the P/N 592014-1 barrel, as reported above. See Figure 25 for documentation of the galling and Figure 3, the Gear Reduction - R.H. subassembly drawing for orientation of the nut on the barrel. A replacement nut was obtained from the four residual assemblies and electrofilmed (per HS 248, Class 42, Type A1). Experimental engineering change E121785, dated 18 November 1977, requires electrofilming of all future parts.

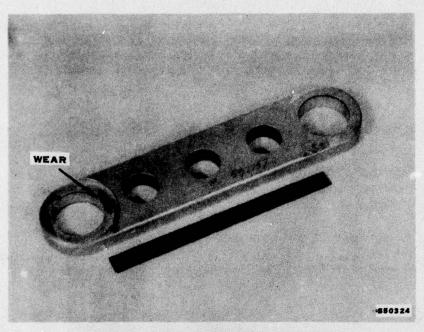
Figure 26. Rigid Connecting Link

The link showed wear where it contacted the interfacing P/N 592075 bearing housing. See Figure 26 for documentation of the wear and Figure 1, the Gear Reduction and Propeller assembly drawing, for orientation of the link in the assembly. Unauthorized teflon washers were found between the link and the two P/N 592075 bearing housing arms. The wear was attributed to a collection of abrasive material between the washers and the link. Because the other assemblies, without the washers, did not exhibit wear and no documentation substantiating installation of washers was found, the link was reinstalled without washers after polishing and alodining (per HS 240, Code 1).

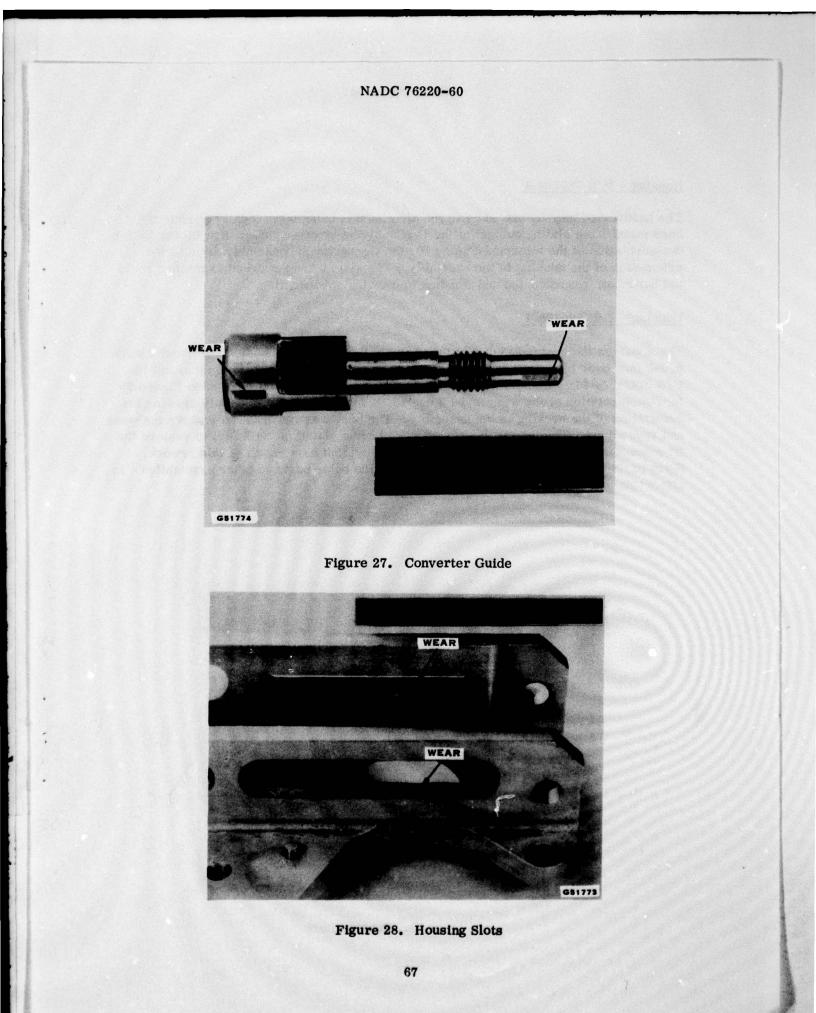
The hardened steel guide was worn at each end from sliding contact with hardcoated longitudinal slots in its interfacing P/N 720777 aluminum housing. See Figure 27 for documentation of the wear and Figure 10, the Converter subassembly drawing, for orientation of the guide within the assembly. A replacement guide was drawn from Calspan spare part inventory and incorporated at reassembly.

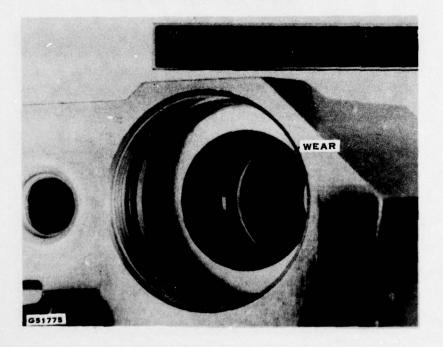
Figure 29. Housing Bore

The anodized internal 0.938-0.039 inch bore in the aluminum housing was locally worn 0.006 inch over high limit from sliding contact with the P/N 720778-1 piston and its P/N MS28775-018 / P/N 719955-3 preformed packing/outer seal ring. See Figure 29 for documentation of the wear and Figure 10, the Converter subassembly drawing, for orientation of the housing in the assembly. The bore was reworked to remove the wear and reanodized. The interfacing piston was chrome plated (per HS 246) to restore the fit required in the end assembly. It must be noted that as a result of this rework, these parts are no longer interchangeable with the same parts in other assemblies - in effect this set of parts is a matched set.

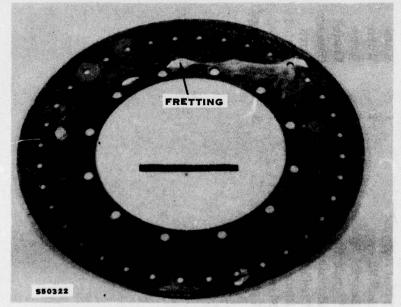
Figure 30. Balance Plate

The mounting face of the plate exhibited relatively severe fretting in the contact area with P/N 592014-1 propeller barrel. See Figure 30 for documentation of fretting and Figure 1, the Gear Reduction and Propeller assembly drawing, for orientation of the plate and the barrel within the assembly. The index pin, which orientates the plate to the forward barrel face, was missing and the contact pattern on the plate indicated that it had been incorrectly located on at least one occasion. A replacement plate was obtained from the four residual assemblies.

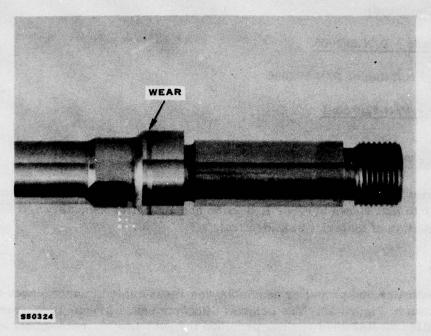
Figure 31. Feedback Rod

The rod exhibited a modest band of wear from contact with its interfacing P/N 592301-1 shaft seal. See Figure 31 for documentation of the wear and Figure 2, the Actuator and Transfer Bearing subassembly drawing, for orientation of the shaft in the assembly. As the wear was of sufficient depth to adversely affect sealing capability, the rod was reworked, replated and refinished to restore surface finish and size.
