SPLIT ROCK POND DAM

PHASE I INSPECTION REPORT

NATIONAL DAM SAFETY PROGRAM

NJ 00264

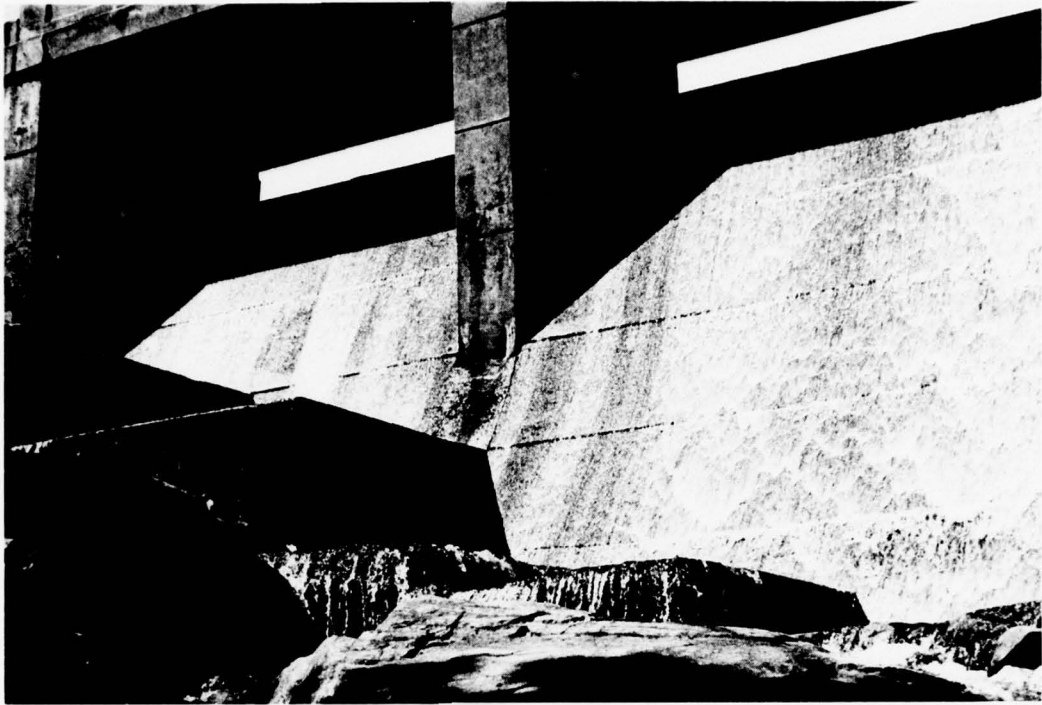
PHOTO 5

Photo 5 - View Upstream (North) at Spillway From Right (West) Bank - Gneiss Foundation Rock at Bottom of Photo - 15 June 1978.

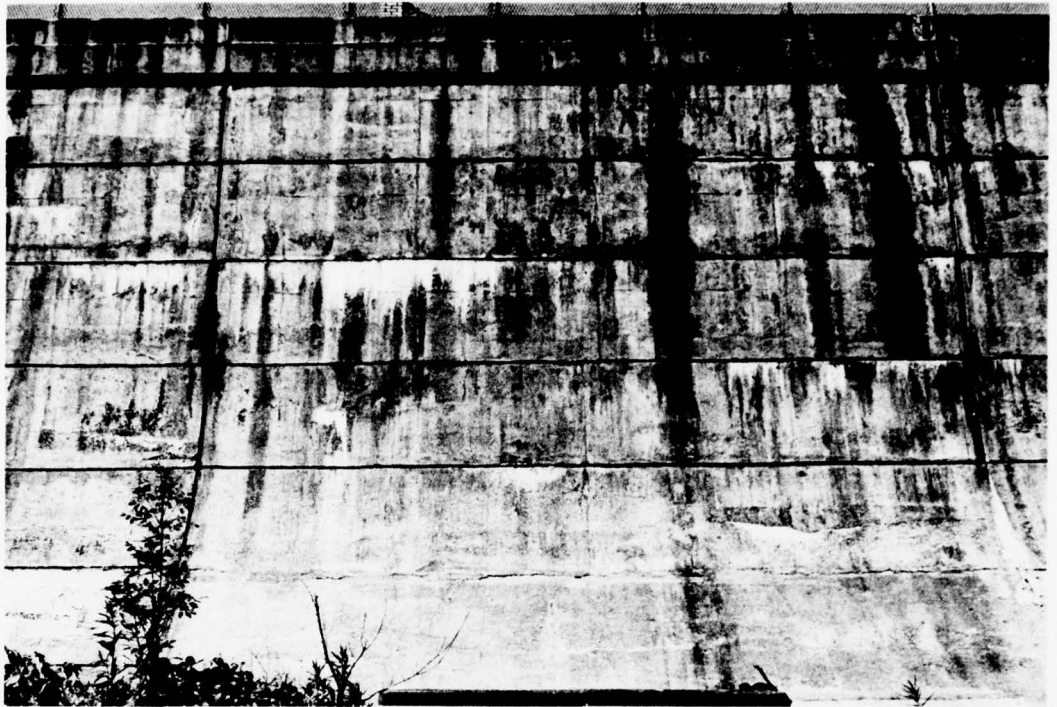
PHOTO 7

An area of bulged and cracked concrete approximately three feet high by ten feet wide was observed on the left side of the downstream face of the dam. The concrete appeared to be bulged outward approximately one-half an inch in this area.

Minor leakage of water (presumably from the reservoir) was observed from several horizontal construction joints, vertical monolith joints, and miscellaneous cracks in the downstream face of the dam. None of these leaks was flowing at a perceptible rate and all leakage evaporated when the sun reached the downstream face of the dam.

Photo 7 - View Upstream (North) at Cracked, Spalled Concrete With Seepage and Mineral Deposits in Downstream Face of Dam - Dam Crest at Top Edge of Photo; Head Wall of 36 Inch Diameter Outlet Pipe in Bottom Center of Photo - 15 June 1978.

- a. Dam - As indicated in paragraph 3.1.a., it is impossible to assess, from the results of a visual inspection of this type, the extent to which concrete cracking, bulging, deterioration and leakage may affect the structural integrity of the dam. The nature and potential implications of these phenomena are such that the owner should immediately retain a properly qualified consultant to make more detailed investigations of structural aspects, including structural stability, of the dam as it presently exists and to develop plans and specifications for remedial work as necessary.

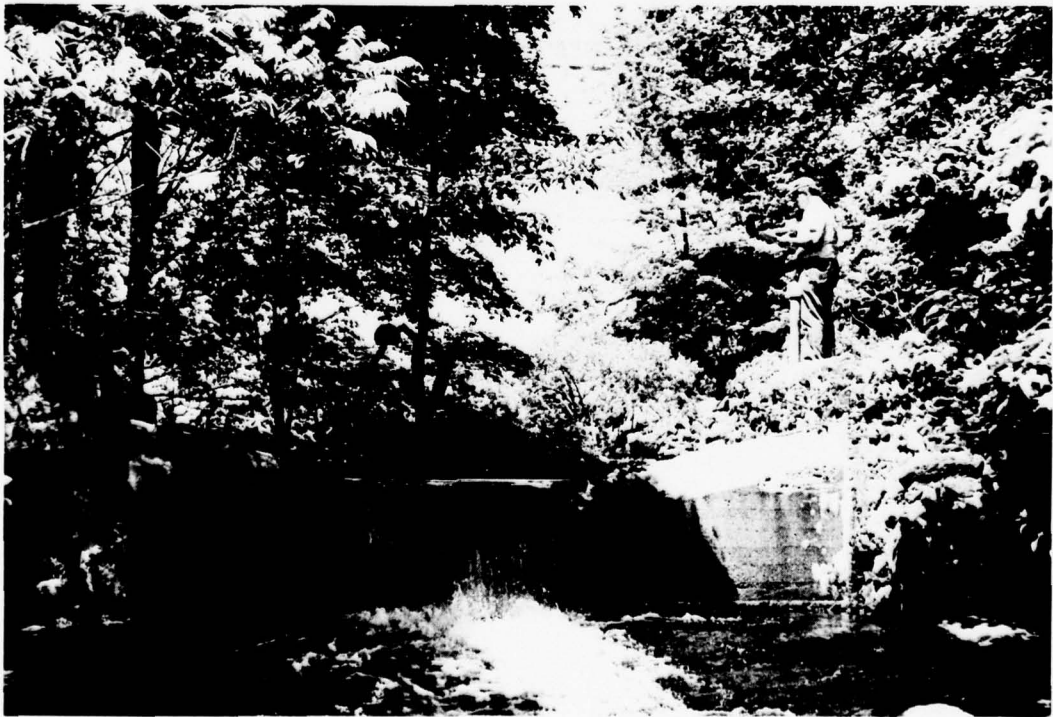
PHOTO 10

Photo 10 - Close-Up View Upstream at Concrete Weir in Outlet Channel 180 Feet Downstream From Dam (Top Center of Photo 9) - 36 Inch Diameter Outlet Pipe Is Dark Circle in Trees, Left Center of Photo Above Weir - 15 June 1978.

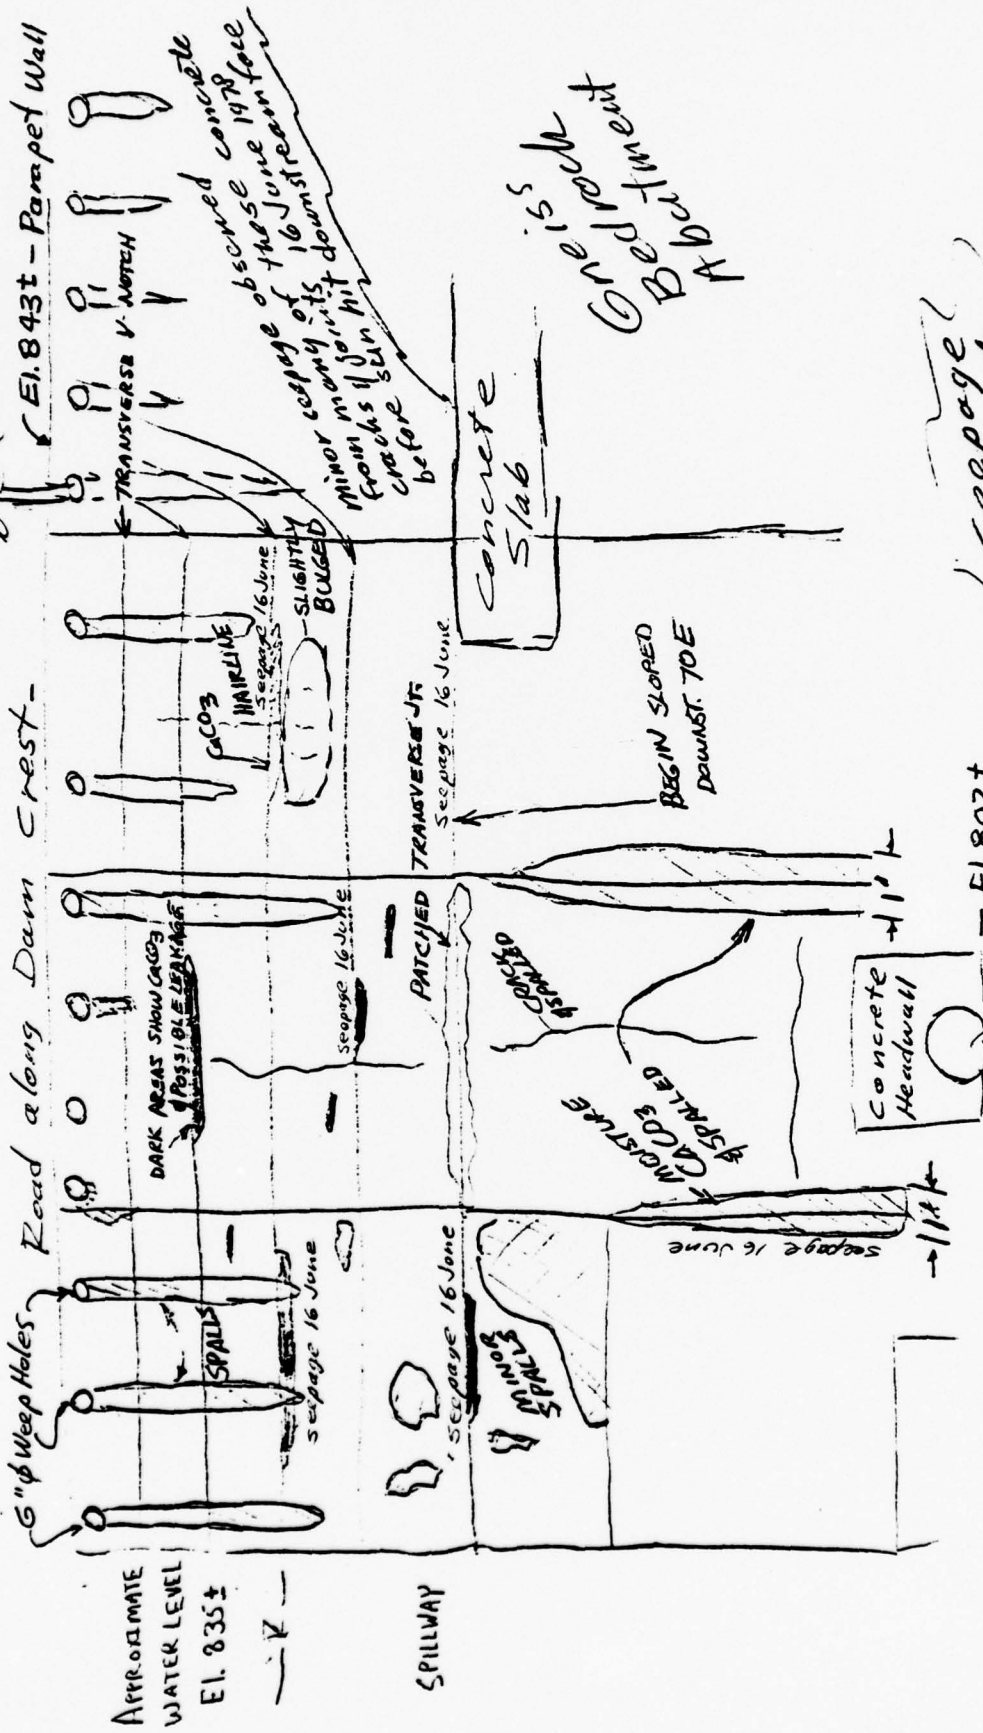
SPLIT ROCK POND DAM
 SKETCH - LEFT SIDE DOWNSTREAM FACE

VISUAL EXAMINATION OF	OBSERVATIONS	REMARKS OR RECOMMENDATIONS
LEAKAGE	<p>Minor leakage was observed through the horizontal (construction) and vertical (monolith) joints on the left (east) side downstream face of dam--see attached sketch. Minor leakage was observed through jointed rock in both abutments. The top of the leakage was located at approximately El. 820 on the right abutment and approximately El. 800 on the left abutment.</p>	<p>Leakage through concrete requires further investigation. Long term, steady state seepage of approximately one g.p.m. on each abutment is not considered detrimental to structural stability at time of inspection.</p>
STRUCTURE TO ABUTMENT/EMBANKMENT JUNCTIONS	<p>Concrete gravity dam has minor earth fill sections (height less than 10 feet) with concrete gravity retaining walls at both abutments (similar to bridge approach fills). No problems were observed.</p>

SURFACE CRACKS Considerable cracking and spalling was observed on all concrete surfaces, including the downstream face of the dam. Some seepage occurs through cracks and construction joints in the left side of the downstream face of dam--see attached sketch.

VERTICAL AND HORIZONTAL ALIGNMENT There was a slightly bulged area (approximately 0.5 inches outward) noted in left side downstream face of dam approximately El. 830--see attached sketch. The bulged area was approximately three (3) feet high and ten (10) feet wide.

Seepage
 from Rock
 Joints - El. 800 ±

Seepage observed from the abutment rock near the junctions with the downstream face of the dam is not considered detrimental to dam stability at the present time. The abutment seepage areas should be visually monitored by the owner's personnel or others who make future inspections of the dam.
