AFFDL-TR-78-79

REPAIR OF BONDED PRIMARY STRUCTURE

BOEING COMMERCIAL AIRPLANE COMPANY  
P.O. BOX 3707  
SEATTLE, WASHINGTON 98124

June 1978

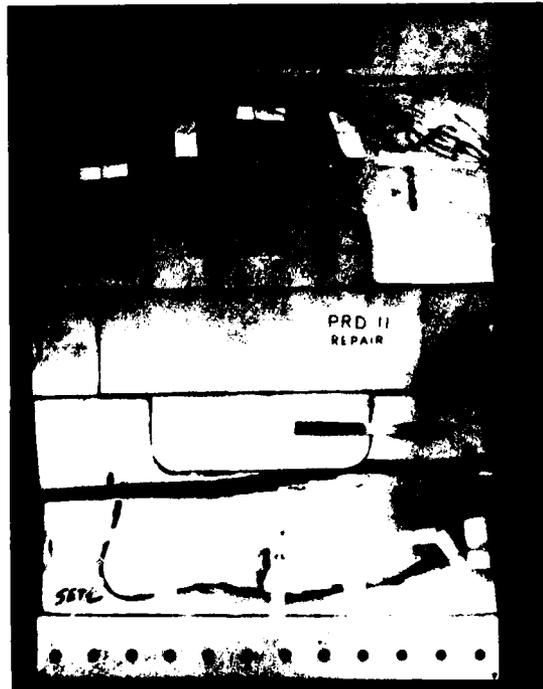
Figure 27.—Typical Failure of a Repaired Skin Splice Panel

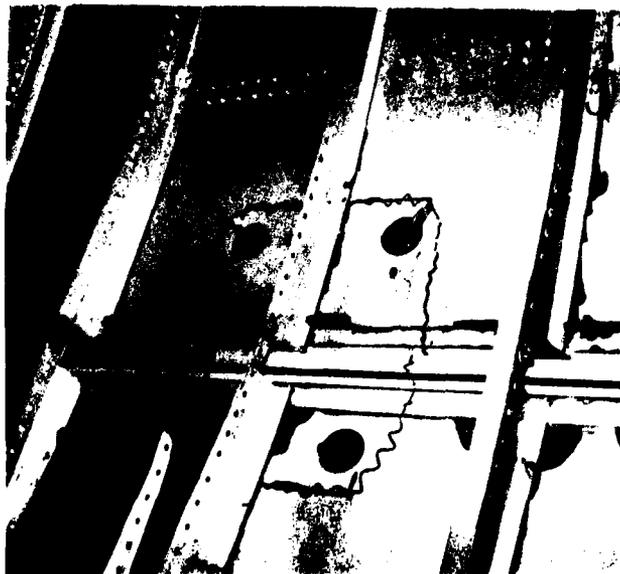
*Figure 51.--Start of Damage Removal*

The start of the first repair on the large panel is shown in Figure 51. The riveted rib web was removed. Guide holes were drilled and then a hole saw was used to radius the corners of the cut-out area. Templates were attached to the panel as shown in Figure 52, to act as a guide for the router cuts. The frame tee and longeron were cut back beyond the skin edge to provide a splice overlap for the repair details. Removal of the "damaged" material is shown completed in Figure 53.

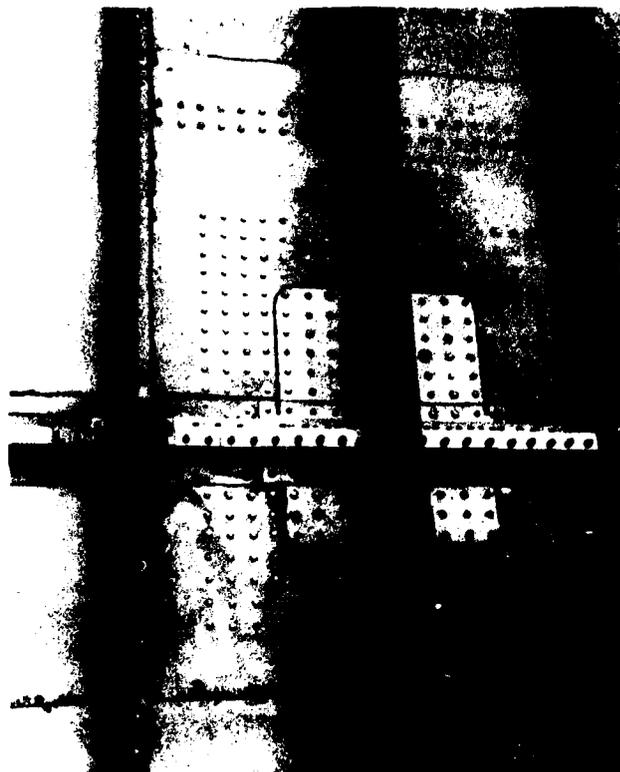
*Figure 62.—Repair Complete—Rivets Installed after Removal of Bolts*

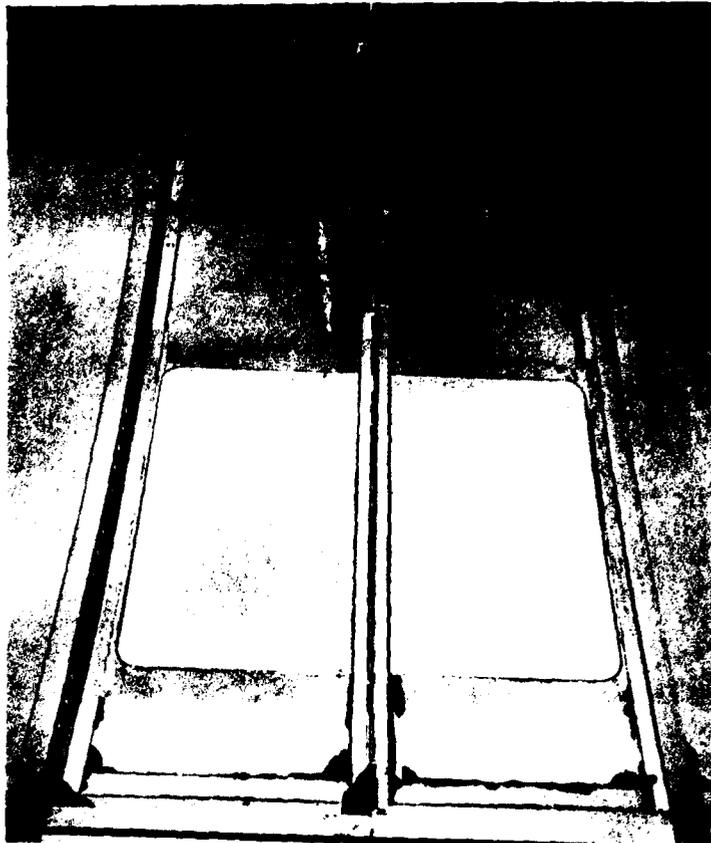
*Figure 74.—Completed Repair—External Longeron*

Bonding of the repair details was accomplished in two stages. The skin plug and patch plate were bonded in the first stage. This was accomplished using the fiberglass tool to maintain the contour and a vacuum bag to apply the pressure (Fig. 72). The compressed air heater was again used for the cure. The bond was inspected after the cure using a Fokker bond tester (Fig. 73). The frame tee and longeron splice details were then bonded in place using vacuum pressure and the compressed air heater. The completed repair is shown in Figure 74.

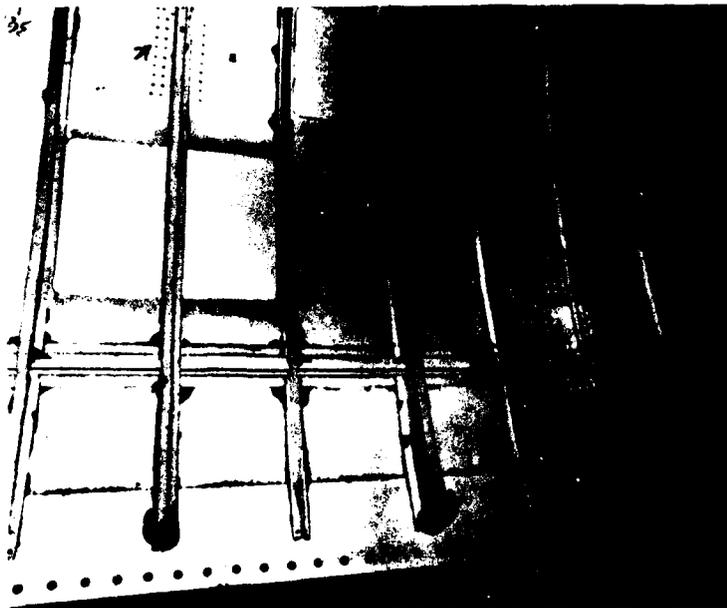
*Figure 80.—Interior View of Completed Repairs*

This completed the three repairs (Figs. 80 and 81).

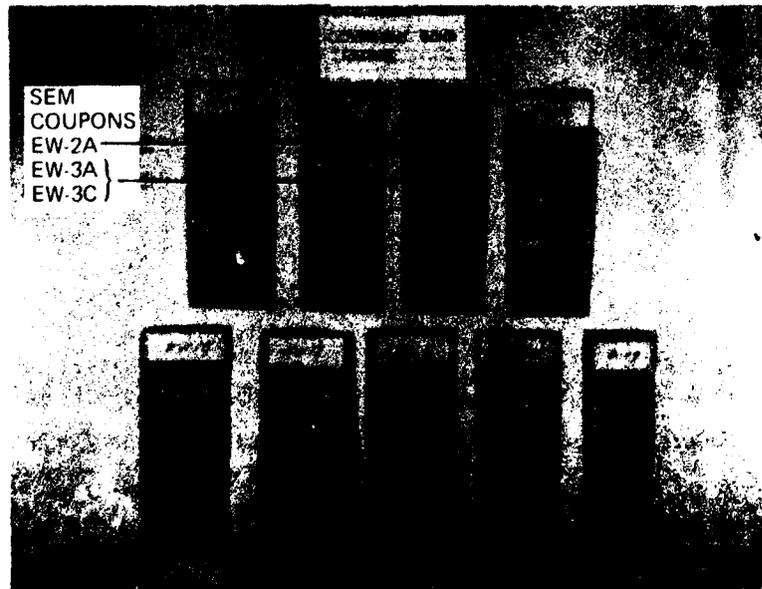
Photos of the failure surfaces of the wedge specimens are shown in Figures 85, 86, and 87. Although the majority of the failure surfaces are cohesive, six of the specimens have partial

*Figure 85.—Failure Surfaces of Wedge Specimens From the Overhead Bonded Repair*

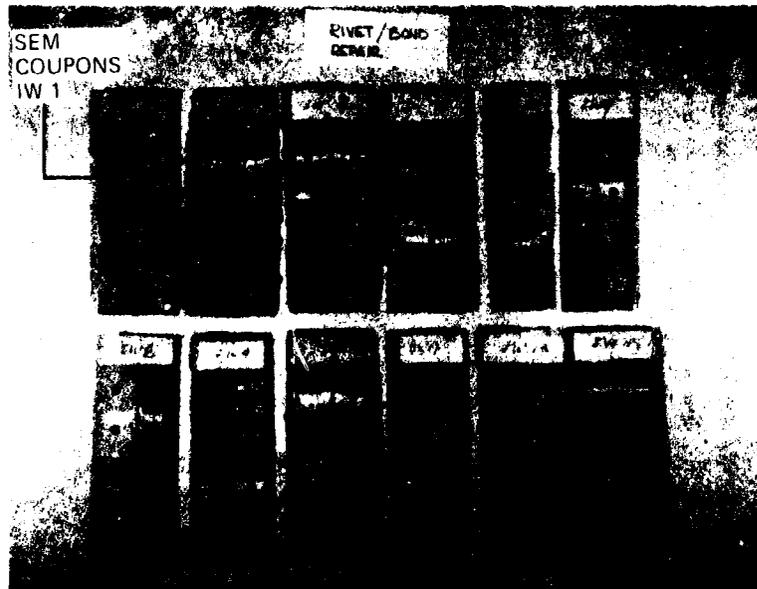
*Figure 86.—Failure Surfaces of Wedge Specimens From the Mechanical Fastener Bonded Repair*
