TECHNICAL REPORT ARLCD-TR-78C17

**FAILURE ANALYSIS OF THE LIGHTWEIGHT
COMPANY MORTAR SYSTEM 60 MM MORTAR FIN**

**US ARMY ARMAMENT RESEARCH AND DEVELOPMENT COMMAND
LARGE CALIBER
WEAPON SYSTEMS LABORATORY
DOVER, NEW JERSEY**

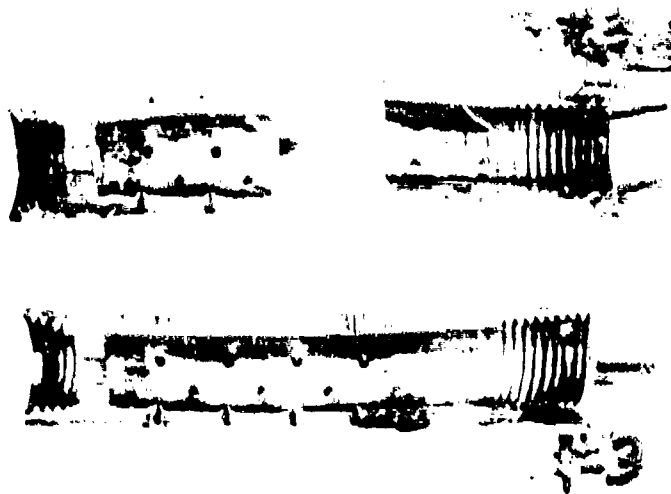
The initial failure of an XM27 fin section occurred during a test firing at Aberdeen Proving Ground in December 1975 when the extruded fin separated longitudinally into two halves and failed to leave the launcher. Several additional malfunctions, similar in nature to the first, have occurred during test firings at Fort Benning, Fort Greely and Aberdeen Proving Grounds. A typical failed fin is shown in figure 1.

Figure 1. Typical abnormal fin failure.

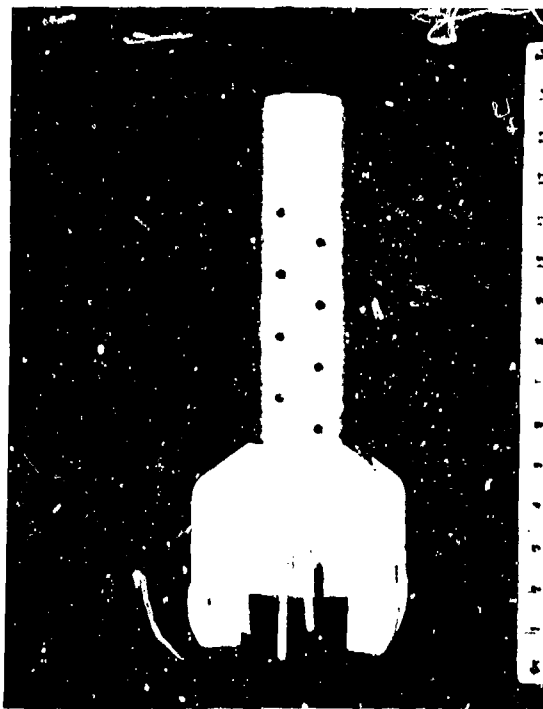
An investigation of the failure mechanism and mode was begun at Frankford Arsenal and Picatinny Arsenal, during which 1800 fins were subjected to mandrel tests resulting in another seven failures similar in nature to those experienced during test firing. A typical "normal" mandrel failure is shown in figure 2.

Figure 2. Typical normal fin failure.

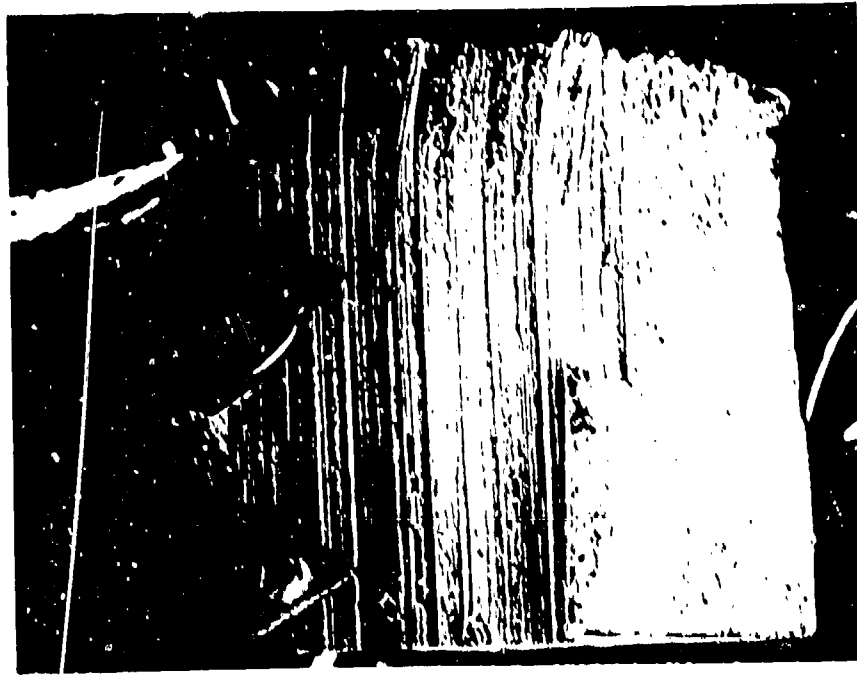
Figure 5. Scanning electron micrograph showing coexistence of both dimpled and striated fracture on the same surface.
