LOW FRICTION HULL COATINGS
FOR ICEBREAKERS

PHASE III TECHNICAL REPORT

S.J. Calabrese and F.F. Ling
Department of Mechanical Engineering,
Aeronautical Engineering & Mechanics
Rensselaer Polytechnic Institute

OCTOBER 1978

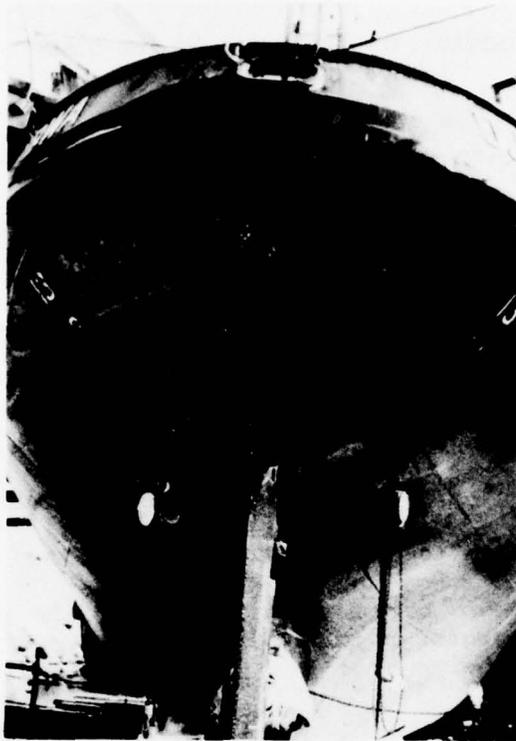
A full-scale test was conducted to determine if the unfilled polyurethane was as effective as the filled polyurethane as an icebreaker hull coating. With the cooperation of Foss Launch and Tug Company, Seattle, Washington, their 140 ft icebreaker, the ALASKA HUSKY was coated with the nonsolvent polyurethane during May 1976. The port side was coated with the amorphous silica-filled polyurethane and the starboard side with unfilled polyurethane. In addition to wear from icebreaking the HUSKY also suffered from abrasion due to silt in the water

Figure 8 Condition of OJIBWA after 358 Hours of Icebreaking

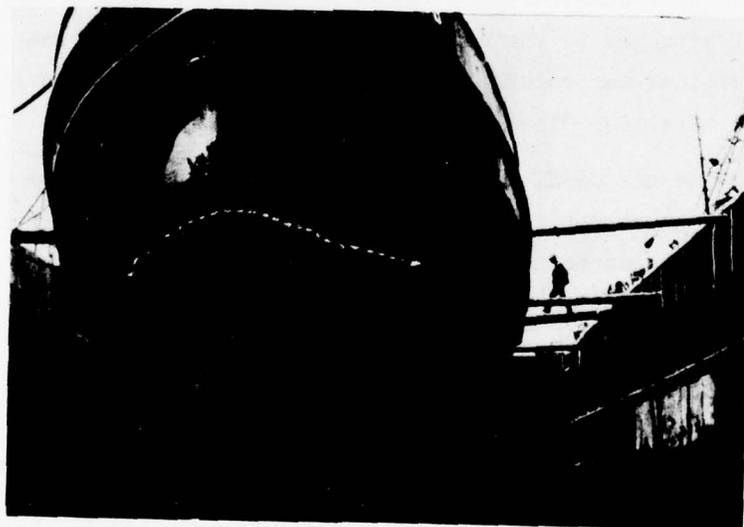
Figure 11 Condition of the USCG Cutter RARITAN after One Year, 600 Hours (Above) and Three Years, Approximately 1800 Hours (Below) of Icebreaking Service

coating is in the high wear and impact area. As of the winter of 1977 season (after approximately 1800 hours icebreaking service) there does not appear to be any wear on the under portion of the hull. The coating is still the original thickness and there is no evidence of corrosion. The only wear is at the ice line near the bow.

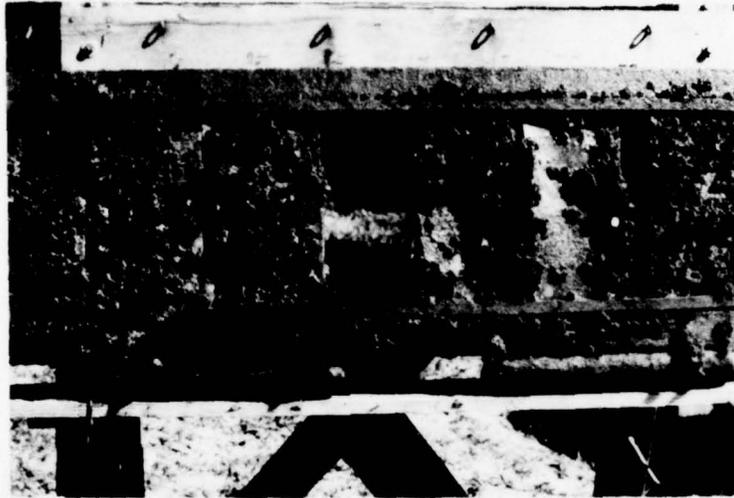
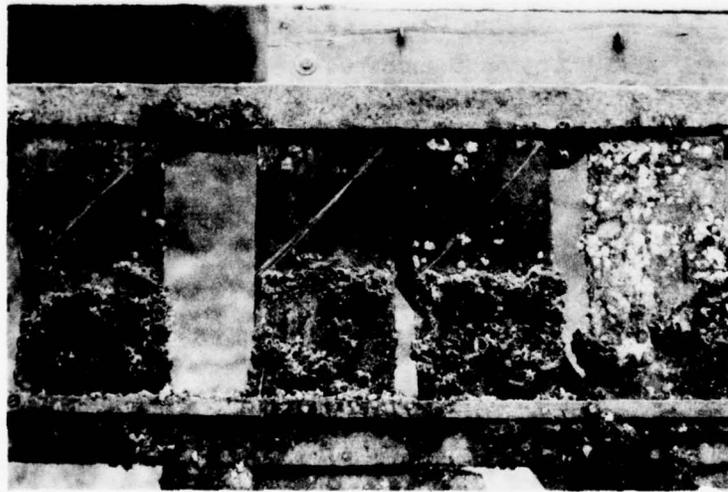
The specimens were placed back in the water for approximately six months. Upon removal, it was found that they had fouled severely similar to the previous 11-month exposure. The attached fouling was slightly harder to remove this time,

Figure 14 Condition of the Zebtron Coated Panels after Exposure for Six Months

but it could be removed from the panels without damage to the substrate. Crustaceans had lodged in the scribe line on the metal surface but they were unable to lift the coating. The penetration under the coating edge was less than 1/16" Figure 15 (upper) shows the condition of the surface as removed from the water and an area which was cleaned after removal. There was no damage to the coating but a slight discoloration was evident. Figure 15 (lower) shows the scribe line where the bare metal had been exposed. Note the barnacles which had attached to the metal but which did not lift the coating at the edge. The metal tangent to the scribe line was still intact. An attempt was made to peel the coating back from the edge but very little (approximately 1/8") of coating could be lifted. The substrate (steel) was still clean with no evidence of corrosion taking place beneath the Zebron. After 17 months of exposure to fouling and two cleanings the coating thickness remained between .028" and .032". There appeared to be no change in thickness.

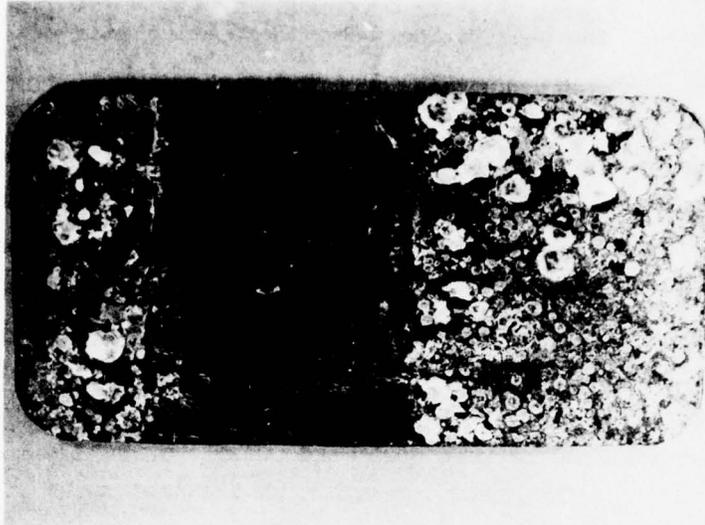
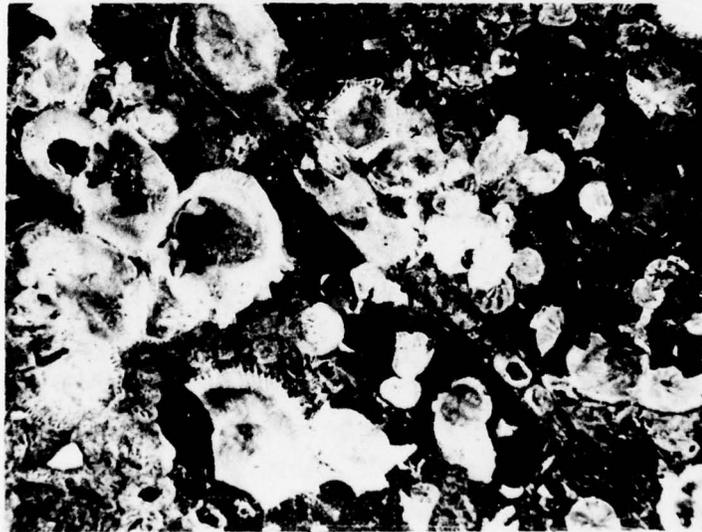
The results of this investigation indicate that the application of a non-solvent coating is an effective method to protect the submerged steel against fouling damage and corrosion. The coatings are not antifouling but do not appear to be significantly damaged by fouling. All organisms can be removed by brushing

Figure 15 Condition of the Zebtron Coated Specimens after Removal from Fouling Exposure. Upper photograph shows the coating before and after cleaning. Lower photograph shows the condition of the scribe line where bare metal was exposed. Mag. 3X.

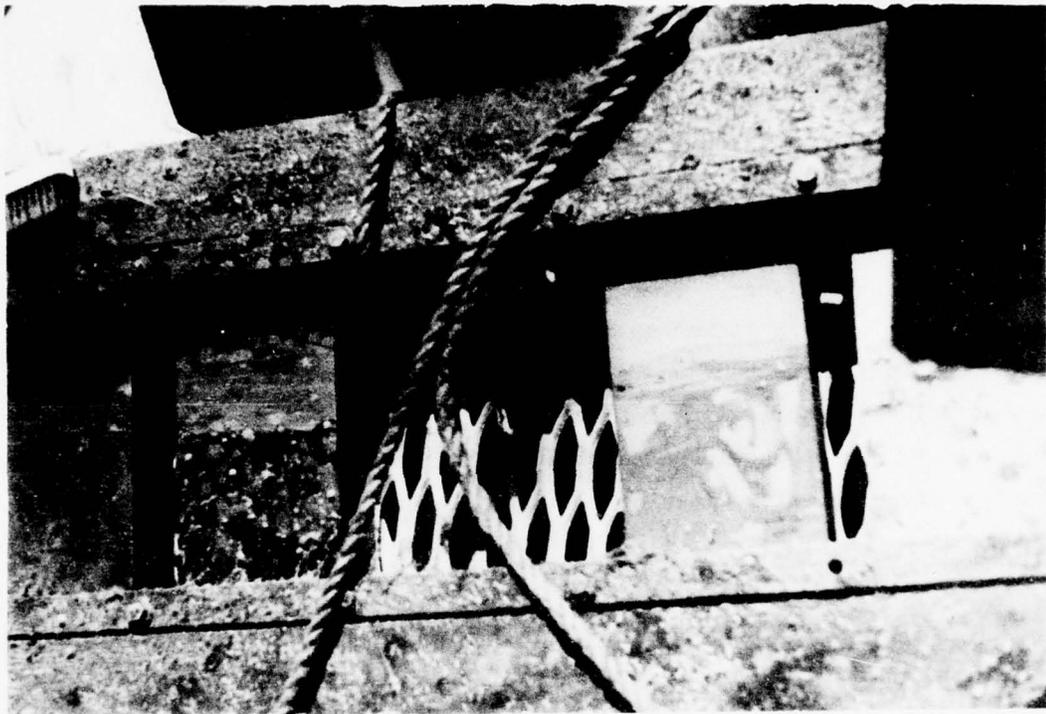
Figure 16 Condition of Test Panel after Four Months Exposure at Long Beach, California. A portion of the test specimen was cleaned by light brushing.

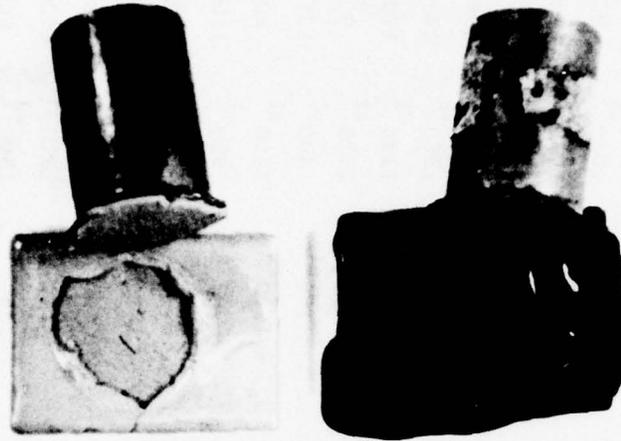
Figure 18 Typical Bond Strength Samples after Test. Gray specimen is nonsolvented polyurethane and black coating is nonsolvented epoxy.

the coating on the steel. The lower photograph shown in Figure 18 shows the polyurethane failure (gray coating) to be partially in the coating and partially at the primer while the epoxy coating failure is all in the coating.

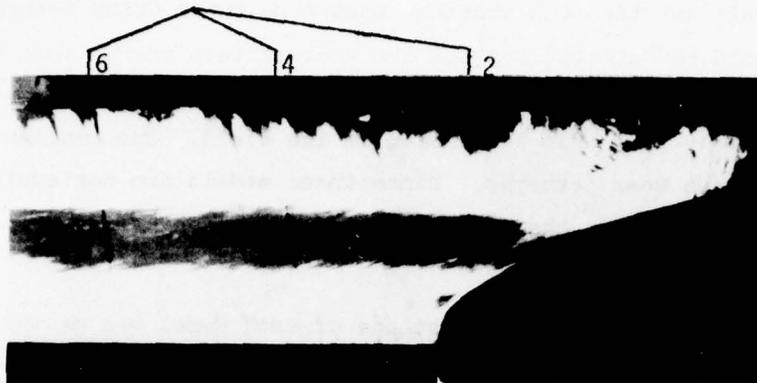
BOW - NOTE DIRECTION OF WEAR LINES
