MISCELLANEOUS PAPER C-78-12

CONCRETE AND ROCK CORE TESTS MAJOR REHABILITATION OF STARVED ROCK LOCK AND DAM, ILLINOIS WATERWAY CHICAGO DISTRICT, PHASE I, REHABILITATION

September 1978 Final Report

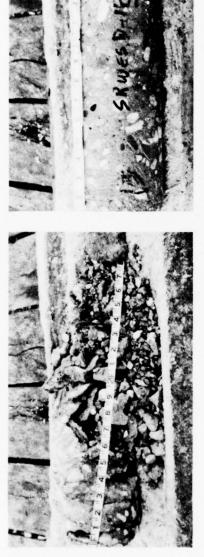
Figure 3. Concrete core from ice chute pier (horizontoal boring SR WES D-18-77) showing broken condition of core

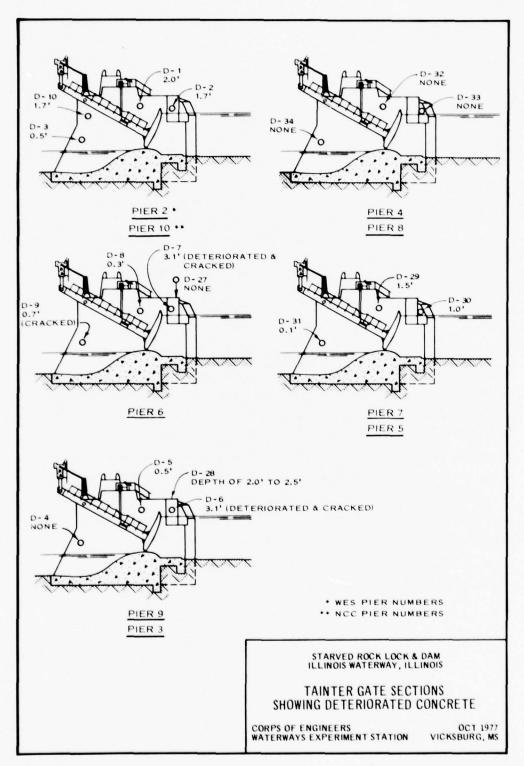
Figure 6. Location of deteriorated concrete, tainter gate sections

92. Average Physical Properties. The average physical properties of the severely and moderately deteriorated concrete from the tainter gate piers are presented below:

One or more of these companies may have had experience with injecting epoxies or chemical grout into porous concrete. It is assumed that the techniques used would be different than techniques used for injecting these materials into single or multiple cracks. The effectiveness of such a procedure should be studied.

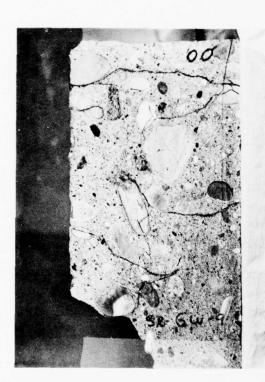
Photograph Bl

Core SR WES GW-9-77 contained traverse cracks near the top of the core and incipient cracks deeper in the core.

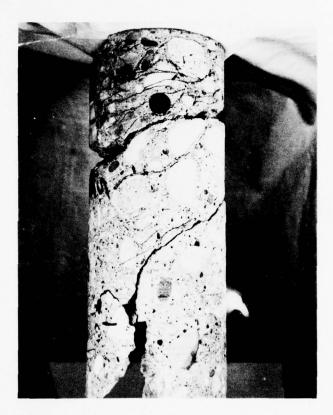
Core SR WES D-22-77 is typical of several cores showing subparallel to parallel fractures going through both aggregate and paste indicating frost damage near the surface and a transition to horizontal cracking related to alkali-silica reaction deeper in the hole.

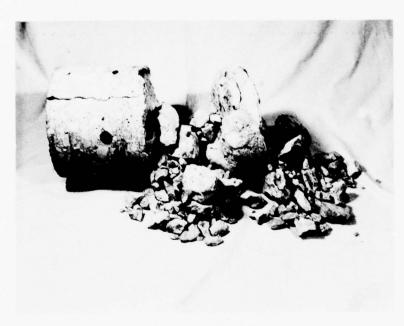
Core SR WES D-1-77 has been resurfaced with a layer of new air-entrained concrete. The zone directly beneath the resurfacing was damaged by frost action and disaggregated during drilling.
