NRL Memorandum Report 3874

Failure Studies of a Third Stage Fan Disk From a TF-30 Turbine Engine

W. H. VAUGHAN, R. J. SANFORD, AND J. M. KRAFFT

November 13, 1978

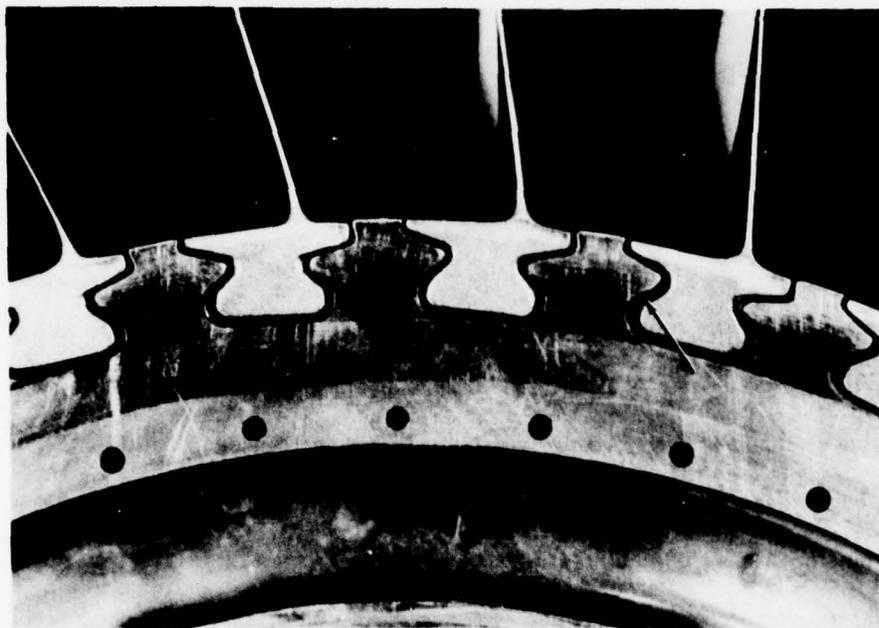
In recent years, the Navy has experienced unusual maintenance problems with its F-14 fighter aircraft. One of these is a tendency to develop cracks in the third stage fan disk of its TF-30 turbo-jet engines. These cracks typically originate in the dovetail region (Fig. 1) near the inner edge of the bearing surfaces between the disk and blades. A fully developed crack viewed from the leading edge of the dovetail is shown in Fig. 2. Cracks developed in this region after an unexpectedly short period of service. An investigation demonstrated a correlation between incidence of cracking and radial clearance between the second- to third-stage air seal. It was found that all of the failures had occurred in engines for which the clearance exceeded 0.025 in. (0.6 mm). This clearance was found to reduce the effective stiffness of the third stage disk, resulting in a strong 2E mode resonance within the operating speed range of the engine ($< 10,500$ rpm). This resonance results in vibratory stresses the order of 15 ksi (103 MPa) which, superposed on the high centrifugal stress, induce high frequency fatigue failures. A program to reduce the air-seal clearance has essentially eliminated this mode of failure and increased the service life of this part. However, fatigue cracking problems were found in other parts of the engine. Thus several studies were initiated at NRL to probe general aspects of the problem.

Fig. 1 — Side view of the intact portion of the third stage fan rotor showing the dovetail attachment of the blades. The arrow indicates the region where fretting occurs.

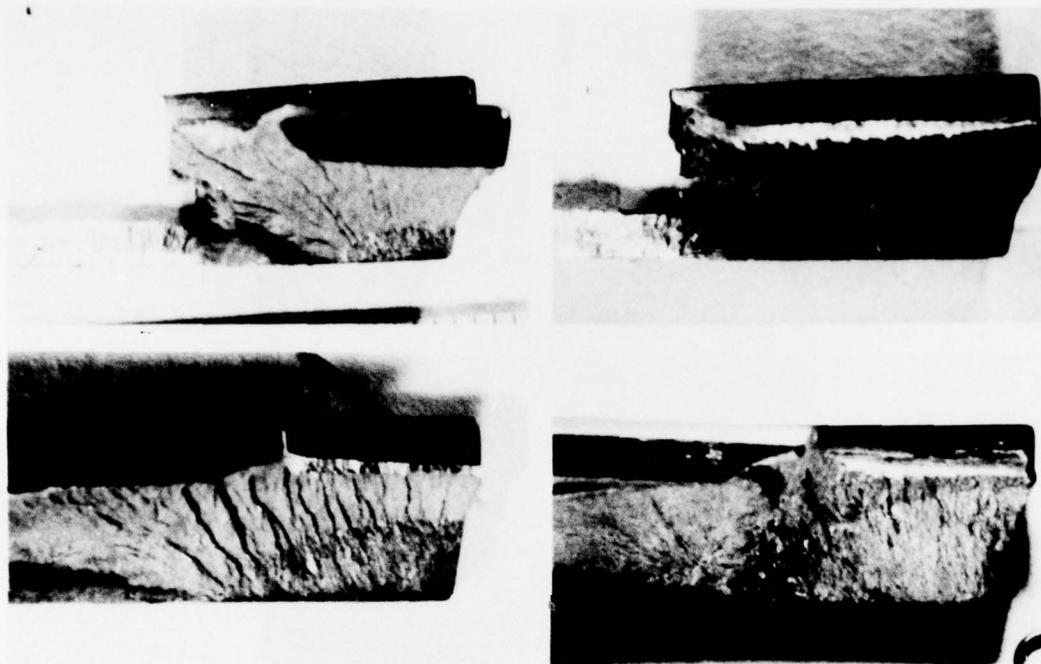
The fracture surface of each of the removed lugs was photographed at 3.25X and examined under a low-power binocular microscope. All of the cracks originated near the inboard edge of the bearing area with the majority (13) of them occurring on the left side of the disk lug (when viewed from the front). The exposed fracture surfaces revealed that the cracks are initially planar and follow the same path as shown on the surface of the lug (see Fig. 2). Four typical fracture surfaces are shown in Fig. 5. In the figure the front face of the disk is on the right and the lug has been rotated so that the fatigue crack is in the plane of photograph. As can be seen, the cracks have quarter-elliptical fronts, of a high length-to-depth ratio, centered

Fig. 5 — Typical cracks that started in the leading edge.

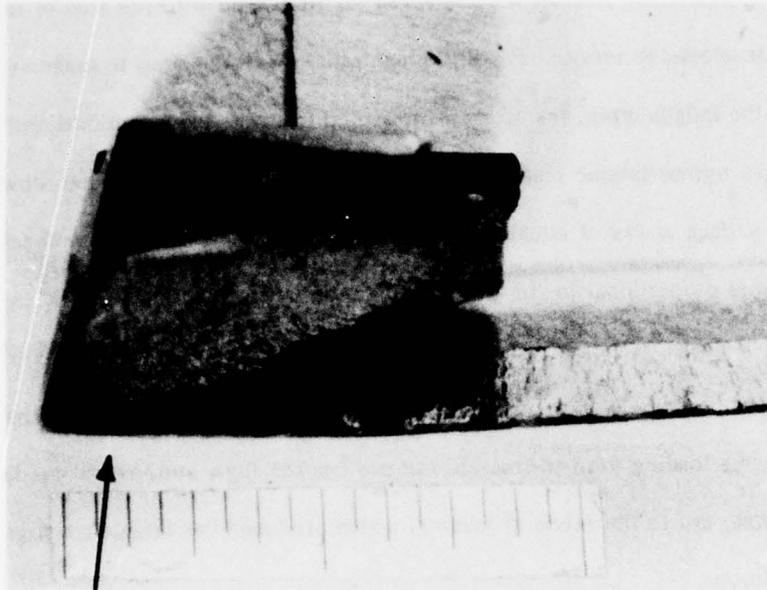
Fig. 6 - A typical crack that started in the trailing edge.

(b) Although the majority of the cracks formed near the leading edge of the lug a small number were found to start at the trailing edge.

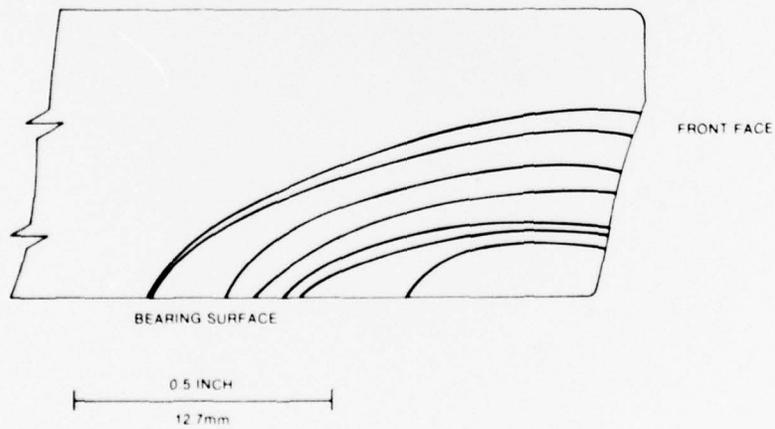
near the slot to front face intersection. The smoothness of the surface texture relative to the fast fracture region beyond the elliptical perimeter suggests that they grew as fatigue cracks, which later high-resolution examination verified. While most of the cracks emanated near the forward leading corner of the disk lug, a small crack (see Fig. 6) was found in the rear of a disk lug. The cracks originated in the fret zone or in the fillet region just below the fret zone. It appears that a given crack initiates at several points over a distance of the order of millimeters along the edge of the slot. This accounts in part for the relatively high ratio of the length of the crack along the disk slot relative to its depth in the lug. The pattern of growth as cracks progress from their origin is relatively consistent, as shown, Fig. 7, in an overlay of this series of various sized cracks.

Fig. 7 - Tracings of the leading edge of seven cracks that developed in service. They appear to have a consistent pattern of initiation and growth.

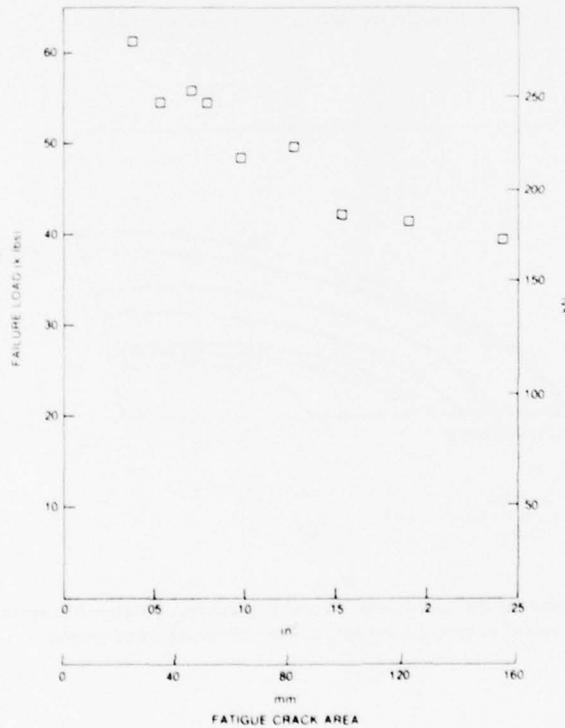
The force required to fracture a pre-cracked lug decreased with the area of the crack surface that had developed in service. For those lugs which fractured so as to make visible the initial surface of the fatigue crack, the area was measured from the low magnification photographs. The failure load versus fatigue crack area is shown in Fig. 8. Irwin [5] has shown that, for semi-elliptical surface cracks of equal aspect ratio, with loading normal to the crack, the stress intensity factor is proportional to the product of the breaking load and the fourth root of the crack area, A . The data used in Fig. 9 shows this dependency when plotted as $\sigma \sqrt[4]{A}$ versus crack area, where σ is the average stress on a lug at failure. It should be noted that this result applies only to the loading used to fracture the pre-cracked lugs, and, as will be demonstrated later in the report, not to the mode of loading, which produced the fatigue crack growth under in-service conditions.

Fig. 8 — The ultimate load to remove a lug as a function of the area of the crack that developed in service.

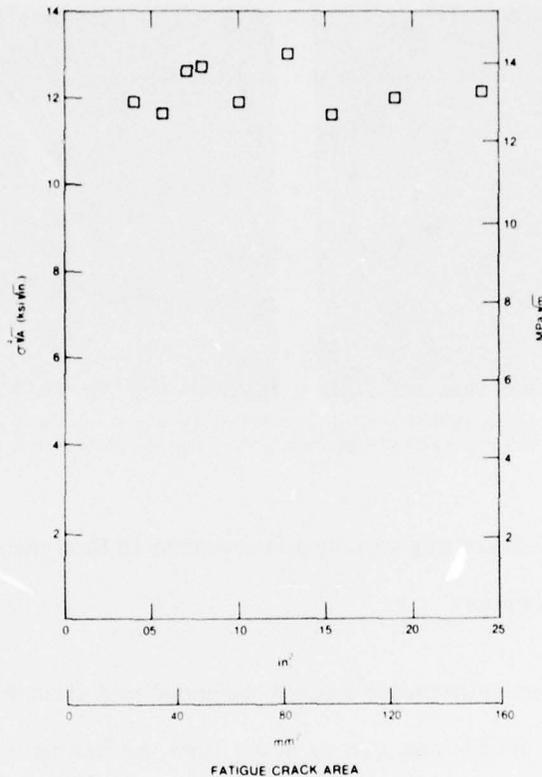
Fig. 9 — This shows that the fourth root of the product of the ultimate load and the crack area is a constant. However this was not the state of stress that occurred in service.

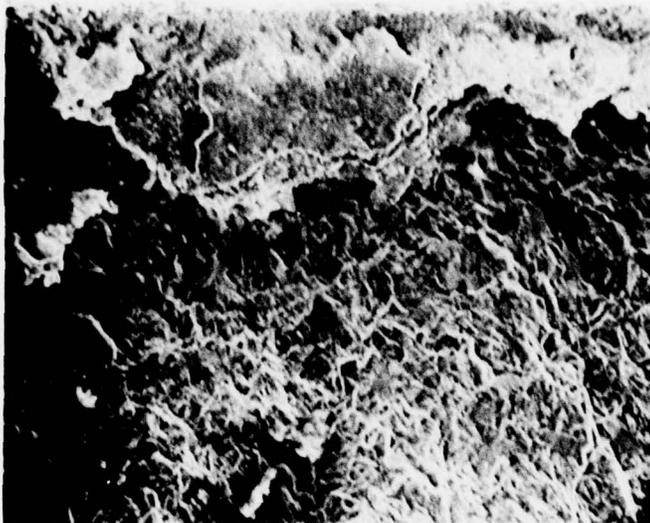
The region around an initiation site was also examined on a crack which had been broken open. The origins were initially obscured by debris from the fretting which had been forced into the crack and was adhering to the crack surface as illustrated in the upper portion of Fig. 11. This debris was stripped off by repeated application and removal of a polycarbonate replica material. The difference in visibility between an unstripped and stripped fracture origin is seen by comparing Fig. 11 and Fig. 12a. Once the debris was stripped away, it was found that the shape of the grains is not clearly defined near the origin, as shown in Fig. 12b. It is possible that the loss of definition is due to abrasion of the fracture surface by fretting debris or to extensive plastic deformation at the fracture initiation site. It can be seen that the origin of the fracture surface is inclined at an acute angle to the bearing surface unlike the rest of the fracture surface which is essentially perpendicular to the bearing surface. This behavior is typical of fretting origins under the contact zone when shearing forces are present.

Fig. 11 — SEM micrograph (200x) showing typical fretting debris along the region where the multiple crack origins occurred

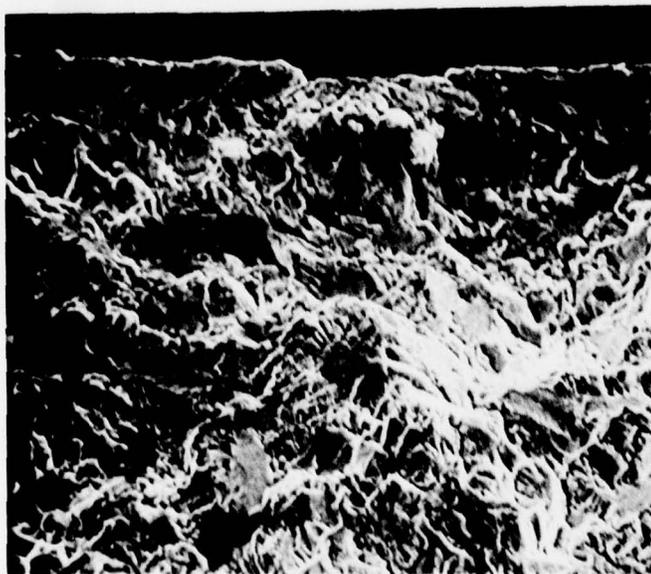
Fig. 12a — SEM micrograph (500x) showing the contrast in microstructure between the cleaned fracture origin at the top and the quasicleavage at the bottom.

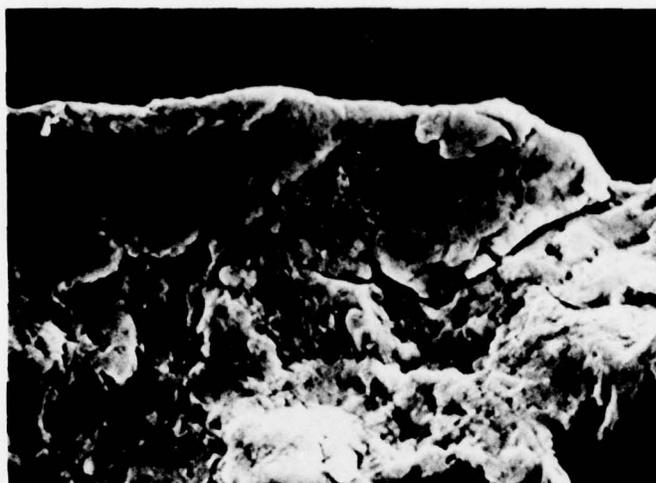
Fig. 12b — SEM micrograph (2k x) of the fracture origin shown in 12a

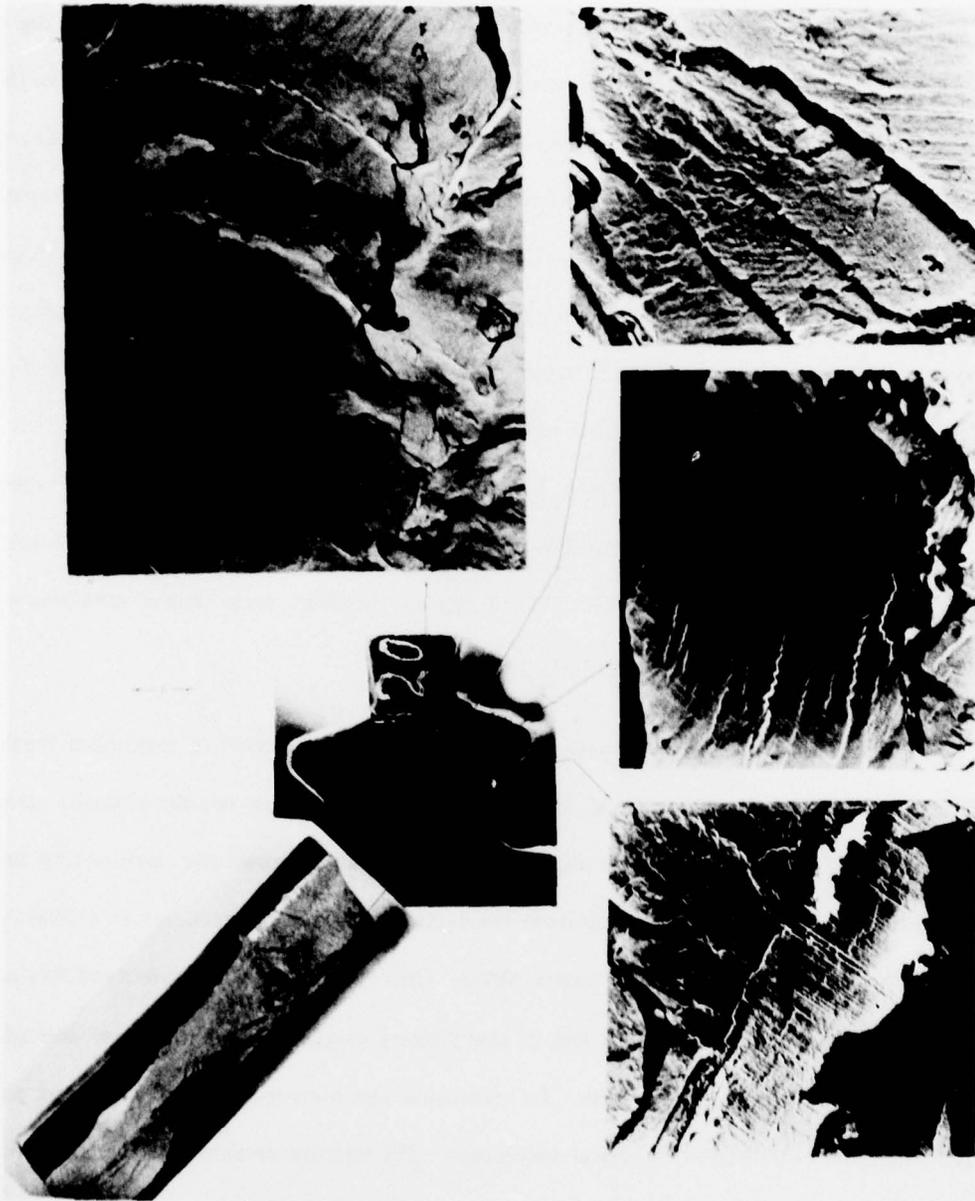
Figure 13 shows several TEM fractographs taken from various regions of the fatigue crack. It was anticipated that the striation spacings would become larger with distance from the surface, corresponding to the stress intensity factor increasing with crack length. Surprisingly, this was not the case. The striations which were formed all had low contrast and a constant spacing that averaged around $.04 \mu\text{m}$ on the portion of the fracture surface perpendicular to the bearing surface. Only after the fatigue crack turned tangentially across the lug did the striation spacing increase, becoming 2 to 5 times larger. These small striations are barely visible in Fig. 13. There is evidence of groups striations with spacings of the order of $0.5 \mu\text{m}$ (2×10^{-5} in.) in the initial stages of fatigue crack growth, increasing to $1.5 \mu\text{m}$ (6×10^{-5} in.) after the crack turns. These groups are clearly visible in Fig. 13. It is reasonable to associate these group spacings with low cycle engine fluctuations. Thus it appears that high cycle fatigue striations are superposed on low cycle engine fluctuations.

Fig. 13 — Examples of the fatigue striations found at the depths indicated by arrows. These micrographs were made in a TEM from replicas.

By comparing the photoelastically determined stress intensity factor with the observed striation spacing in the region of constant crack growth rate, several conclusions can be drawn concerning loading conditions during crack growth. If one assumes, contrary to the fractographic evidence that the loading was that of low cycle fatigue associated with engine speed fluctuations, the measured stress intensity of $14 \text{ ksi } \sqrt{\text{in.}}$ ($15.4 \text{ MPa } \sqrt{\text{m}}$) at the maximum operating speed of 10,500 rpm would correspond to the upper bound on ΔK , i.e., K_{max} . Assuming large engine speed excursions of 50% or greater ($R \geq .5$), the ΔK would vary between 7-14 $\text{ksi } \sqrt{\text{in.}}$ ($7.7\text{-}15.4 \text{ MPa } \sqrt{\text{m}}$). From the data of Bucci and Paris [8] this range of ΔK would correspond to crack growth rates of the order of 10^{-6} to 10^{-5} in./cycle ($\approx 10^{-7}$ mm/cycle). An examination of the fatigue crack fractography as shown in Fig. 12a, shows this region to consist predominantly of cleavage leaves with little dimple rupture. Yuen et al. [9] have shown that in titanium alloys cleavage is not produced at crack growth rates in the range of 10^{-5} in./cycle or faster. Therefore low cycle fatigue as the primary mechanism of crack growth must be ruled out. The presence of groups of striations as seen in Fig. 13 (upper left) is consistent with the

superposition of high cycle fatigue on the low cycle engine fluctuations through some resonance range.

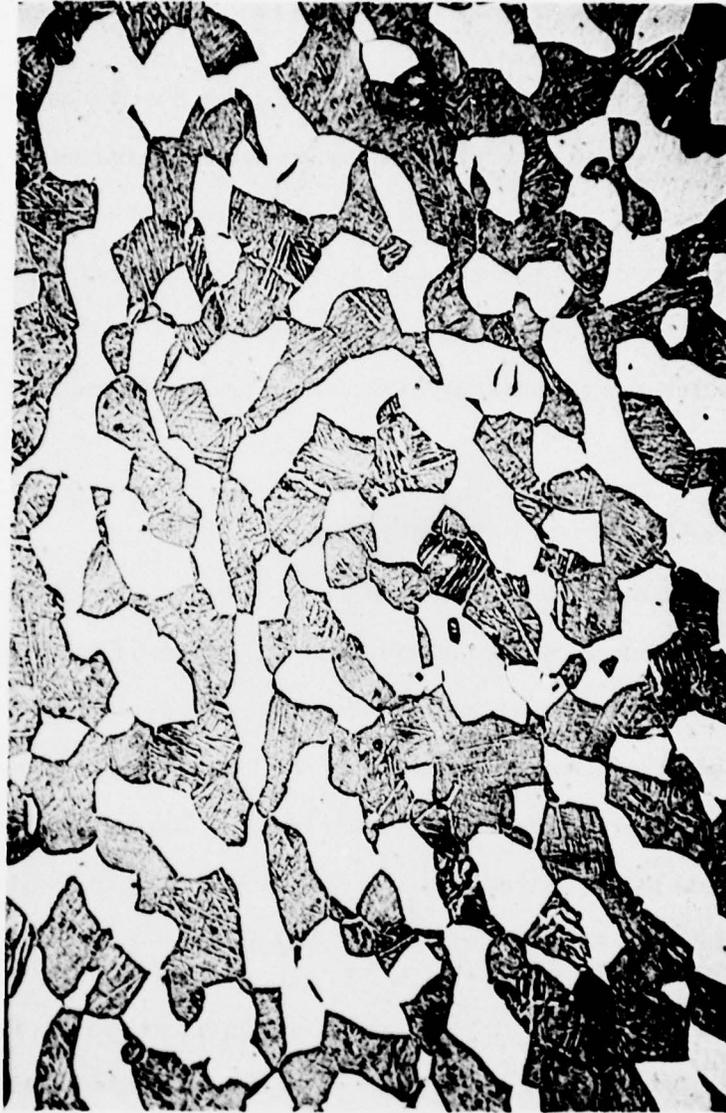
The path of the crack through each lug is not along the direction of maximum tensile stress that develops under centrifugal loading, as indicated by the two-dimensional stress analysis studies of the lug [1, 2]. This analysis would lead one to expect the crack to turn into the tangential direction a short distance from the surface and then to propagate in a direction normal to the direction of maximum tensile stress. One possibility for the observed fracture path is that the cracks are following a line of low fracture toughness resulting from flow patterns produced by the forging operation. To investigate this a cross-section of a lug was polished, etched, and examined in an optical microscope. The micrograph shown in Fig. 14, which was typical of the whole lug, shows that the microstructure is alpha phase in the white areas and acicular alpha plus beta in the dark area. The alpha/beta region showed some signs of an incipient transformation to lamellar alpha-beta. Such microstructure is typical of titanium-

Fig 14 — Microstructure of the third stage fan lug. It is primary alpha in the light areas and acicular alpha plus beta in the dark areas. There is no evidence of a preferred orientation.

aluminum alloys which have been air-cooled from the alpha-beta transition region of the phase diagram. There is no evidence of a pattern of flow lines associated with the forging process.

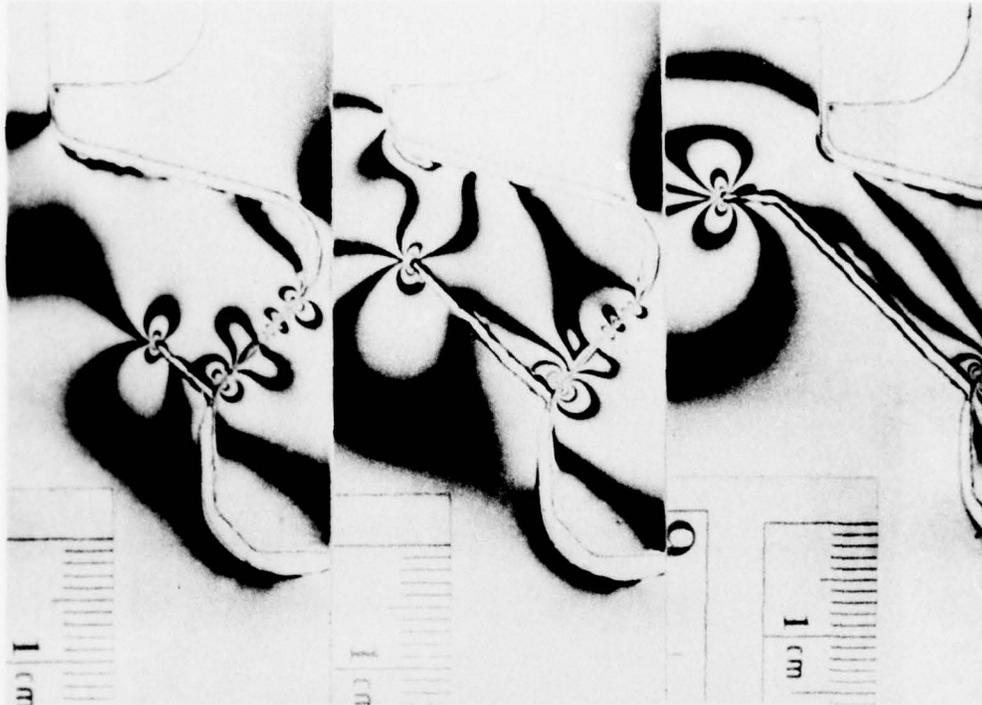
Typical isochromatic fringe patterns obtained during the test are shown in Fig. 15 with an enlargement of one of these in Fig. 16. Inspection of the fringe pattern of Fig. 16 indicates that the characteristic fringe loops associated with the stress singularity are not symmetric with respect to the crack line and that the fringe loops on either side of the crack line are rotated by different amounts. This configuration of the fringe loops indicates that the driving force on the crack has both opening (K_I) and forward shear (K_{II}) components. The observation that the

Fig. 15 - Isochromatic fringe patterns of the photoelastic model. They show little change in stress intensity until the simulated crack turned the corner.

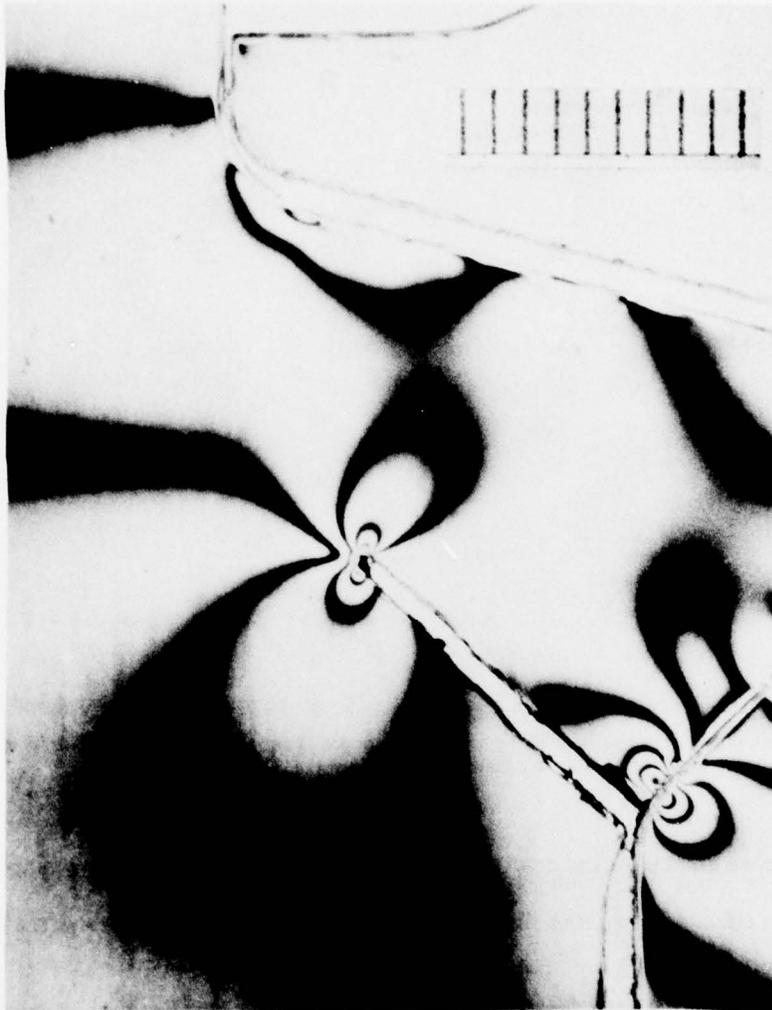
fringe loops above and below the crack line are of different size and different rotations indicates that there is an effect due to a non-singular stress component which complicates the analysis.

Fig. 16 — An enlarged view of the bottom photograph of Fig. 15. The evident asymmetry of the fringe pattern is indicative of the mixed mode state.

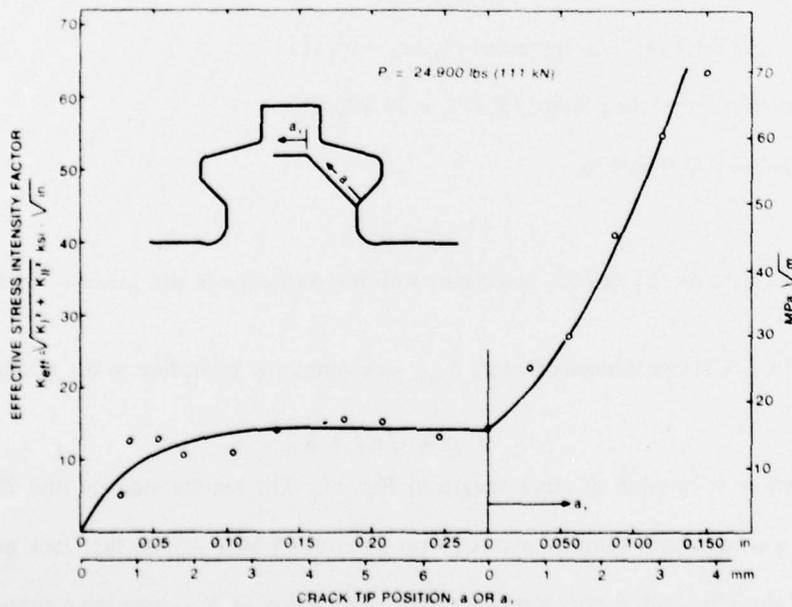
and is shown as a function of crack length in Fig. 17. The results indicate that K_{eff} increases from zero to a maximum value of about 14 ksi $\sqrt{\text{in.}}$ (15.4 MPa $\sqrt{\text{m}}$) as the crack penetrates the region near the fillet with a high stress gradient. The value of K_{eff} remains essentially constant as the crack extends into the lower stress region and propagates across the lug. As the crack

Fig. 17 - The effective crack tip stress intensity factor K_I as a function of the position of the crack tip.

approaches the compressive fillet, K_{II} increases and K_I decreases (see Table 1) until the crack turns through an angle of 45 degrees and begins to propagate circumferentially. At this point K_I increases markedly and K_{II} decreases. With further increases in crack length K_{eff} increases to a value exceeding $60 \text{ ksi } \sqrt{\text{in.}}$ ($66 \text{ MPa } \sqrt{\text{m}}$).
