SUSQUEHANNA RIVER BASIN
GRASSY ISLAND CREEK, LACKAWANNA COUNTY
PENNSYLVANIA

OLYPHANT NO. 2 DAM
NDS ID NO. 382
PENNSYLVANIA GAS AND WATER COMPANY

PHASE I INSPECTION REPORT
NATIONAL DAM INSPECTION PROGRAM

MAY 1978

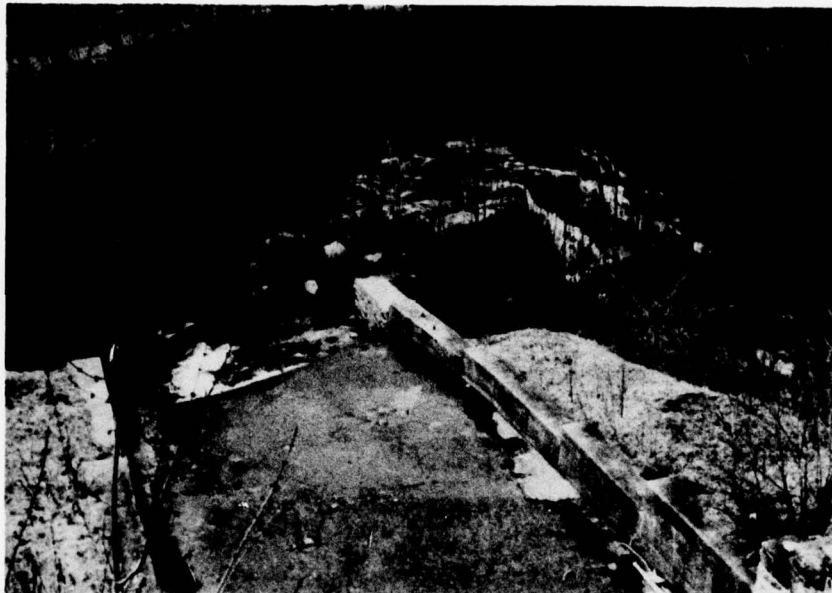
(2) The concrete apron below the spillway (Photograph C) was in poor condition. Much of the concrete had deteriorated to the point where the foundation material, a coarse gravel, was visible. The apron is unevenly bulged over its entire length. There appeared to be seepage from the junction of the apron and the left training wall. Since water was flowing over the apron, a definite conclusion as to the seepage could not be reached. The concrete at the downstream end of the apron, where it meets the natural rock ledge, was completely eroded. Apparently, this junction was originally constructed of rubble blocks covered with concrete. Only the rubble is remaining.

- (1) No conditions were observed on the spillway which might present a significant hazard to the dam.
- (2) The concrete apron was almost completely deteriorated. It may not protect the toe of the spillway or training walls from erosion during high spillway discharges.

C. Spillway Apron and Downstream Channel

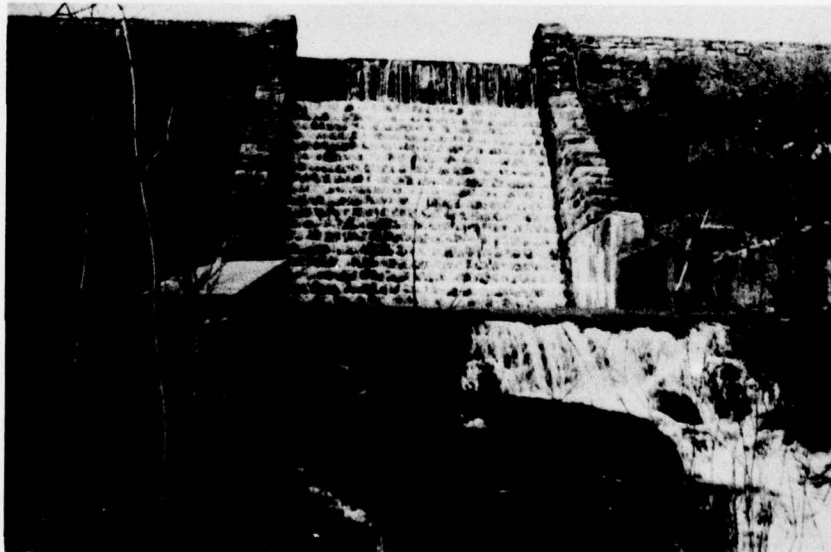
(1) The main spillway (Photograph D) had no observable defects. Water was flowing over the spillway and, therefore, a detailed inspection was not possible.

D. Spillway and Spillway Apron

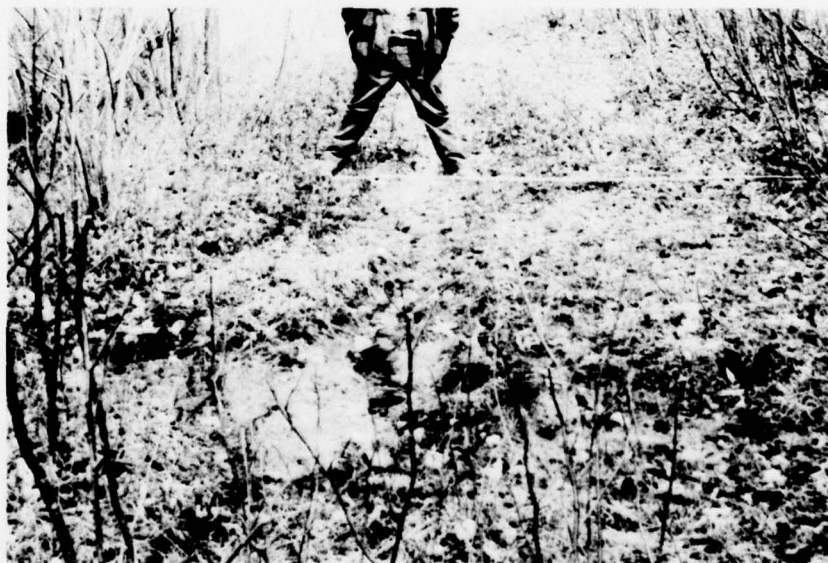
F. Wet Area at Left of Spillway Apron

(2) Provide six observation wells or other instrumentation in the earthfill slopes, three on each side of the spillway. Also, one observation well or other instrumentation should be placed in the vicinity of the wet area. Instruments should be read periodically and any rises in water level should be analyzed to determine the effect on the stability of the earth slopes and earth masonry dam. Monitor wet and seepage areas and if conditions worsen, take necessary action.

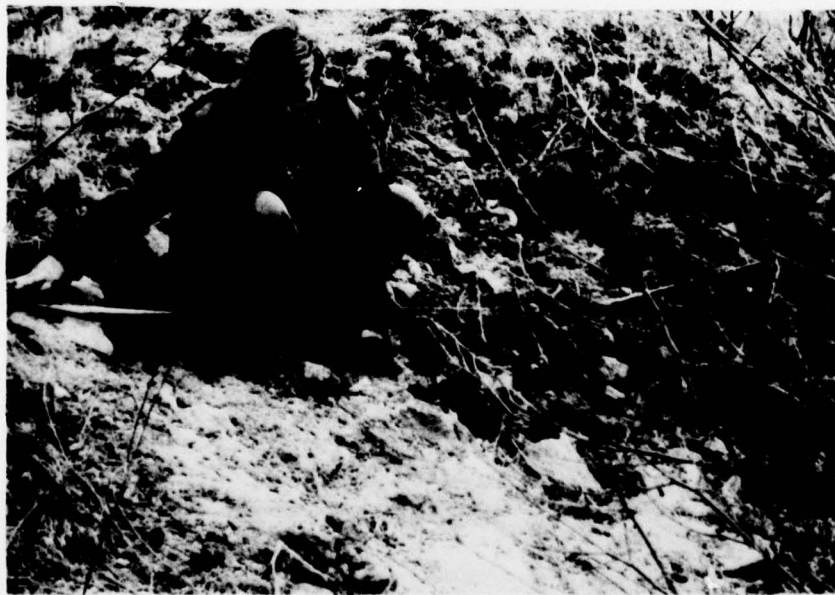
a. Dam. The continued growth of brush on the earthfill is undesirable. The sloughed area could indicate serious embankment problems. A review of available photographs in the files of the Pennsylvania Office of Dams and Encroachments indicates that this area of earthfill apparently had problems previously. The recommendation of the 1914 Pennsylvania Water Supply Commission report on this dam was to raise the spillway training walls to prevent splashing water from eroding the earthfill. Although this recommendation was implemented in the early 1920's,

an inspection by the Pennsylvania Water Supply Commission in 1945 noted that splashing water from the spillway had eroded some of the earthfill at approximately the same location as the present sloughing. There is also a possibility that seepage through the masonry joints in this area, during periods of high pool, could collect sufficiently to erode the area. It is also a possibility that the earthfill in this area is not stable. The sloughed area is of general concern. No special significance could be attached to the two lumps. They could be remnants of construction operations or evidence of past instability. As the lumps are covered with brush, they are apparently not indicators of an active condition. The wet area and seepage at the toe of the earthfill to the left of the spillway were noted on various Pennsylvania Water Supply Commission inspection reports. The wet area was noted in the inspections of 1928, 1933, 1941, 1945 and 1953. It was not noted in inspections before 1928 nor in the inspections of 1930, 1934, 1957 and 1965. The seepage was noted only in the 1933, 1941, 1945 and 1953 inspections. The descriptions in these inspections are insufficient to determine if the areas under discussion are identical. The area has apparently stabilized but, because of the potential seriousness of the problem, it is of general concern. Deteriorated mortar in masonry joints increases the possibility of seepage and does not allow the structure to act as a monolith.

H. Sloughing on Embankment
Left of Spillway — Near Crest

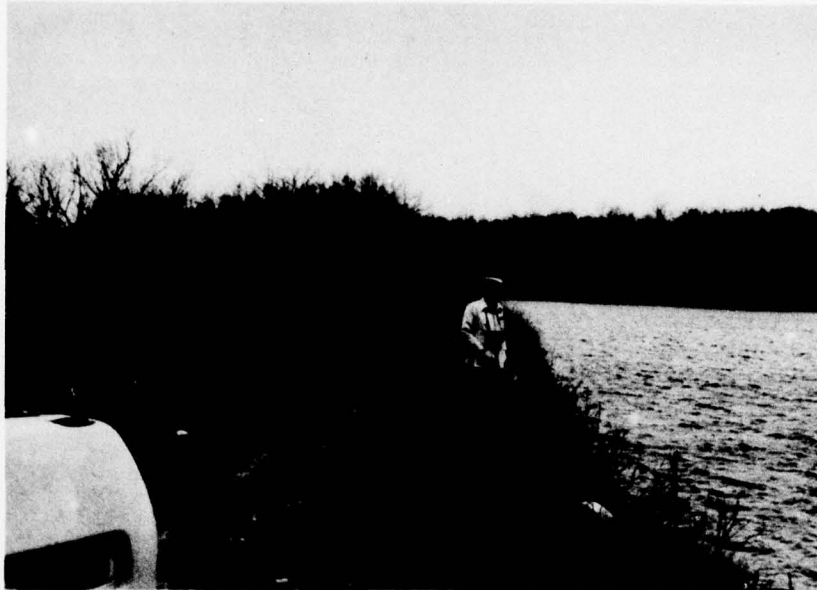
I. Olyphant No. 3 Dam
Located Upstream of Olyphant No. 2 Dam
View from Left Abutment

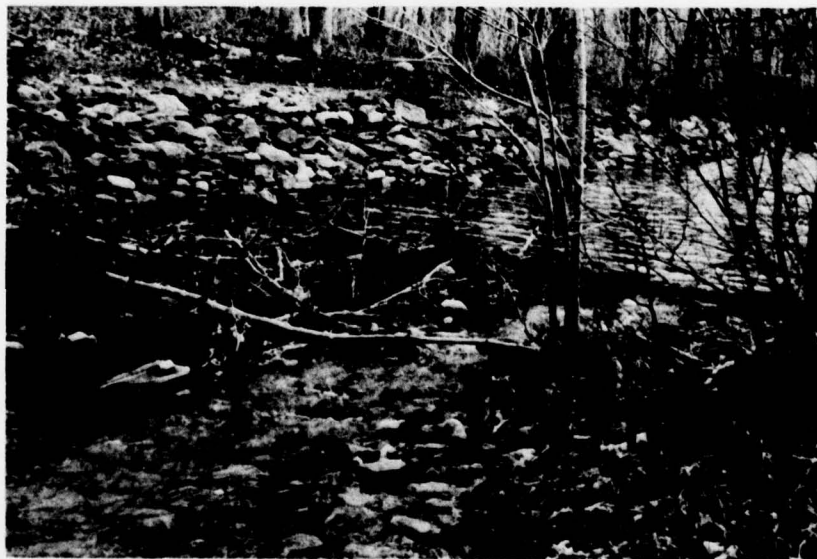
J. Olyphant No. 3 Dam
Located Upstream of Olyphant No. 2 Dam
Spillway with Beaver Dam at Left
Looking Upstream
