**GREATER JOHNSTOWN WATER AUTHORITY DAM
(SALT LICK DAM)**

**PHASE I INSPECTION REPORT
NATIONAL DAM SAFETY PROGRAM**

Greater Johnstown Water Authority (Salt Lick Dam)
Pennsylvania
Cambria County
Salt Lick Run
April 4, 1978 (visual inspection)
Inspection Team - EADS

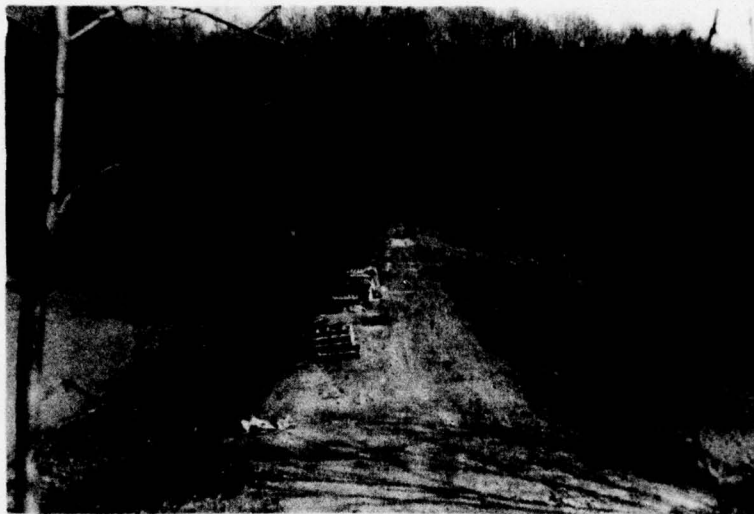
VIEW OF TOP OF DAM, LOOKING SOUTHEAST

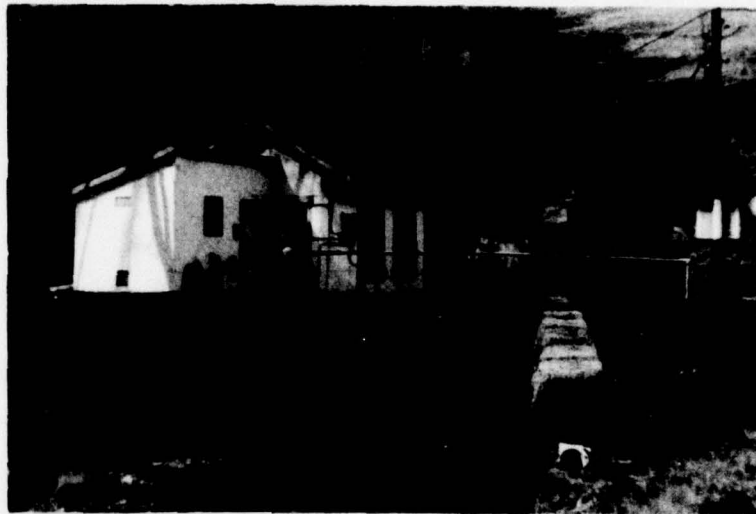
(4) The concrete retaining wall at the outlet end of the access conduit is badly spalled and in need of repairs. The stone masonry wall against the right abutment is bulging and ready to fail. The meter and chlorination house is partially blocking this outlet channel.

OUTLET CHANNEL	Concrete wall on right deteriorating; left wall constructed of stone masonry about ready to fall down at one location. Channel obstructed by valve house and earthen ramp with 6" drain tile; could cause backwater in chlorination building.	Walls need repaired and earthen embankment removed from channel.
EMERGENCY GATE	Blowoff and drain valve or gate shows no sign of leaking. Questionable when it was last opened, if ever.

VIEW OF CONTROL HOUSE AND DAM CONDUIT

(3) The Owner initiate a program to make the minor repairs to the end of the weir and the walls of the conduit outlet channel, and improve the flow characteristics of said outlet channel around the meter and chlorination building.

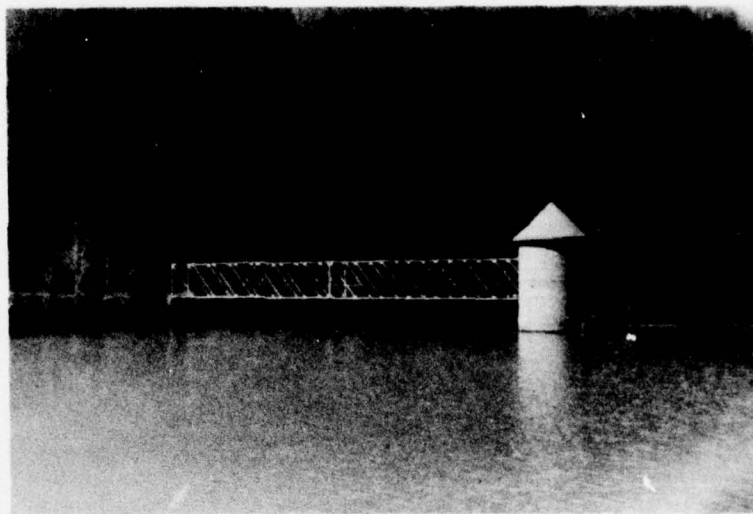
(7) The concrete intake tower appears to be in fairly good condition, and contains a steel core of riveted plates. The amount of rust on the inside or dry side of the steel core is not known; however, we question the safety of the steel ladder.

VIEW OF DAM INTAKE TOWER AND BRIDGE

(5) The Owner should investigate the degree of deterioration of the intake tower ladder and other steel members therein, and prepare the necessary plans and specifications to repair them.

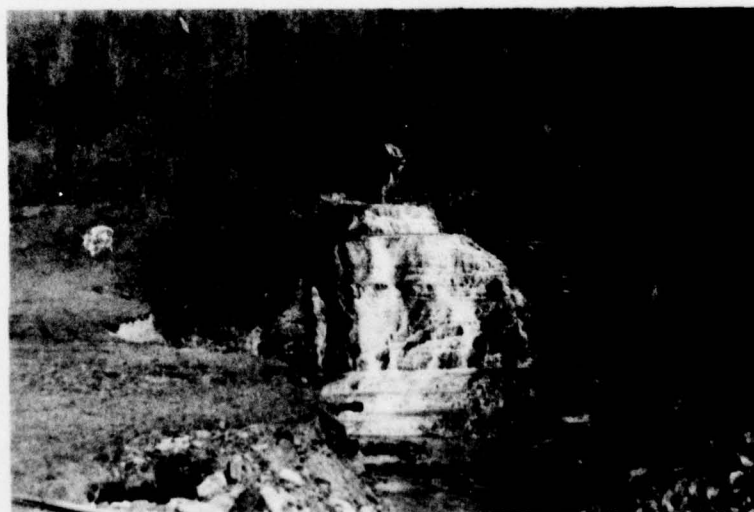
VISUAL EXAMINATION OF	OBSERVATIONS	REMARKS OR RECOMMENDATIONS
<p>CONDITION (OBSTRUCTIONS, DEBRIS, ETC.)</p>	<p>Channel from end of spillway badly eroded by July, 1977 flood. Water cascading down bedrock channel has eroded a hole in bottom of channel at least 100 feet wide. Evidence of scour hole already made by past flood.</p>	<p>Scour of outlet channel doesn't seem to affect stability of dam.</p>
<p>SLOPES</p>	<p>All slopes and overbank washed out in flood of 1977.</p>	<p>Channel slopes should be ripped. Repairs to outlet channel to be performed this year.</p>
<p>APPROXIMATE NO. OF HOMES AND POPULATION</p>	<p>Numerous homes and extensive population downstream from dam.</p>

VIEW OF DAM OUTLET CHANNEL. NOTE
SCOUR FROM FLOOD OF JULY, 1977
