**BIRCH RUN RESERVOIR DAM**

## **PHASE I INSPECTION REPORT**

**NATIONAL DAM INSPECTION PROGRAM**

Name of Dam: BIRCH RUN RESERVOIR DAM  
State & State Number: PENNSYLVANIA - 1-69  
County: ADAMS  
Stream: CONOCOCHEAGUE CREEK, POTOMAC RIVER BASIN  
Date of Inspection: APRIL 20, 1978

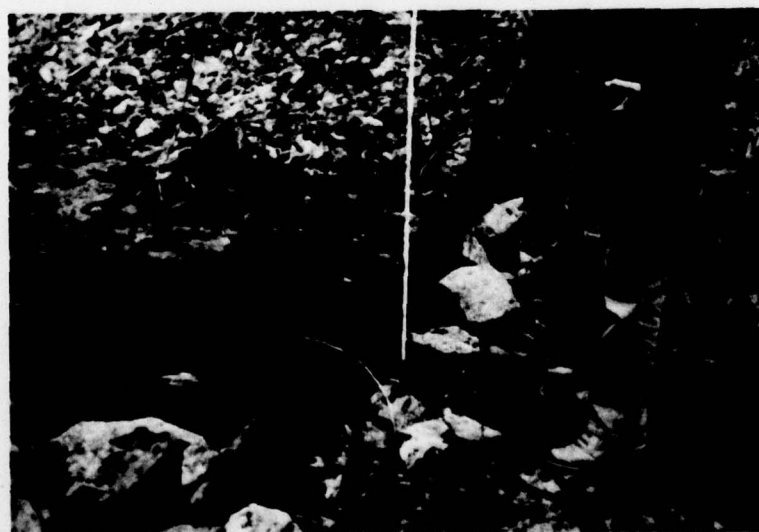
The slopes were stable and no failures or unusual movements were detected. Several locations had considerable water leakage. One location was on the left abutment about 20 feet above the toe of the dam and approximately 16 feet downstream of the embankment fill. A deteriorated weir for flow measure is still visible (Photograph in Appendix D, Plate IV). Leakage was also noticeable on the top of the headwall of the conduit outlet. The weirs at this location have totally deteriorated.

Weir at  
Right Abutment
