LONG PINE RUN DAM

INVENTORY NUMBER NDS 328

PHASE I INSPECTION REPORT

NATIONAL DAM INSPECTION PROGRAM

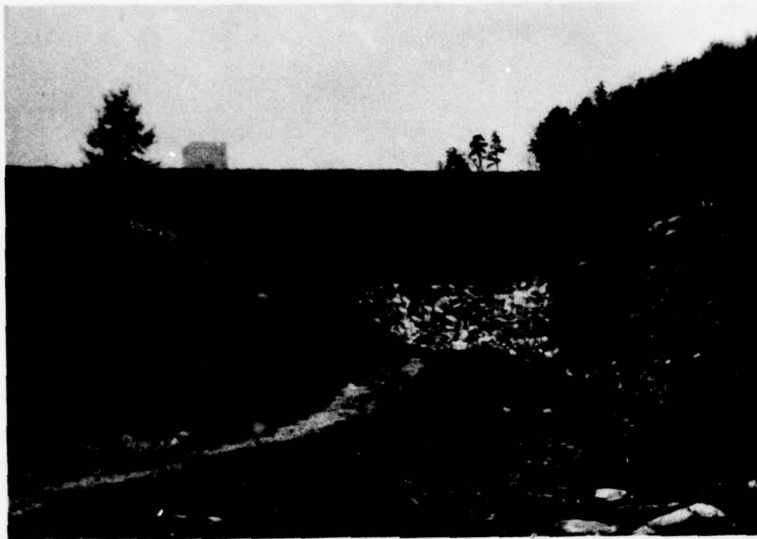
The dam embankments are in good condition. A large area of the downstream slope has been seeded with vetch. The berm at elevation 1300.0 has some wet areas caused by poor drainage. The concrete gutter at the right embankment needs some cleaning, especially the gutter on the berm. This will reduce the amount of water running onto the berm. Bike riders caused some scars on the embankment slope. These areas and a few erosion spots on the slope need repair and reseeding.

General View of
Downstream
Embankment

1. Owner should employ an experienced engineer to investigate the erosion in the spillway chute and contract for necessary repairs if deemed necessary to prevent undermining of the retaining wall.
2. Owner should maintain embankment slopes by repairing eroded areas and seed ground cover.

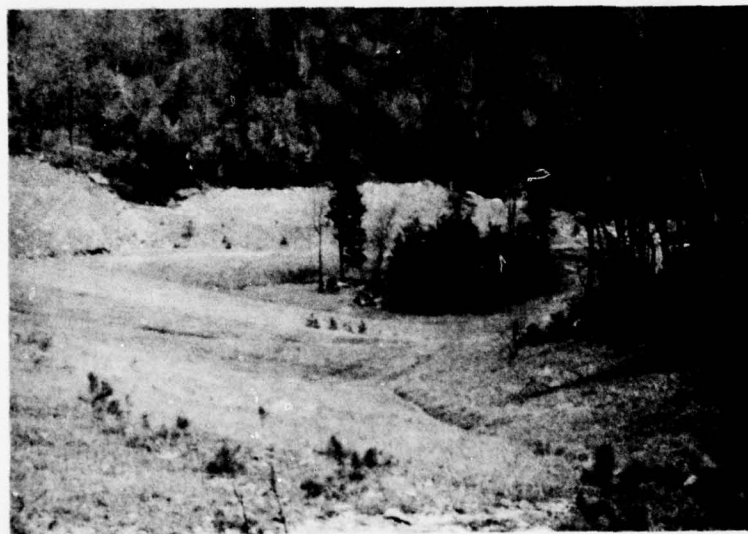
Right
Embankment
Abutment

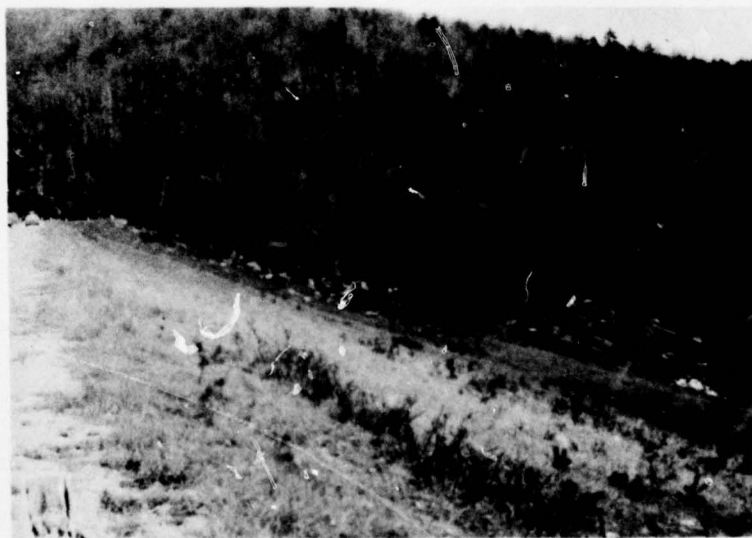
Top of Dam

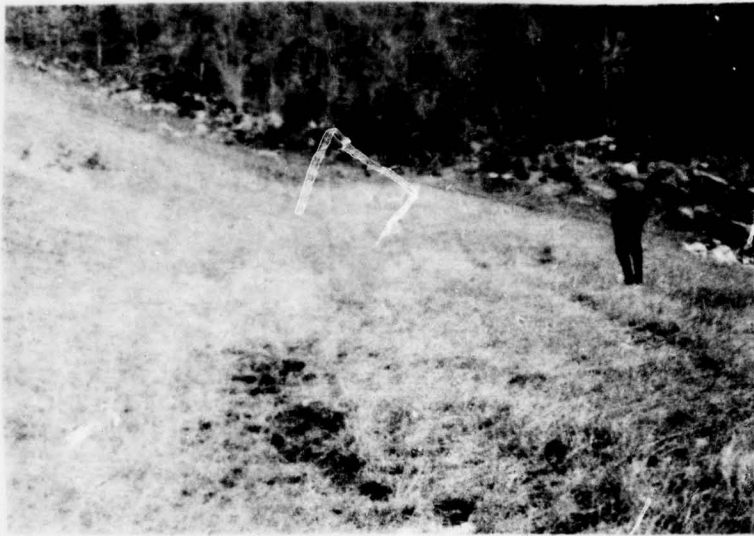
Design criteria for embankment stability was not available in the files. The indicated zoning and slopes of the embankment appear to be adequate for this type of construction. The grouting take was limited and this indicates a good foundation. The borings indicate a good subsurface and the dam appears to be well engineered. No seepage problems have occurred. The cross slope and longitudinal profile of the berm prevents good drainage and water was standing on the berm.

Berm With
Wet Area

Eroded ditch on lower slopes
from terrace or berm. Should be
repaired with possible regrading
of entire terrace. Other erosion
and rutting on lower slope at random
mostly on left side upstream.

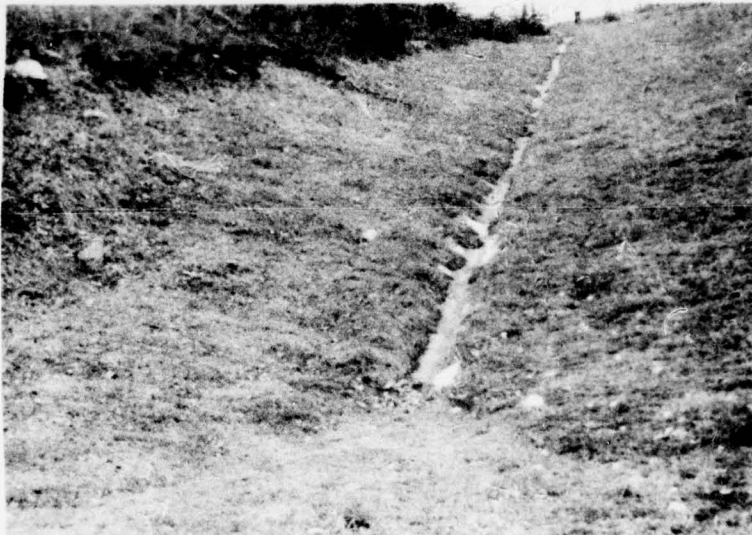
D. VERTICAL & HORIZONTAL ALIGNMENT OF CREST	No distress stoned roadway on breast	
E. RIPRAP FAILURES	No evidence	
F. JUNCTION EMBANKMENT & ABUTMENT OR SPILLWAY	Appears sound - no distress Some rutting due to roadway extension up over slopes to top of dam	Concrete gutter on right abutment should be cleaned

Right Concrete
Gutter

1. The owner shall inspect the spillway erosion to determine if the retaining wall is or may be undermined.
2. The owner shall repair damaged areas on the downstream embankment and improve the drainage of the gutter at the right abutment.

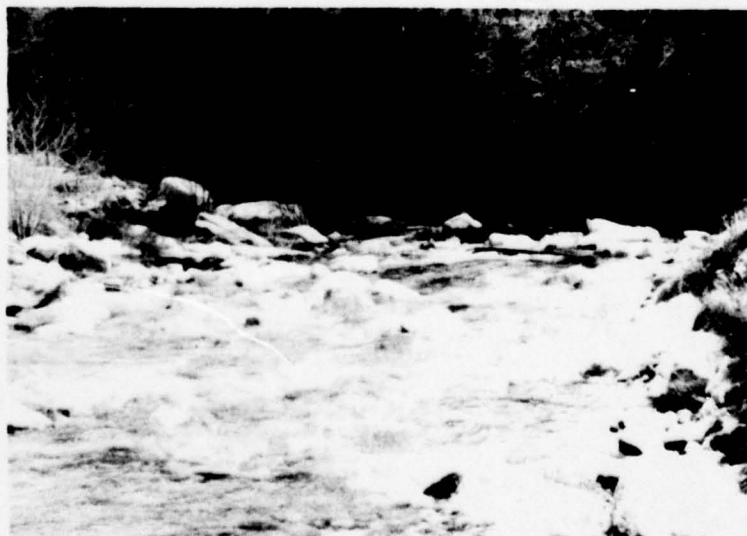
The downstream channel appears to be clean and clear of obstructions. The ford built across it has been damaged and is not usable.

Downstream
Channel

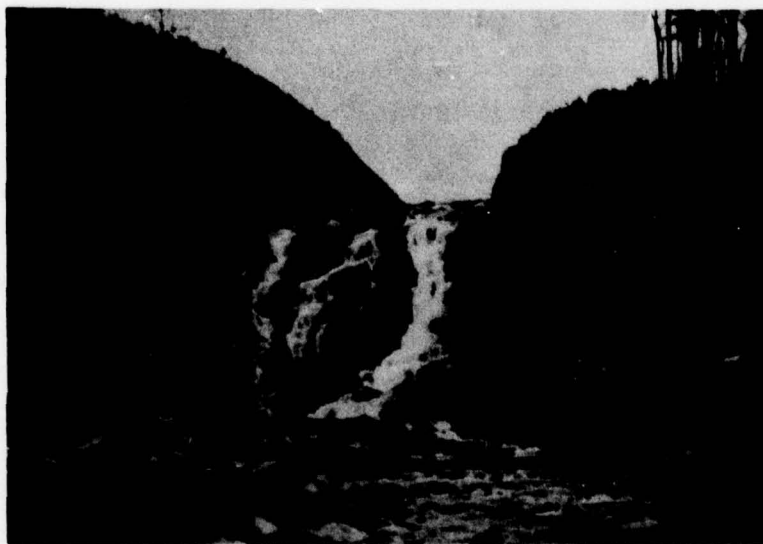
Spillway and
Stilling Basin
