THOMAS W. KOON DAM

INVENTORY NUMBER NDS 240

PHASE I INSPECTION REPORT

NATIONAL DAM INSPECTION PROGRAM

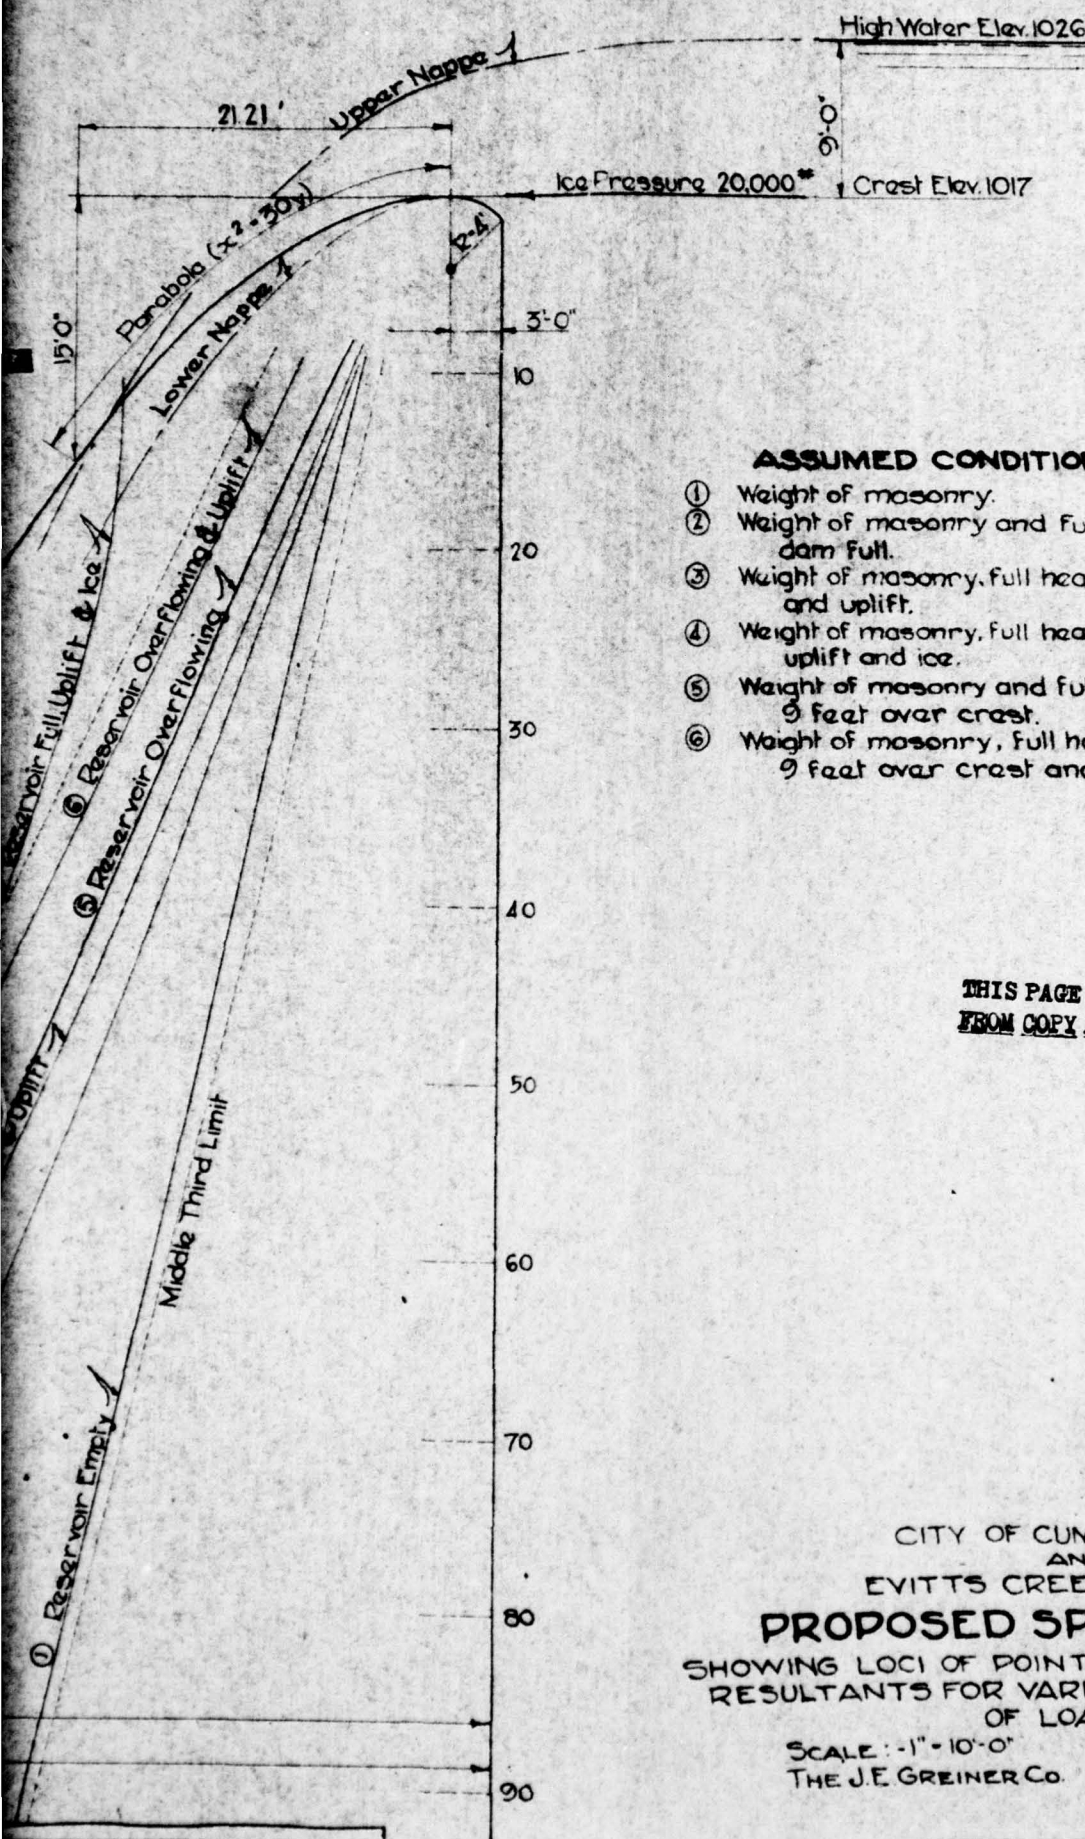
PLATE VI

Appendix D, Plate VI, indicates the loci for different loading conditions for a maximum pool elevation of 1026. In Appendix C, approximate calculations have been made for an assumed pool elevation of 1037, neglecting the pool influence at the downstream side and the weight of water on the spillway. The results indicate that the dam would be in danger of overturning or sliding. The resultant falls outside the middle third of the spillway section and this could cause additional uplift forces under the spillway.

The available information is not sufficient to determine the maximum pool level this dam could sustain without failure. Additional information is required on the rock foundation strata. The collection of this information and a detailed stability analysis should be a part of the additional investigations.
