National Dam Safety Program. F. Houston  
McIlvain Dam (Marsh Creek Dam) (National  
I.D. Number 00626), Delaware River Basin,  
Marsh Creek, Chester County, Pennsylvania  
Phase I Inspection Report.

F. HOUSTON McILVAIN DAM (MARSH CREEK DAM)  
CHESTER COUNTY, PENNSYLVANIA  
NATIONAL I.D. NO. PA 00626

PHASE I INSPECTION REPORT  
NATIONAL DAM SAFETY PROGRAM

May 1978

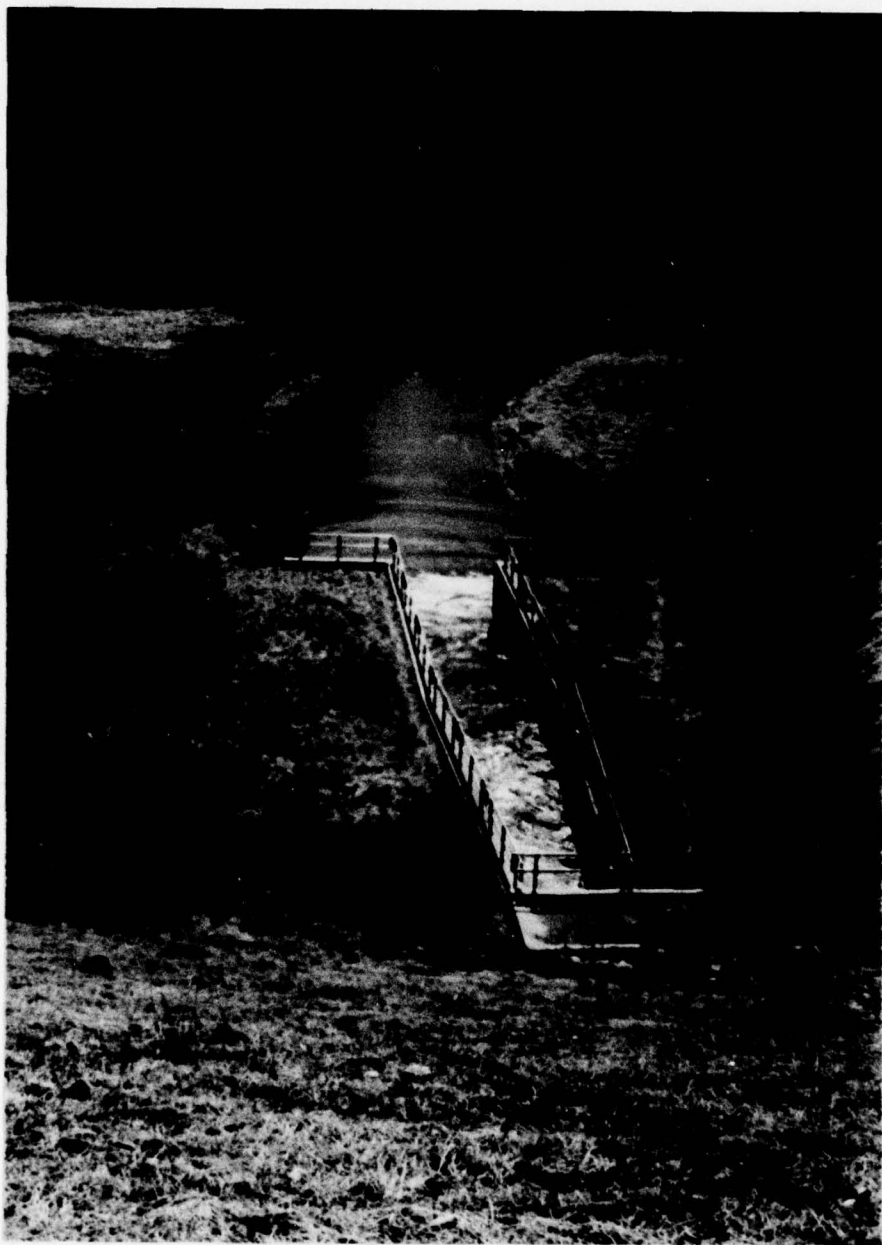
PHOTO NO. 3

*Immediately below the stilling basin, no debris or obstructions were observed. The riprap appears to be in good condition. The outlet from the emergency spillway discharges into a wooded area approximately 500 to 600 feet below weir. There are no problems expected.*

VIEW OF STILLING BASIN AND OUTLET CHANNEL  
WHICH CONTAINS DISCHARGES FROM THE  
PRIMARY SPILLWAY AND CONTROL TOWER.

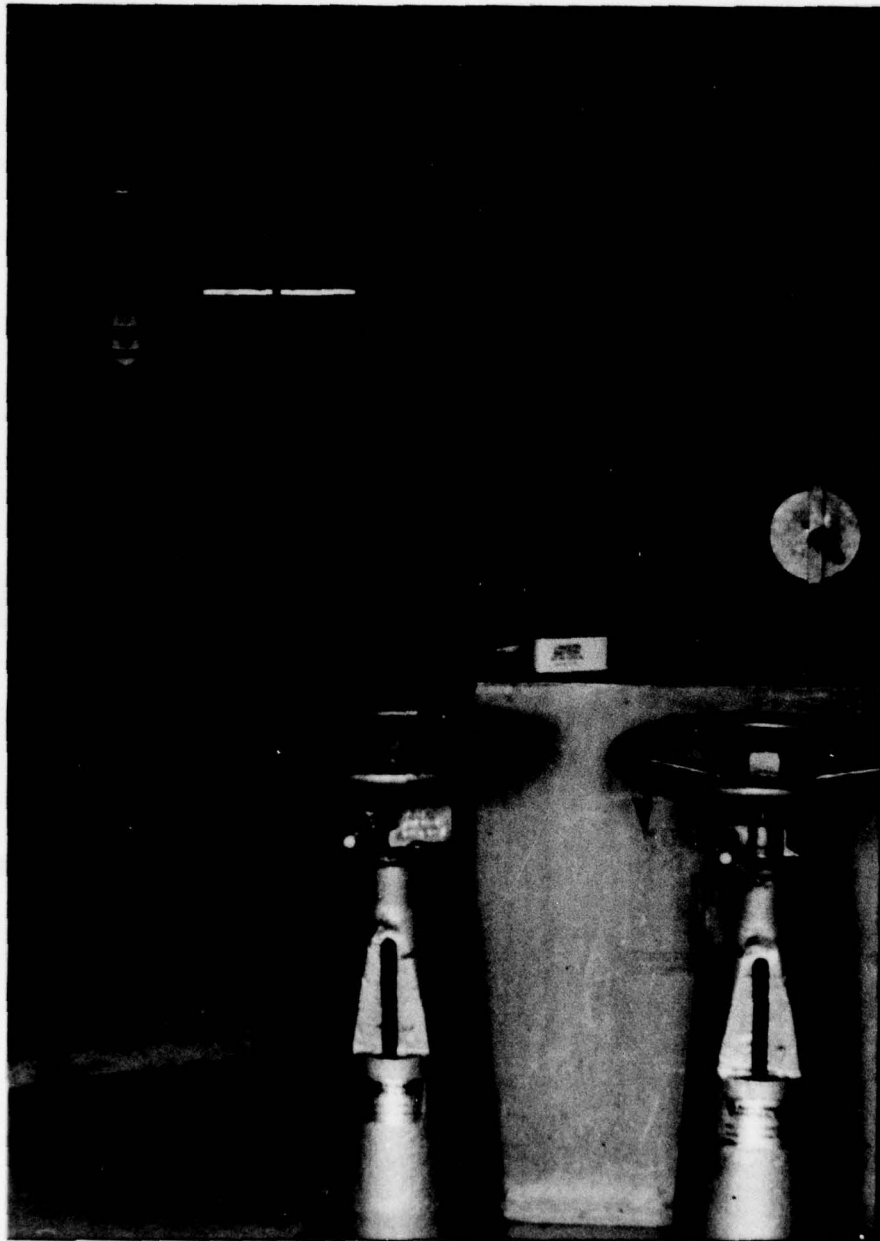
PHOTO NO. 4

VIEW INSIDE CONTROL TOWER AT THE CREST ELEVATION  
SHOWING INTAKE CONTROL VALVES AND THE USGS GAGE STATION.
