PHASE I INSPECTION REPORT

⑥
National Dam Safety Program. Loch
Raven Dam (MD-0002), Gunpowder River
Basin, Gunpowder Falls, Baltimore County,
Maryland. Phase I Inspection Report.

Name of Dam: Loch Raven
State Located: Maryland
County Located: Baltimore County
Stream: Gunpowder Falls
Date of Inspection: 14 and 16 December 1977
Inspected By: Baltimore District, Corps of Engineers

PHASE I INSPECTION REPORT
NATIONAL DAM SAFETY PROGRAM
LOCH RAVEN DAM MD 0002

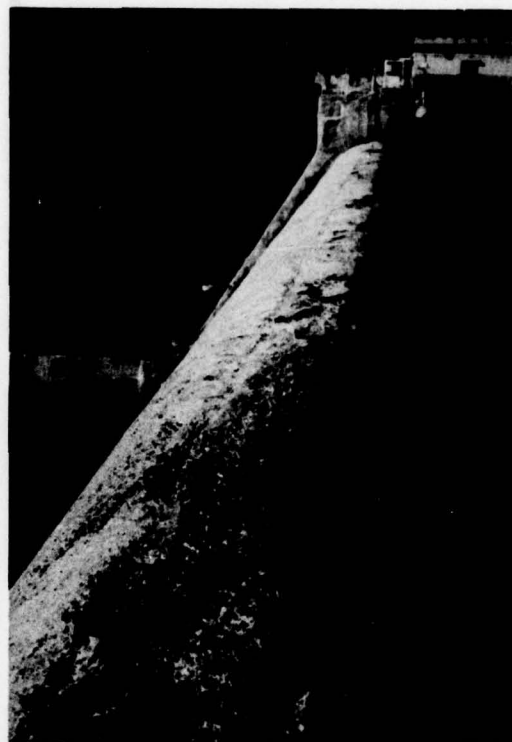
(2) Considerable surface deterioration (spalling) of the concrete was evident on the crest and downstream face of the spillway and the upstream face of the dam in the zone of pool fluctuation. The probable cause of such deterioration is freezing and thawing and erosion of the spillway crest and downstream face. The depth of deterioration appeared to be as much as 12 to 18 inches at the worst locations, exposing temperature reinforcement. Although not showing the magnitude of deterioration as the spillway, the non-overflow section had spalling and uplifting of a gunite surfacing believed to have been placed in the 1940's.

Concrete Deterioration of Face of
Overflow Section. Note plugged
48" By-pass on Right Wingwall.

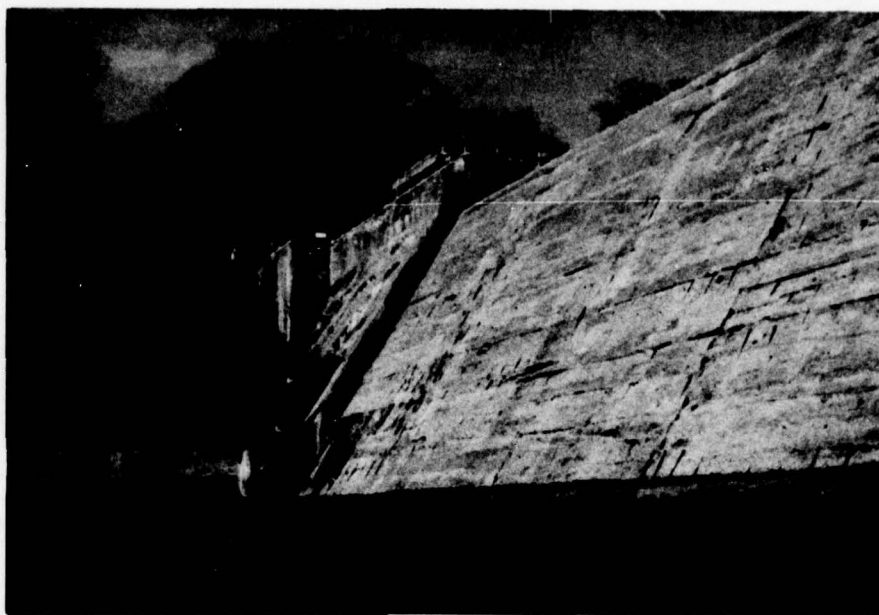
(7) Seepage along a horizontal construction joint was observed on the overflow section near the right side and on the non-overflow section on the upstream side of the left abutment above the pool elevation. (See photographs)

Seepage on Right Side Downstream Face of Spillway

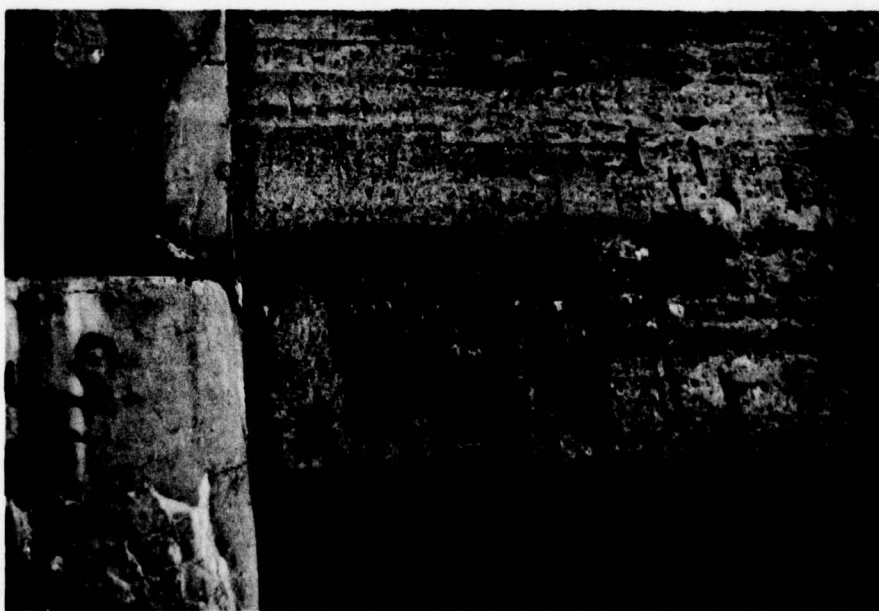
Seepage on Right Side Downstream Face of Spillway
