D'APPOLONIA CONSULTING ENGINEERS PITTSBURGH PA
NATIONAL DAM INSPECTION PROGRAM. SUGAR RUN DAM. (NDS ID NUMBER --ETC(U)
JUN 78 L D ANDERSEN

PHASE I INSPECTION REPORT

Sugar Run Dam, Ohio River Basin, Unnamed
Tributary of Conemaugh River, Westmoreland
County, Pennsylvania. Phase I Inspection
Report.

SUGAR RUN DAM
NDS I.D. NO. 460
APRIL 26, 1978

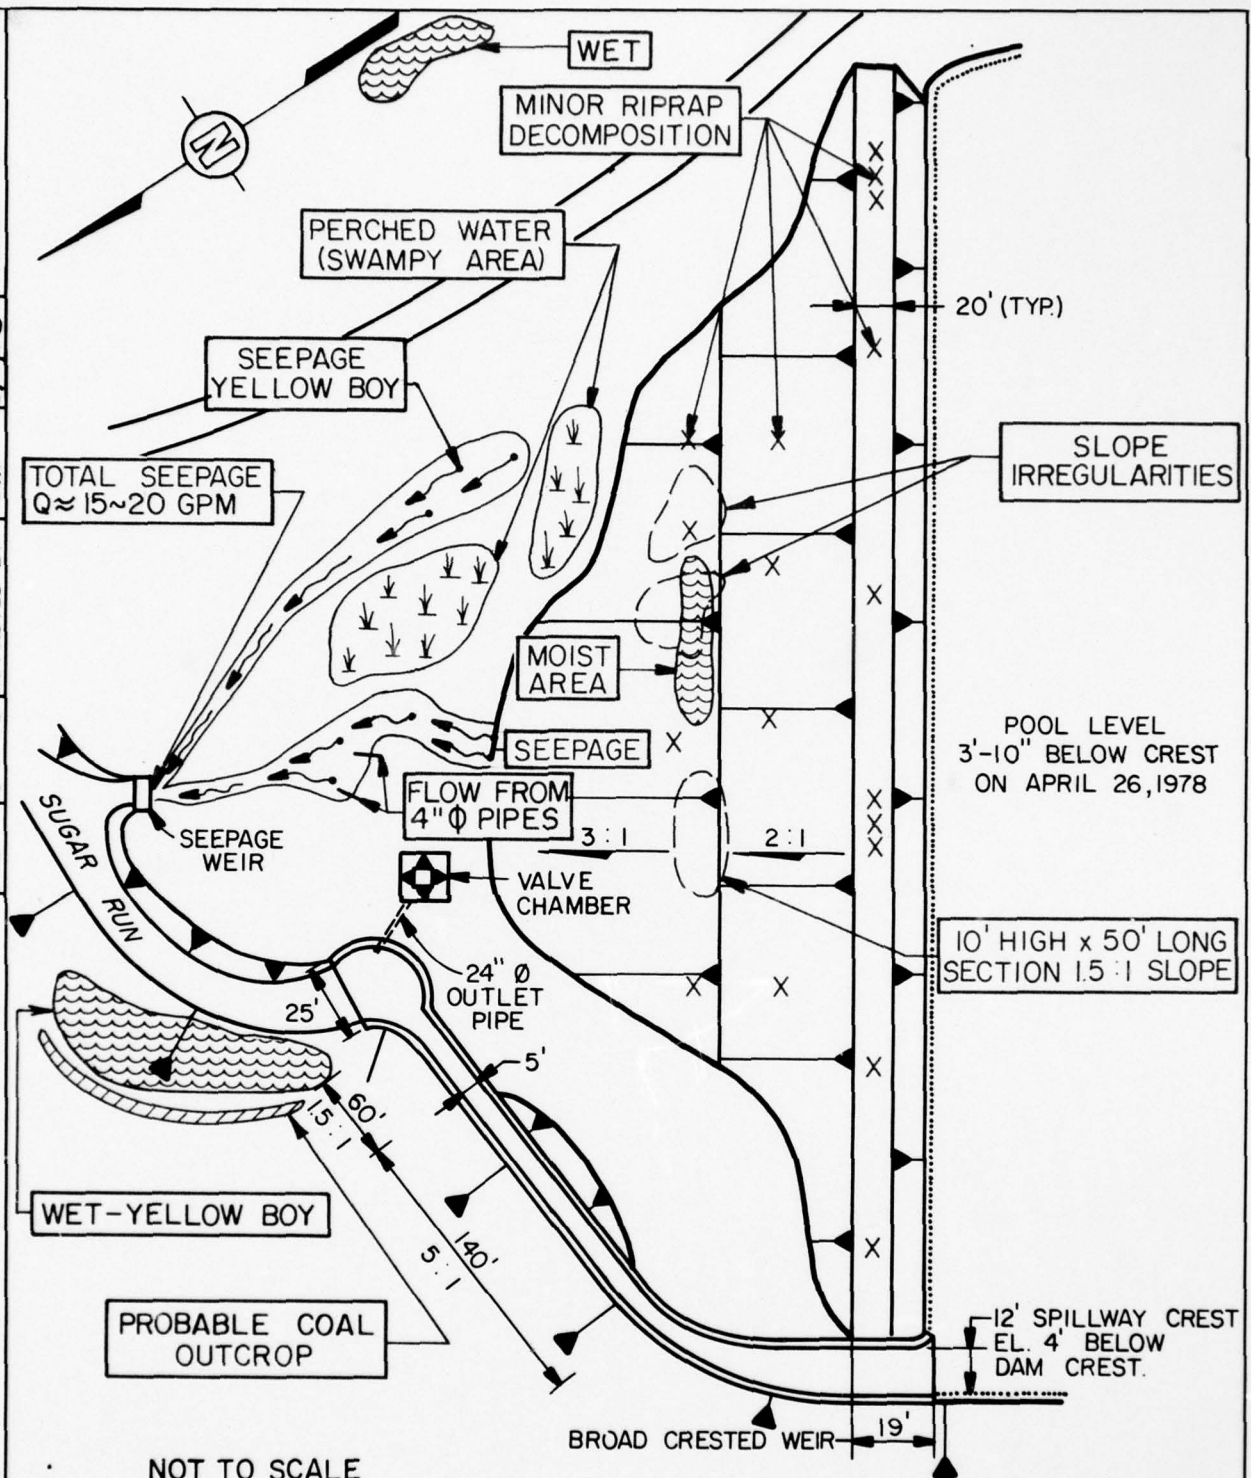
PLATE 3

SUGAR RUN DAM
GENERAL PLAN
FIELD INSPECTION NOTES
FIELD INSPECTION DATE : APRIL 26, 1978

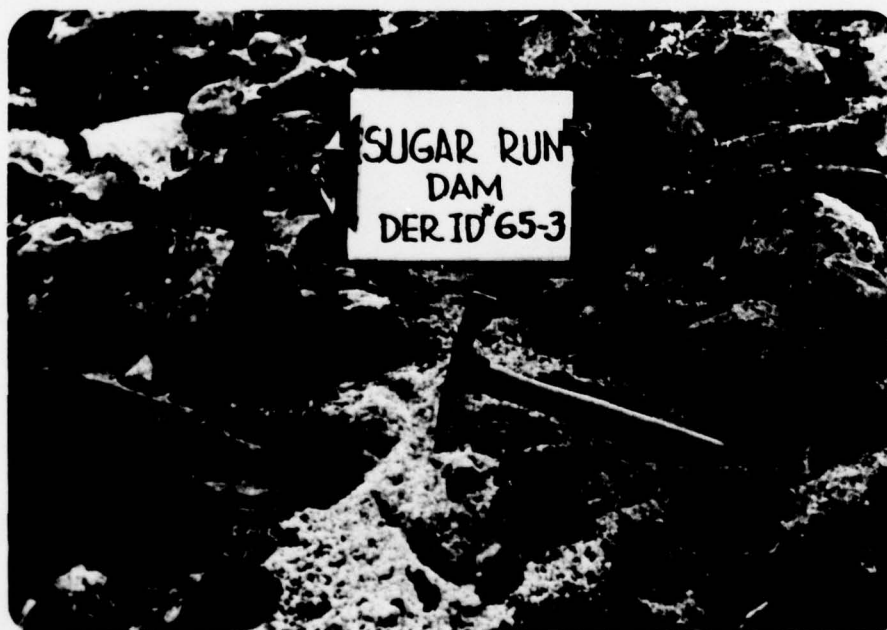
Photograph No. 8
Decomposing riprap.
