North Fork Dam. (NDS ID Number 234).  
Ohio River Basin, North Fork Bens Creek,  
Somerset County, Pennsylvania.

PHASE I REPORT  
NATIONAL DAM INSPECTION PROGRAM

NAME OF DAM: North Fork Dam  
STATE LOCATED: Pennsylvania  
COUNTY LOCATED: Somerset  
STREAM: North Fork of Bens Creek, tertiary tributary of Conemaugh River  
DATE OF INSPECTION: April 24 and 25 and May 4, 1978

NORTH FORK DAM  
NDS I.D. NO. 234  
APRIL 24 AND 25, 1978

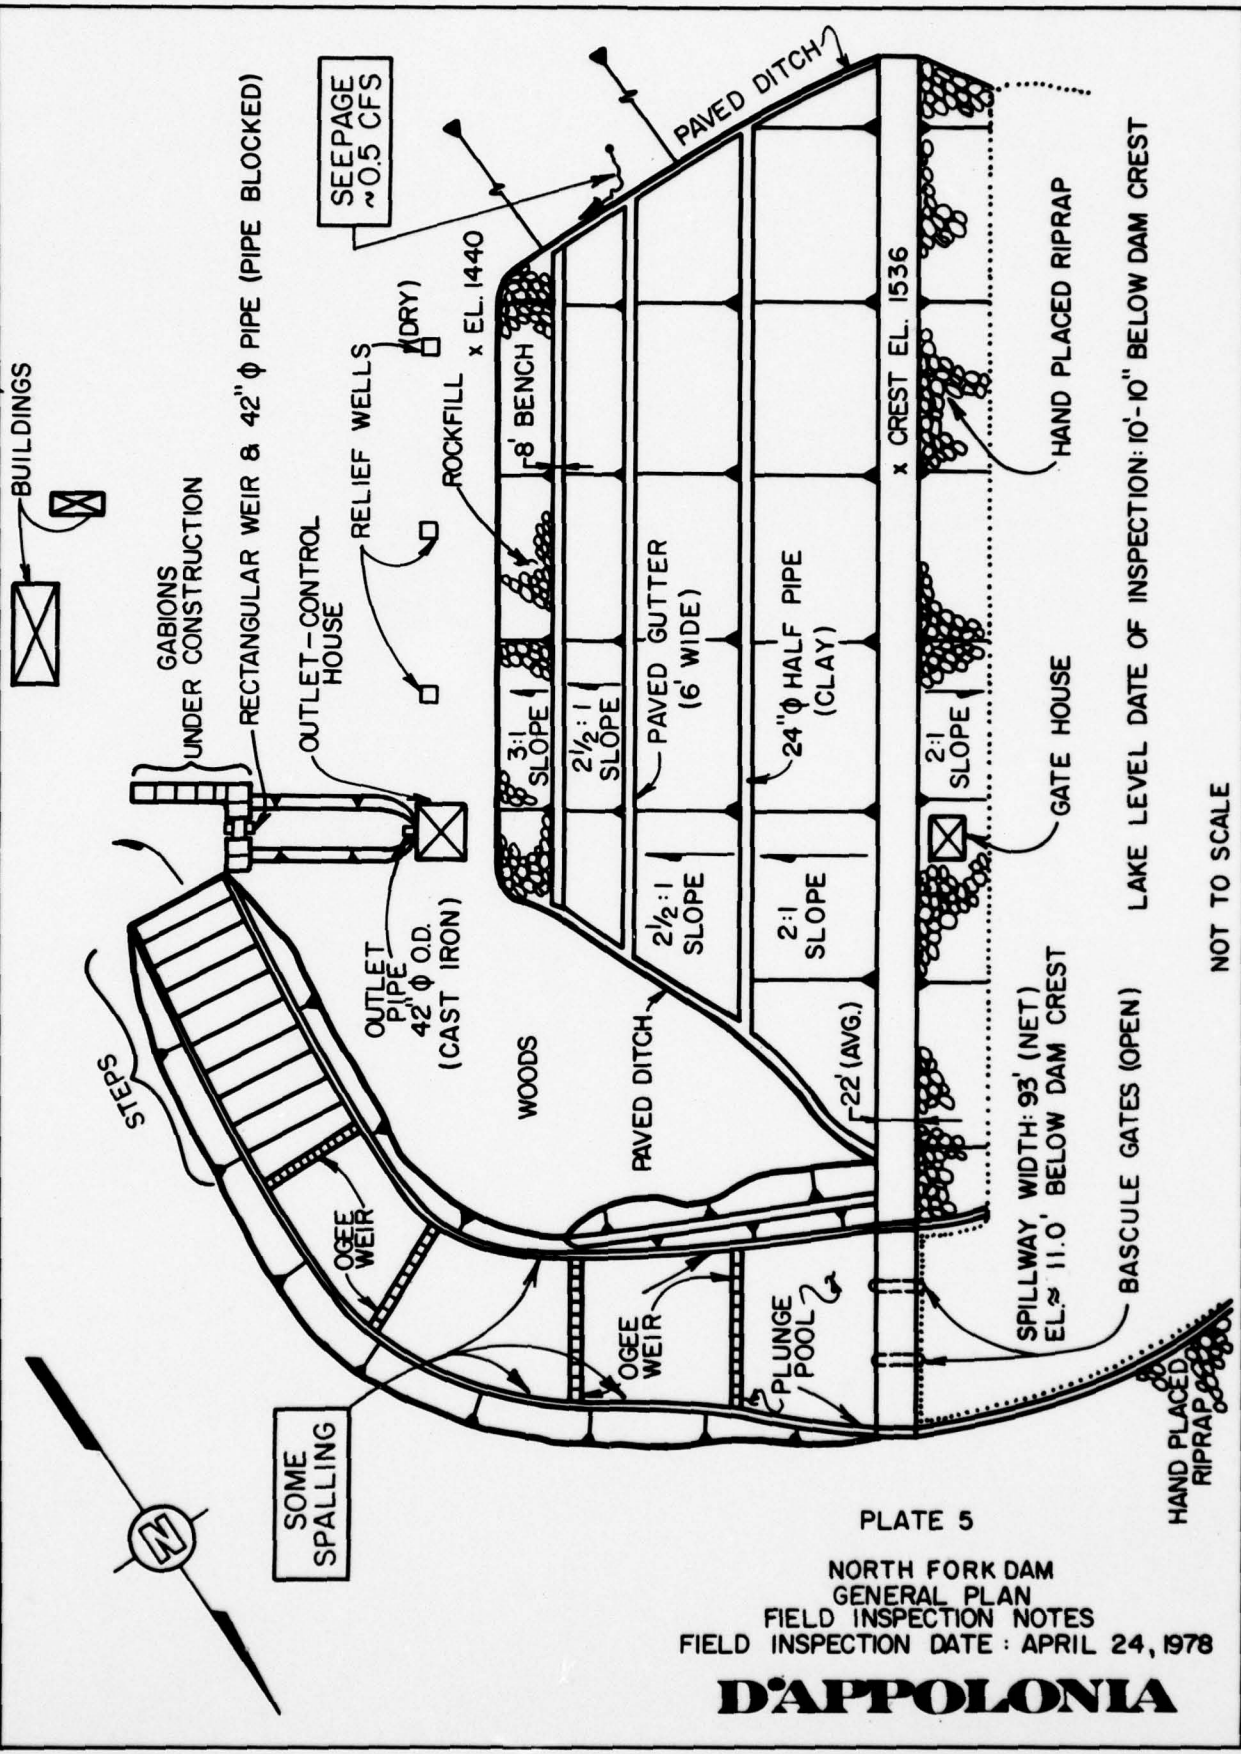
PLATE 5  
 NORTH FORK DAM  
 GENERAL PLAN  
 FIELD INSPECTION NOTES  
 FIELD INSPECTION DATE : APRIL 24, 1978  
**D'APPOLONIA**

3.2 Evaluation. In general, the condition of the dam is considered to be very good. A review of previous inspection reports revealed that during the period from 1933 to 1941 some seepage was reported along the right toe and on the abutment approximately 10 feet above the lower berm elevation. Two recent state inspections in 1966 and 1976 note no such seepage. On this inspection, minor seepage was observed on the right abutment (Plate 5).

| VISUAL EXAMINATION OF | OBSERVATIONS | REMARKS OR RECOMMENDATIONS |
|---|---|---|
| DRAINS | 3- PRESSURE RELIEF WELLS ABOUT 50-75' FROM TOE. (THESE WELLS WERE NOT FOUND IN ORIGINAL DRAWINGS) SEE PLATE-5 FOR APPROX LOCATION OF WELLS LOCATED DURING INSPECTION. | 2 OF THE 3 WELLS WERE DISCHARGING ~ 10 TO 20 GPM, EACH. ROUGH ESTIMATE ONLY. NO MEASURING DEVICE INSTALLED. |

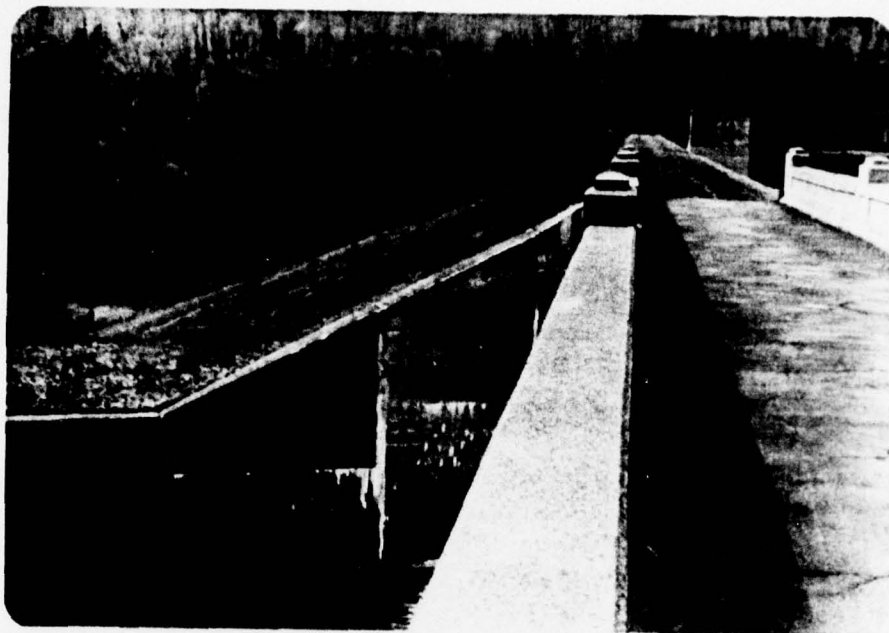
Photograph No. 1  
Crest (looking south).

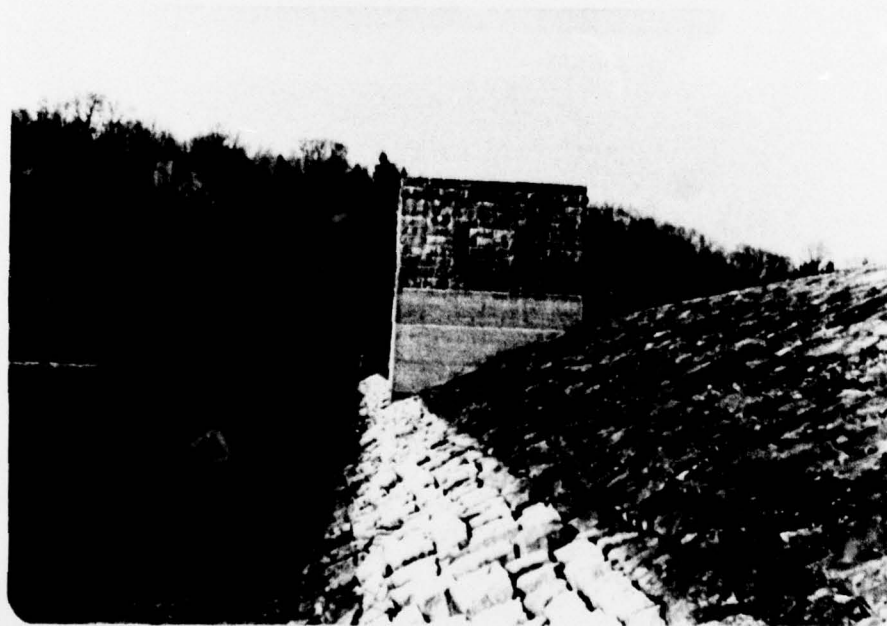
Photograph No. 2  
Upstream slope (looking north).

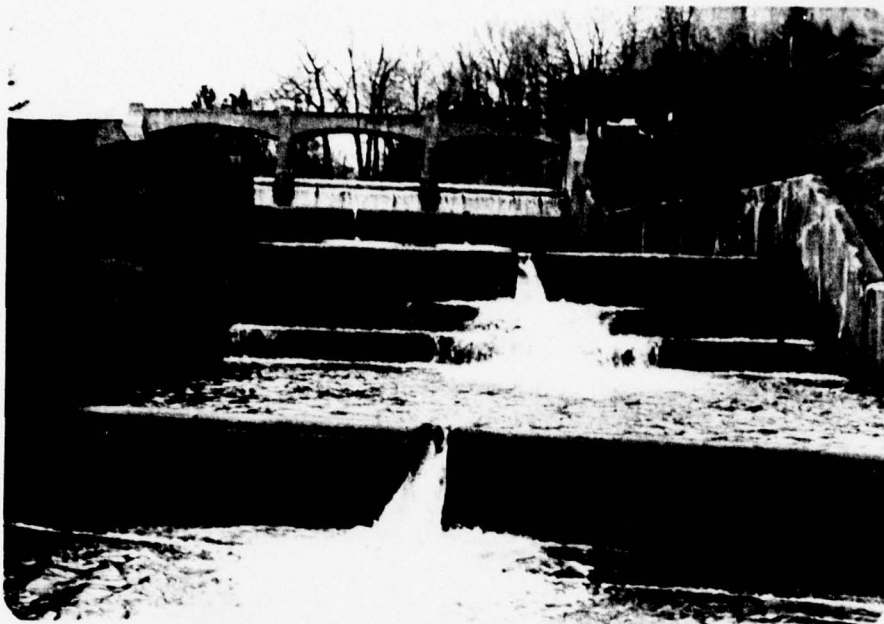
Photograph No. 3  
Spillway and spillway discharge channel.

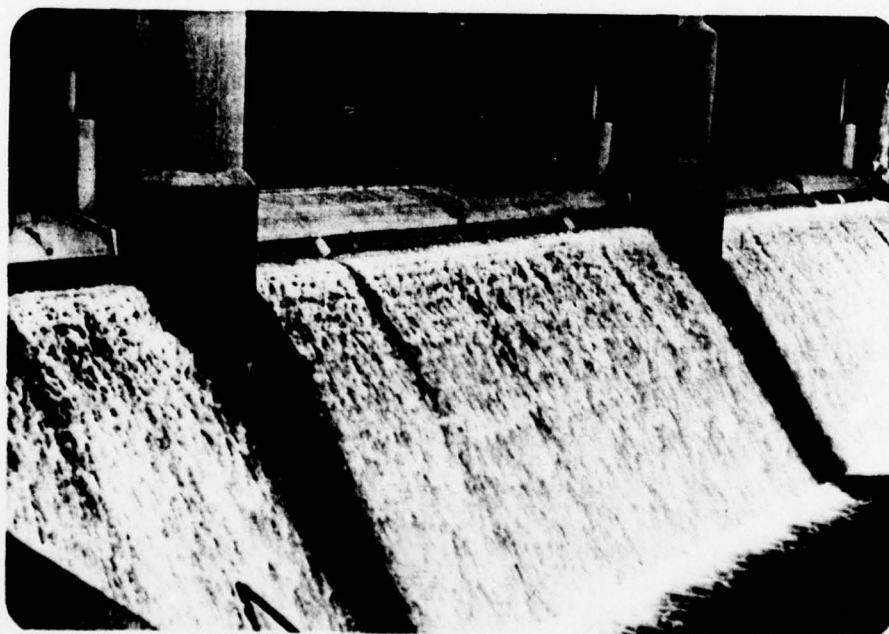
d. Post-Construction Changes. In 1959, the crest of the dam was raised by one foot by earth fill and the bascule gates were installed at the spillway crests. Maintenance conditions of the bascule gates are satisfactory and the crest fill appears to be adequately constructed.

Photograph No. 4  
Spillway crest. Note bascule gates (open).

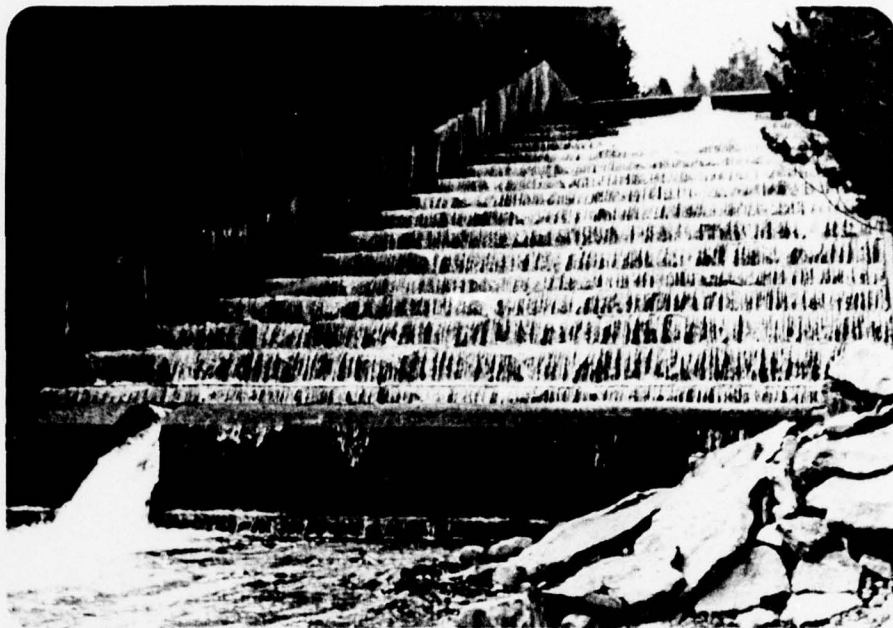
Photograph No. 5  
Downstream end of spillway discharge channel.

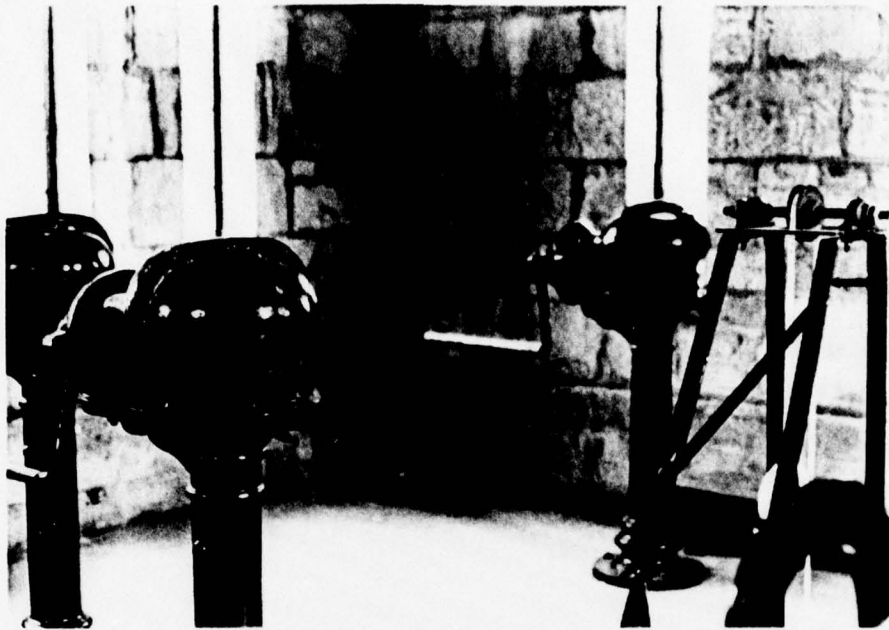
Gate controls. Located in the gate house on the crest.

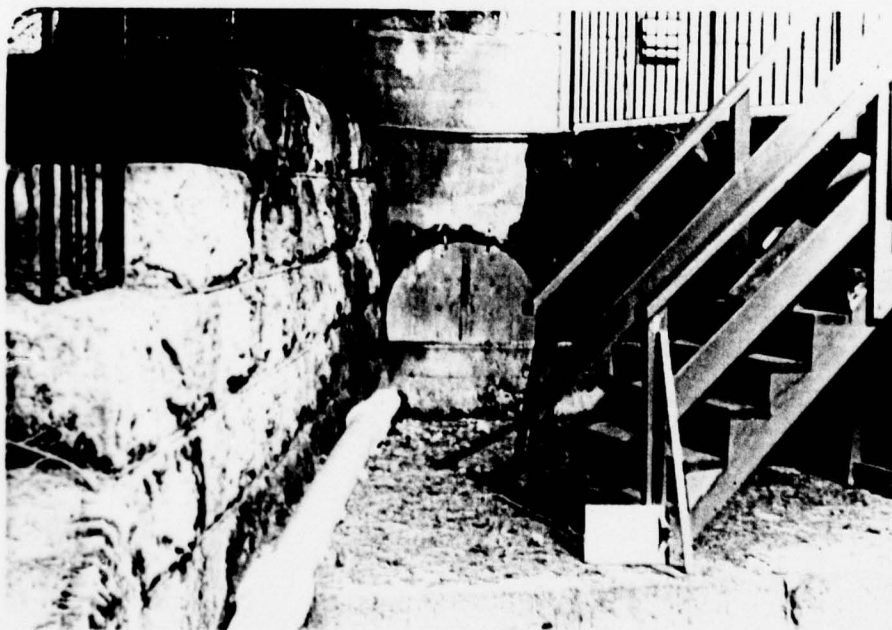
4.3 Maintenance of Operating Facilities. The blow-off pipe was operated by water company personnel and was observed to be functional.

Outlet end of "blow-off" pipe.

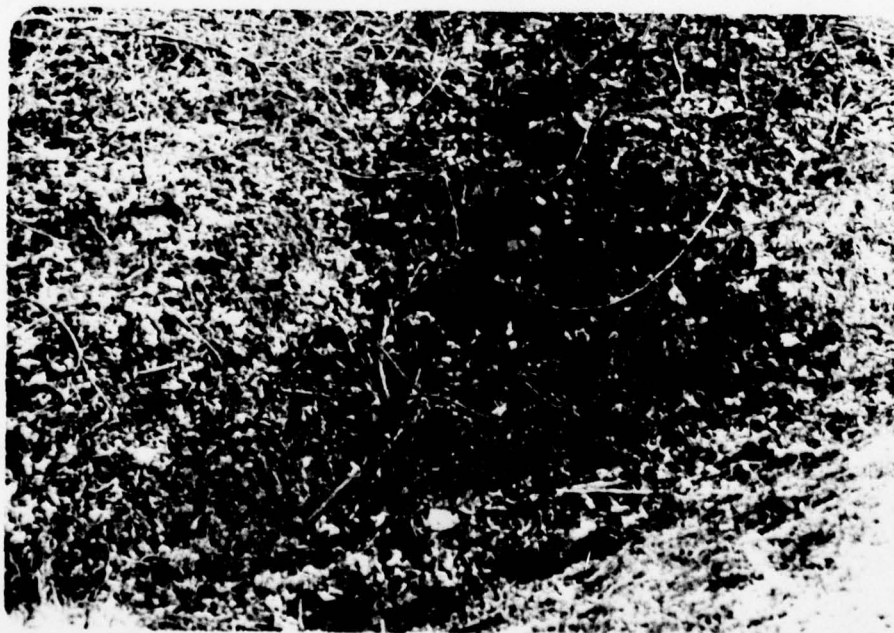
Only one seepage area was observed (Photograph 10). This was located on the right abutment, approximately at the elevation of the lower paved interceptor ditch on the downstream slope. The flow was estimated to be approximately 0.5 cfs. The effect of this seepage on the overall performance of the dam is considered to be inconsequential, but it should continue to be monitored to assure that it is not increasing.

Photograph No. 10  
Minor seepage on south abutment (see Plate 3).

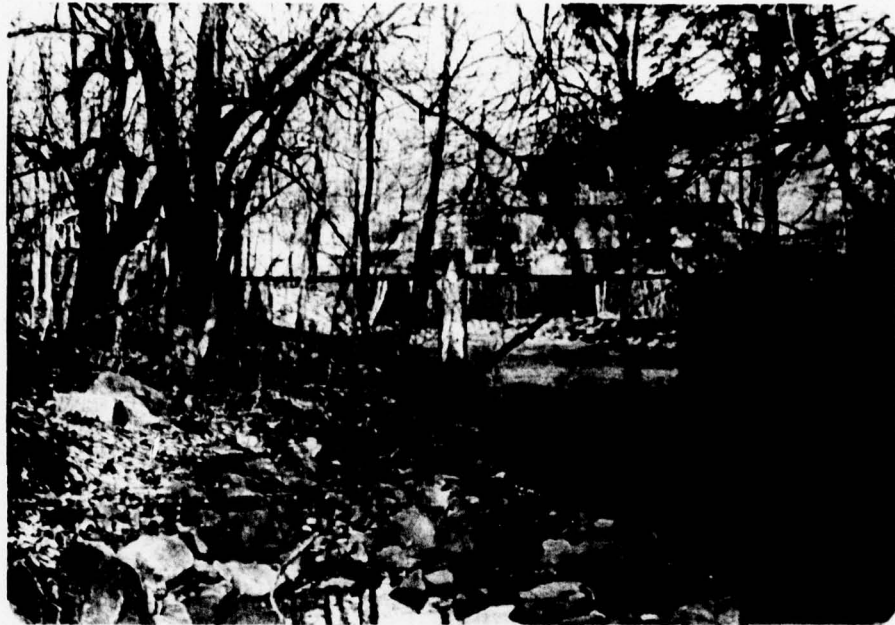
Bridge No. 1 (see field sketch in Appendix A).

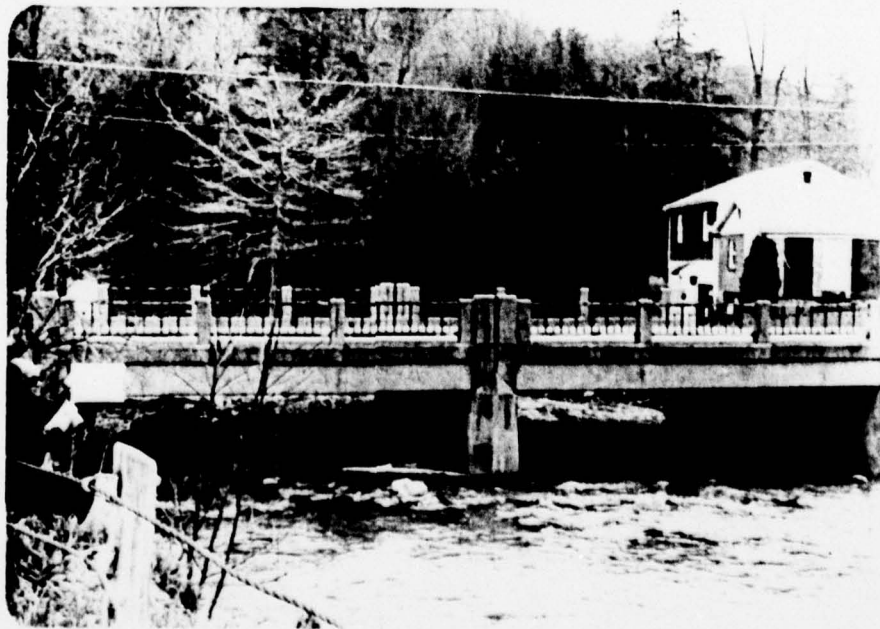
Bridge No. 2 (see field sketch in Appendix A).
