## PHASE I REPORT National Dam Inspection Program

Immel Dam

26 April 1978 (visual inspection)

Inspection Team - GAI Consultants, Inc.  
570 Beatty Road  
Monroeville, Pennsylvania 15146

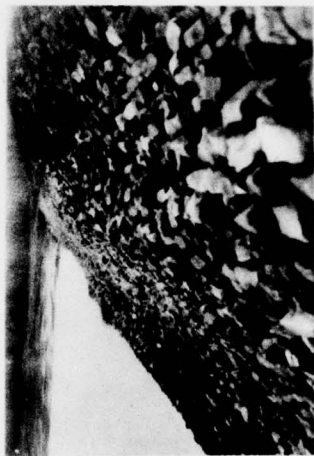
PHOTOGRAPH 2     Photograph 2 shows the southern embankment as it appeared in 1935. Note the bulge evident over entire width of the embankment.

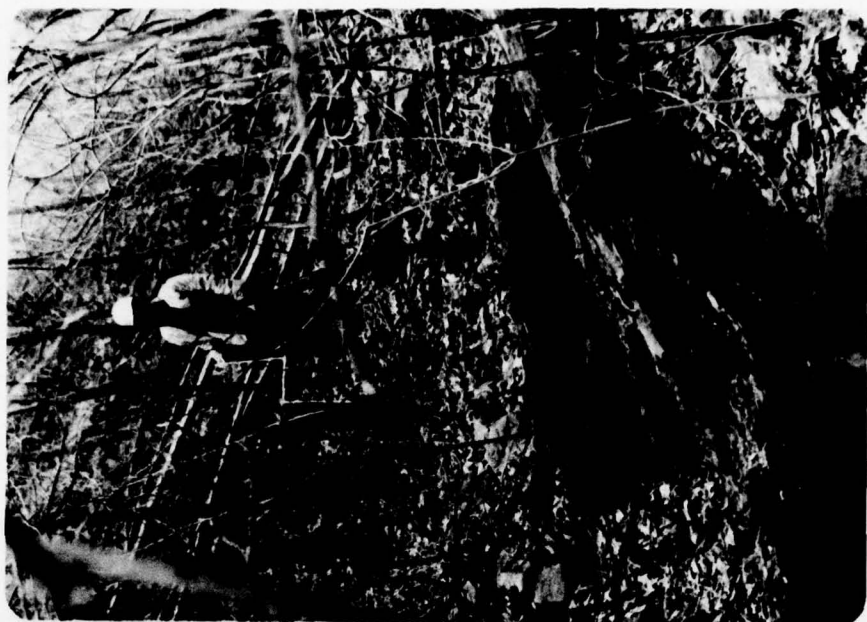
PHOTOGRAPH 4     A view of the control pipes located at the toe of the southern embankment which are used to regulate incoming water which is gravity fed from Sewickley Creek Reservoir.

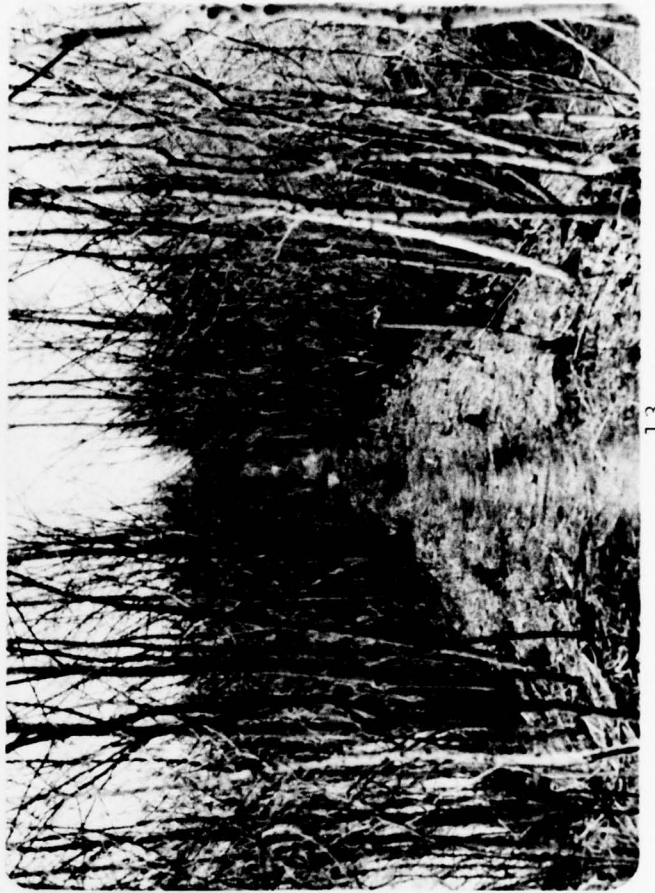
PHOTOGRAPH 13 View of the crest of the northern embankment of Immel Reservoir.

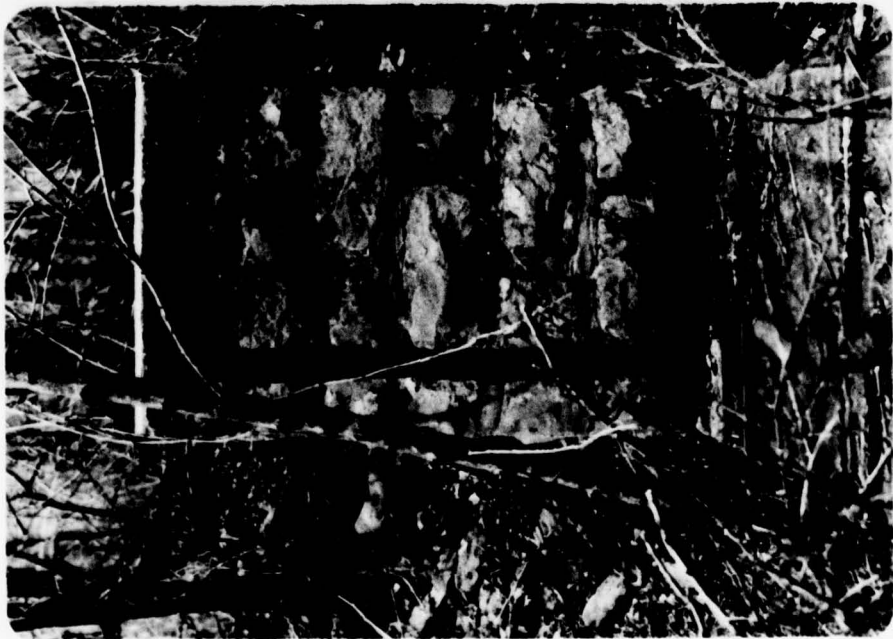
PHOTOGRAPH 11 This is a close-up view of one of the end walls of the spillway. Historical records mention the possible use of splash boards for increased storage capacity, however, there is no records indicating that the spillway was ever used and it may have been dry since it was constructed in the late 1800's.

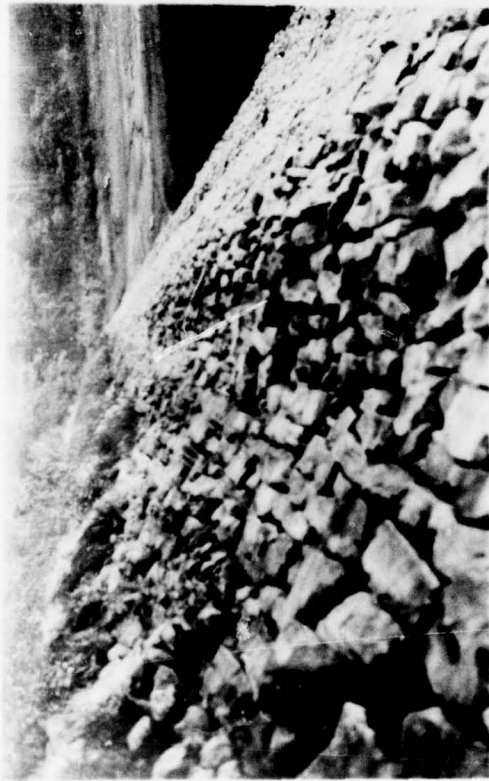
PHOTOGRAPH 18    Photograph 18 shows some of the bulges in the north embankment as they appeared in 1946.
