KEYSTONE STATION DAM

NDI Pa - 275 .

## PHASE I REPORT National Dam Inspection Program

15 May 1978

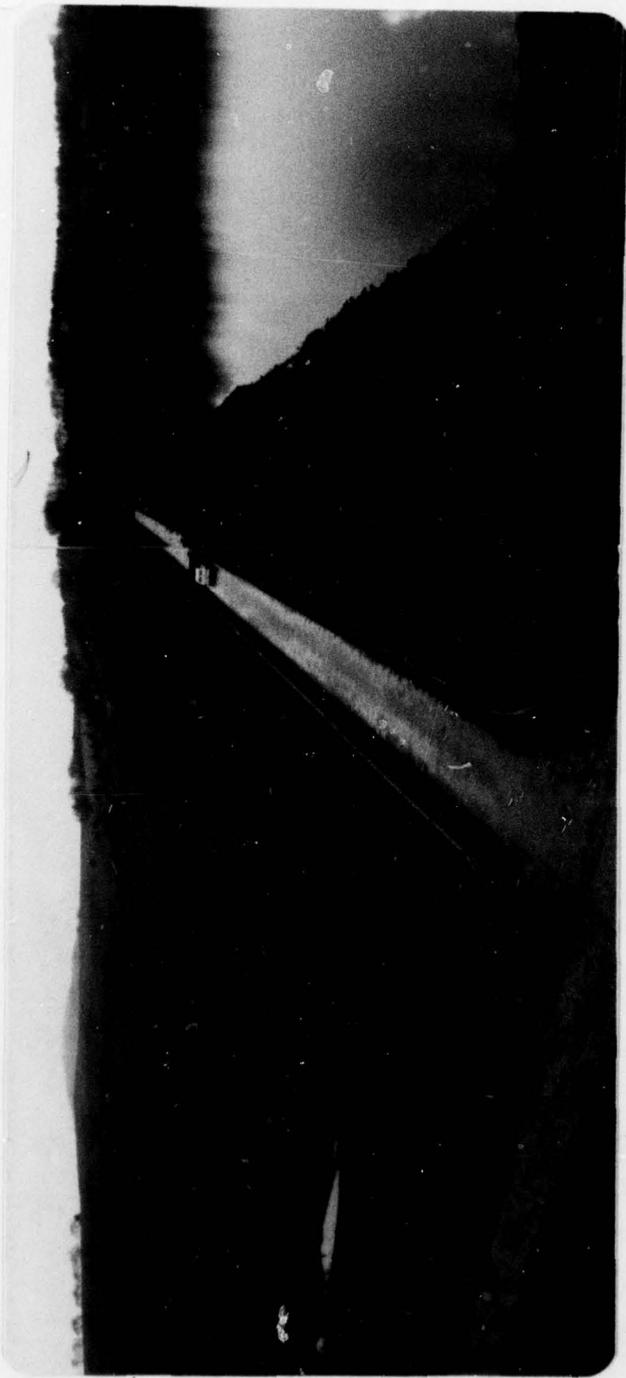
PHOTOGRAPH 1    Panoramic view of the Keystone Station Dam, the area immediately downstream, and the reservoir area. Note the wide open valley just downstream of the embankment.

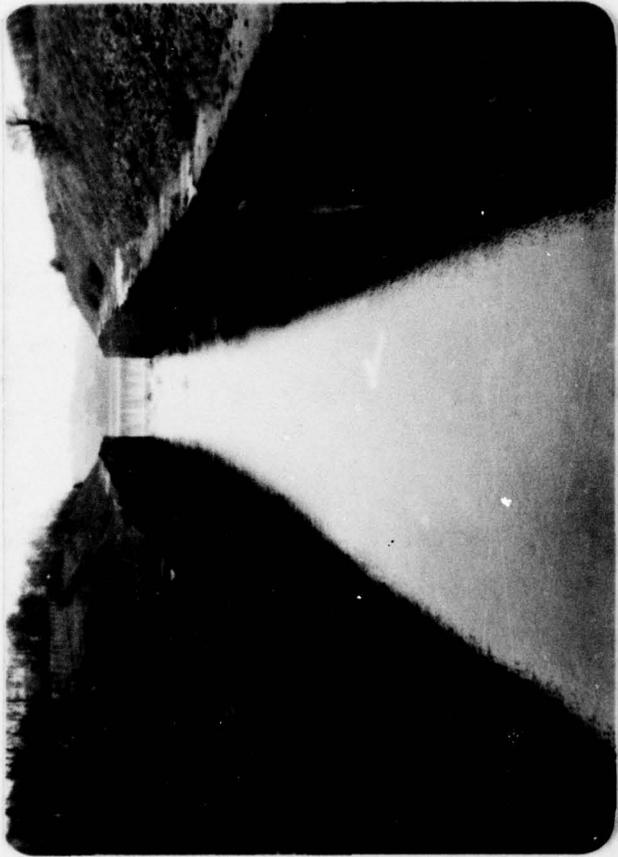
1. Spillway. The spillway, spillway abutments, and pre-split rock channel walls all appeared to be in excellent condition (see Appendix E). It was reported that some additional rock bolts had been installed in the spillway channel walls and that gunnite had been applied in areas following the "Agnes" storm in 1972.

PHOTOGRAPH 8 This is a view of the spillway at the Keystone Station Reservoir located approximately one mile upstream of the Keystone Reservoir embankment.

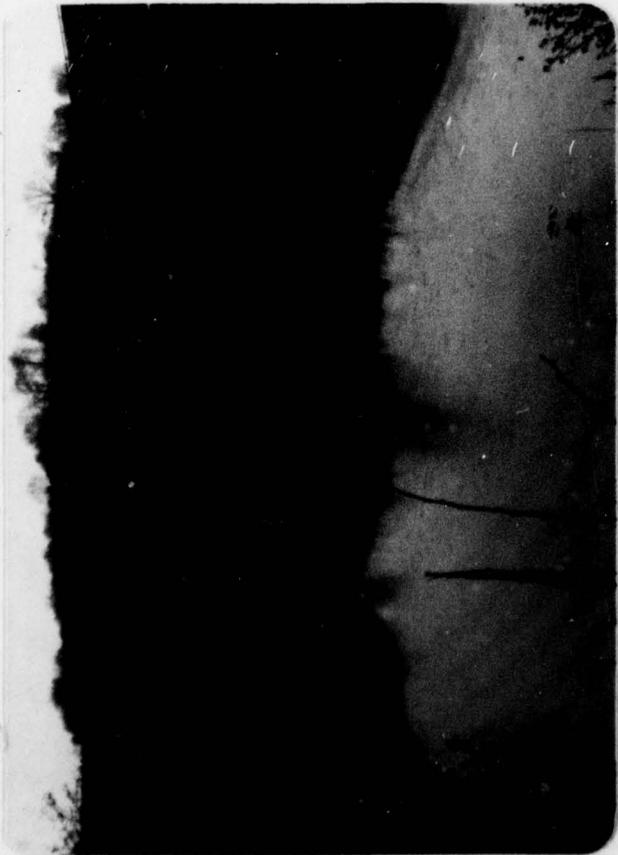
PHOTOGRAPH 7 View of the toe drain of the embankment and the relief wells mentioned in the previous photograph. The weir in the center of the photograph gauges flow from the area of the right abutment and any flow which might be discharging through the relief wells.

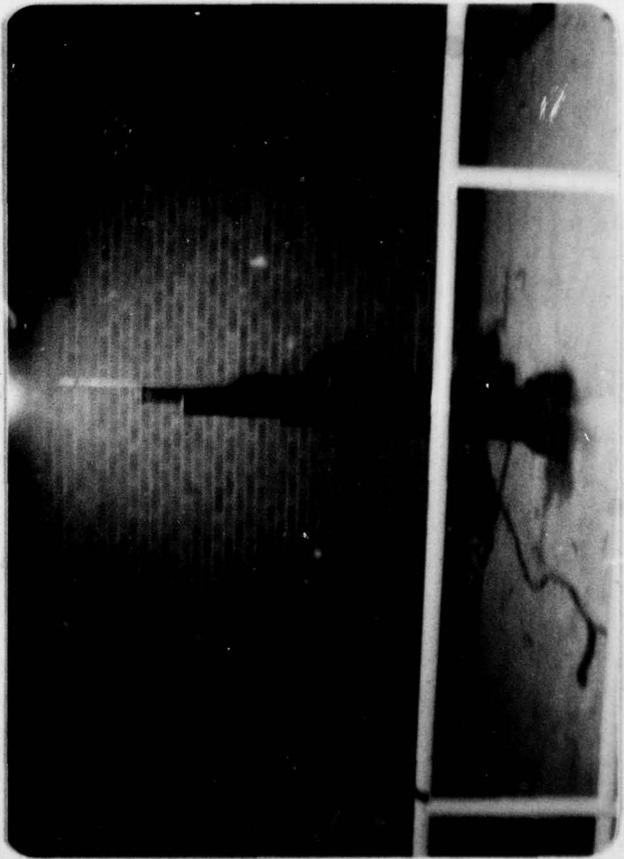
2. Gate House Valves. The gate house and valves which control the release of water into the downstream channel via a 7-foot square concrete box culvert appeared to be in satisfactory condition. According to a representative of the power company, the gate controls are maintained on an as-needed basis.

PHOTOGRAPH 9 This is a view of the interior of the gate house at the Keystone Reservoir. The gate controls in the center of the photograph are used to raise sluice gates on the discharge system for the reservoir.
