SPEERS RUN DAM
NDI Pa - 505 .

PHASE I INSPECTION REPORT,
NATIONAL DAM INSPECTION PROGRAM. ✓

Speers Run Dam

9 June 1978 (visual inspection)

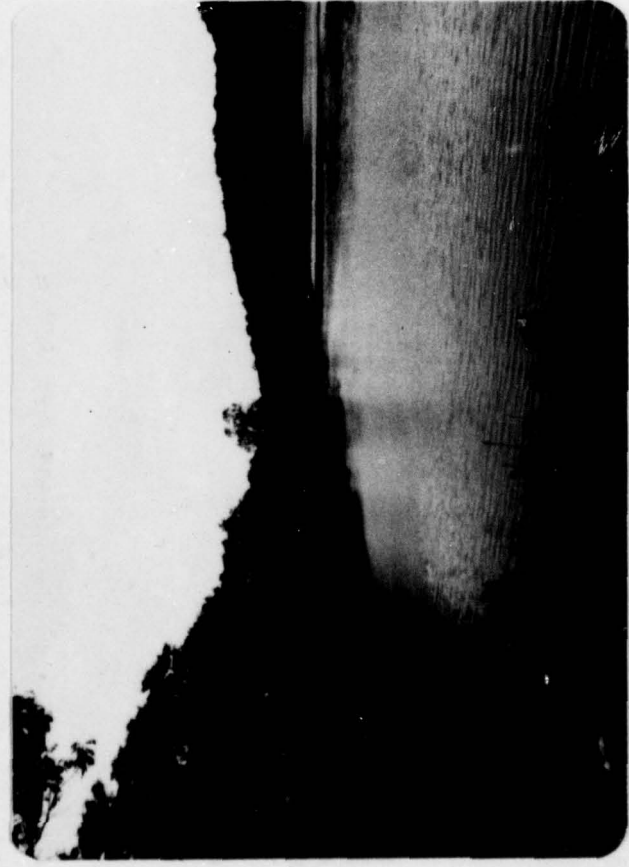
PHOTOGRAPH 3 View of the upstream portion of the Speers Run embankment taken from the left abutment.

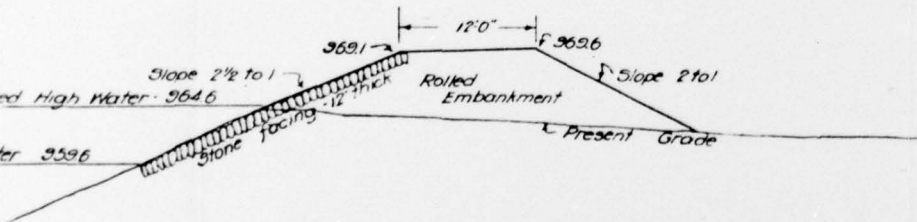
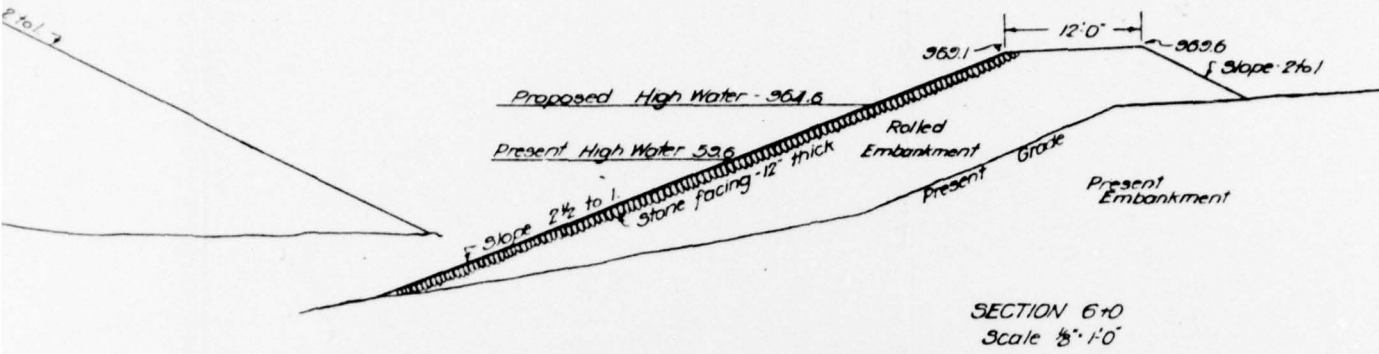
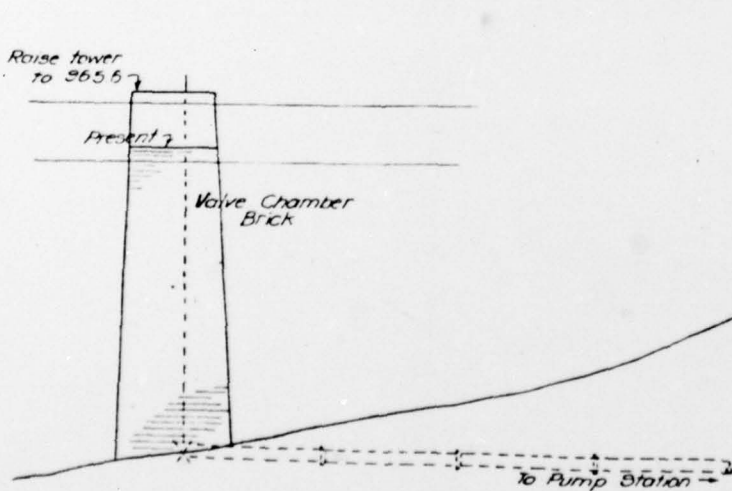
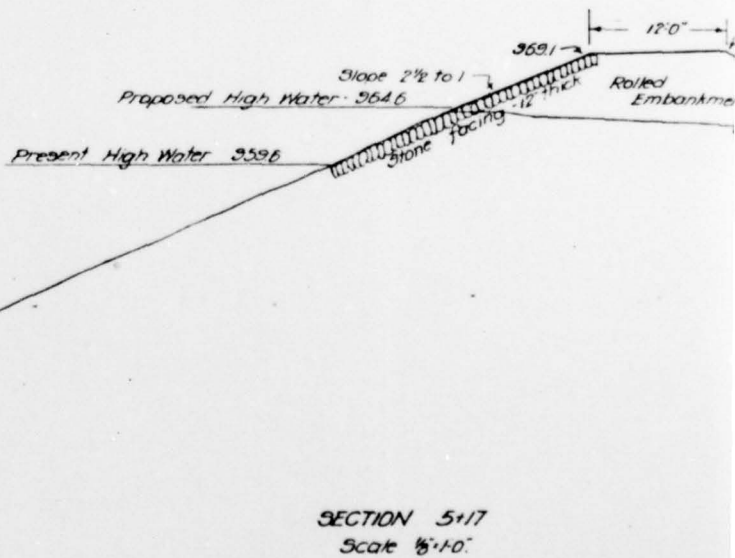
FIGURE 3

The intake structure shown on Figure 3 is submerged and cannot be inspected at the present reservoir level. Outlet appurtenances could not be located and as such pose a potentially hazardous condition, since they are under full hydraulic head beneath the embankment and apparently cannot be closed.

a. The owner enlist the services of a registered professional engineer to inspect and assess the condition of the intake and outlet works and perform those remedial measures deemed necessary to restore their operability including closing the outlet works at their intake ends.
