WATRES DAM

NDS ID NO. PA-00451

PHASE I INSPECTION REPORT,

6 NATIONAL DAM INSPECTION PROGRAM.

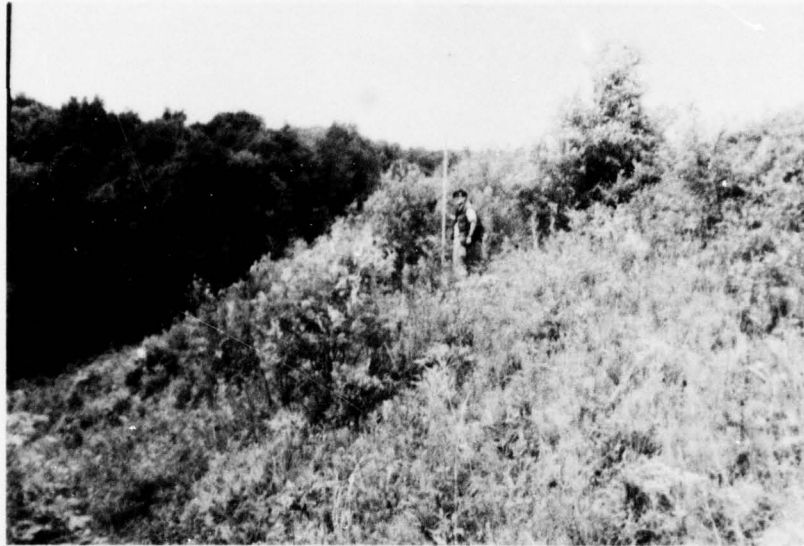
b. Embankment. The upstream slopes above the normal reservoir level appear to be in good condition, except for brush growing over the upper half of the exposed slope (Photograph D). The riprap appeared in good condition, with hardly any evidence of weathering. A survey performed for this inspection revealed that the lowest point on top of embankment is 1.1 feet below design elevation. The low area extends over 600 feet of the top. The left end of the low area is about 350 feet right of the left end of the embankment. The downstream slope was heavily overgrown with brush (Photographs A and C), except at the toe near the streambed. The toe in this area is rock fill. The abutment line was indistinct because of the heavy and, in some areas, impenetrable growth. One cross section of the embankment was surveyed for the inspection. To gain access to areas of the embankment, a path had to be cut with a machete. Because of the brush, many of the features shown on the section supplied by the Owner could not be seen. The surveyed cross section indicates that the embankment is somewhat steeper near the top than the Owner's cross section indicates. The survey revealed that the upper 20 feet of embankment is 1V on 1.3H or steeper. As changes in slope could not be observed, the survey data cannot be considered definitive. Most of the embankment could not be observed. The toe of embankment, at the streambed, was swampy (Photograph E). Two seepage areas were observed. About 30 feet downstream of the toe, on the right, clear water was seeping from the hillside at about 1 gpm. About 60 feet downstream of the toe, on the left side of the streambed, clear water was seeping at 2 to 3 gpm. Flowing water could be heard running through the rock fill at toe of dam. Access to the toe was through the woods from an access road about 200 feet to the left. Trees were growing adjacent to the rock fill at the toe. There did not appear to be any permanent watercourse from the swampy area at the toe to the stream.

C. Brush on Downstream Slope of Embankment

(3) Remove brush from the embankment slopes and perform a detailed inspection to ascertain the condition of the embankment. Surveys should be performed to determine the existing template of the embankment. The results of the survey should be evaluated to ascertain if remedial action is necessary.

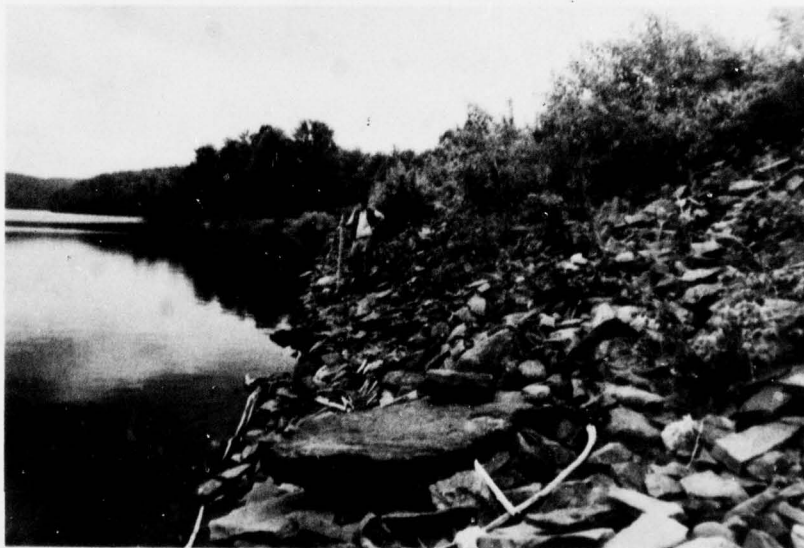
D. Riprap on Upstream Slope of Embankment

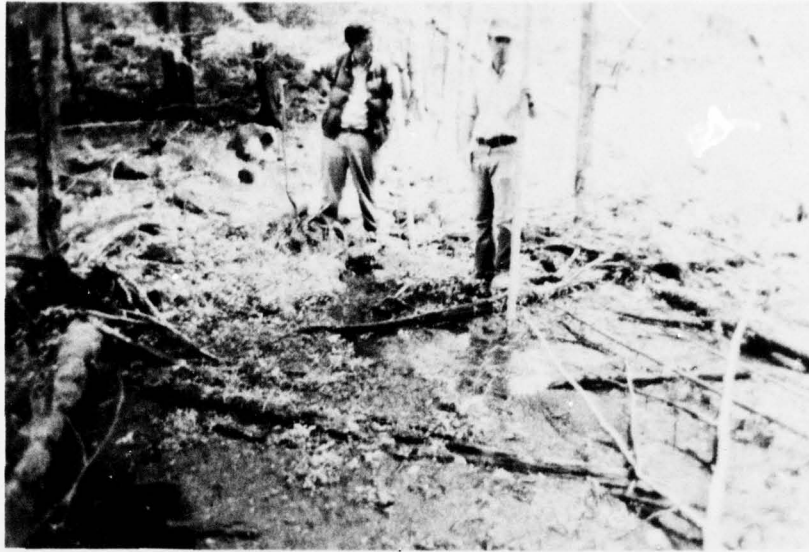
E. Seepage at Toe of Dam

(4) Provide positive drainage and good vehicular access at toe of dam to aid in assessment of seepage. Install at least eight observation wells, or other instrumentation, downstream of the axis of the dam. One well, or other instrumentation, should be located in the vicinity of the seepage. The others should be at appropriate locations to determine general water level in downstream embankment. The number of wells, or other instrumentation, will be dependent on the results of the inspection recommended above. Data collected from observation wells or other instrumentation should be utilized in evaluating the stability of the structure and assessing piping potential in the future. Continue to observe wet areas and seepage downstream from dam. If conditions worsen, appropriate action should be taken to control apparent seepage with properly designed drains.

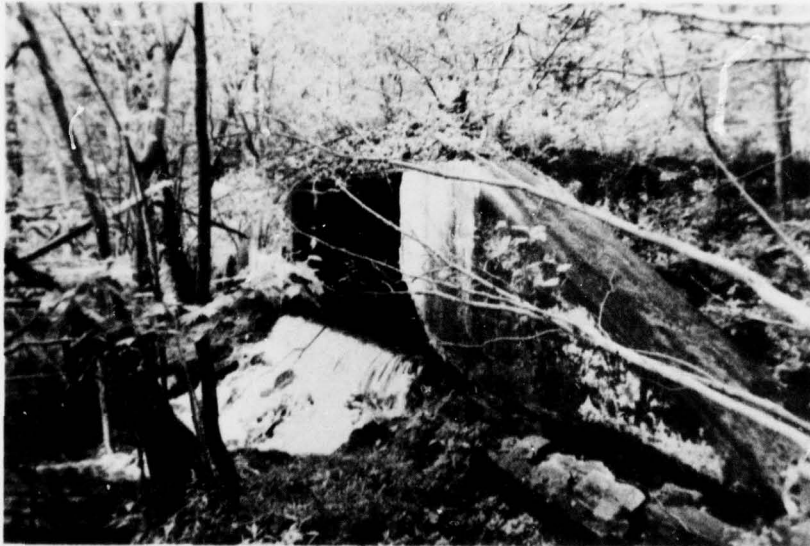
d. Outlet Works. The stem for the floatwell intake valve in the valve house is bowed. The floatwell does not function. The ladder from the valve house which extends down the vertical shaft is rusting. The concrete tunnel lining near the downstream end of the tunnel has 1-inch diameter hole through which water is leaking. The top of the headwall at the downstream end of tunnel is severely deteriorated, with the reinforcing steel being exposed over all the top (Photograph F). The operation of the downstream valve on the left pipe was observed. It required four men 30 minutes to open the valve 8 inches. The Owner requested that the valve not be opened more to avoid getting sediment in the water transmission line on the right. No problems were noted with the valve operation. This valve leaked.

c. Outlet Works. The inoperable floatwell presents no hazard to the dam. However, if operable it would be an aid, in assessing the seepage downstream. The rusting ladder could eventually be a hazard to personnel. The leakage observed in the tunnel presents no significant hazard to the dam. The deteriorated headwall does not present a hazard to the dam.

F. Headwall at Downstream End of  
Outlet Works Tunnel

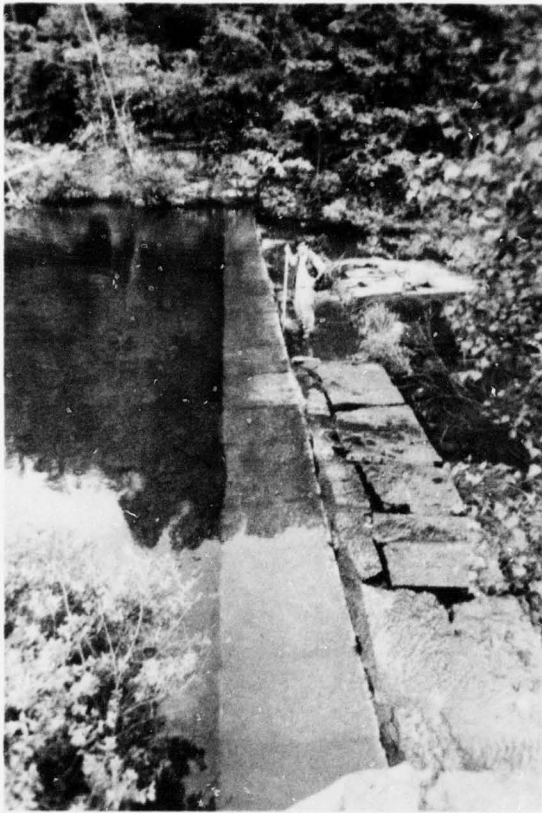
c. Spillway. Mortar is missing for up to a 2-inch depth from some joints in the weir and downstream apron (Photograph G). There is a small amount of vegetation in the channel immediately downstream of the weir (Photograph H). The stream below the spillway channel has dead trees strewn across it (Photograph I). The masonry retaining wall on the right bank in this area has deteriorated mortar, with

b. Spillway. The deterioration of the mortar is not sufficiently serious to be of concern. The vegetation downstream of the weir is too small to create problems at present. The trees in the downstream channel, while not desirable, present no significant hazard to the dam. Trees adjacent to the retaining wall are undesirable. Long-term neglect of the deteriorating mortar could prevent the spillway from acting as a watertight structure.

G. Spillway Crest

- (1) Remove trees close to slopes.
- (2) Visually monitor vegetation in spillway channel and clear vegetation when warranted.
- (3) Repair deteriorated mortar in masonry joints.
- (4) Remove trees close to retaining wall near spillway channel.
- (5) Clear downstream channel of dead trees.
- (6) Visually monitor leaks in outlet works tunnel and take remedial action should conditions worsen.
- (7) Repair concrete at downstream headwall of outlet works.
- (8) Repair or replace, and maintain the monitoring equipment, bent gate stem and ladder.
- (9) Investigate if the beaver dam in the downstream channel is causing the swampy conditions at toe of embankment. If it is causing this condition, it should be removed.

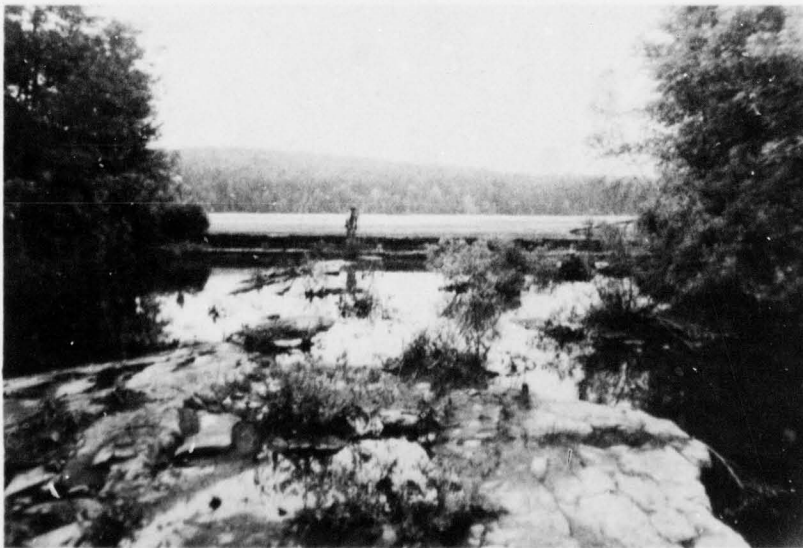
H. Spillway — Looking Upstream

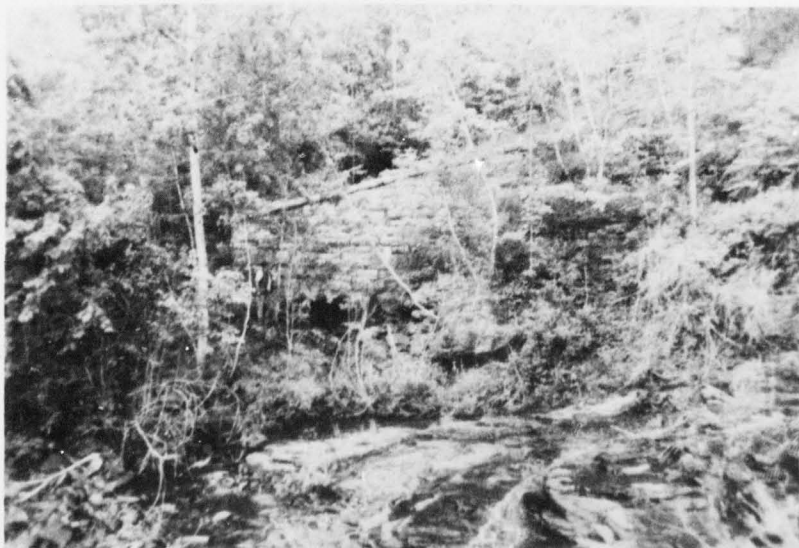
grass growing in some joints (Photograph J). A brown-colored leaching was observed over the lower half. Trees are growing close to this wall.

J. Retaining Wall on Right Bank of  
Downstream End of Spillway Channel
