SUSQUEHANNA RIVER BASIN
STAFFORD MEADOW BROOK, LACKAWANNA COUNTY
PENNSYLVANIA

WILLIAMS BRIDGE DAM
PENNSYLVANIA GAS AND WATER COMPANY

PHASE I INSPECTION REPORT
NATIONAL DAM INSPECTION PROGRAM

11 MAY 1978

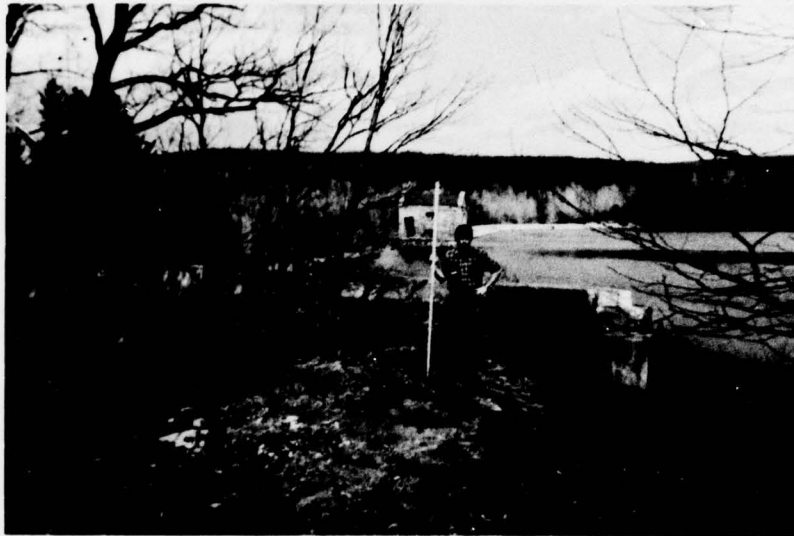
C. Left Approach Wall of Auxiliary Spillway
Showing Low Area Behind Wall

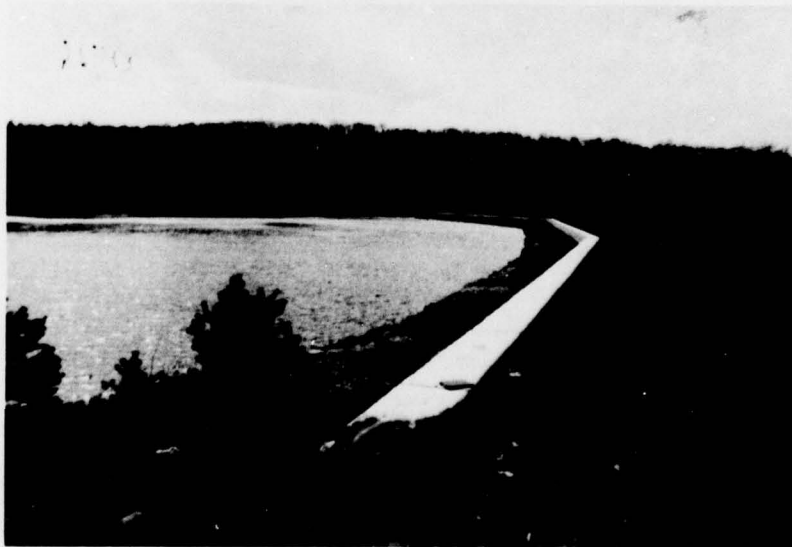
The exposed concrete extension to the masonry core wall was recently repaired with epoxy cement.

D. Concrete Extension of Masonry Core Wall
Extending Above Top of Embankment

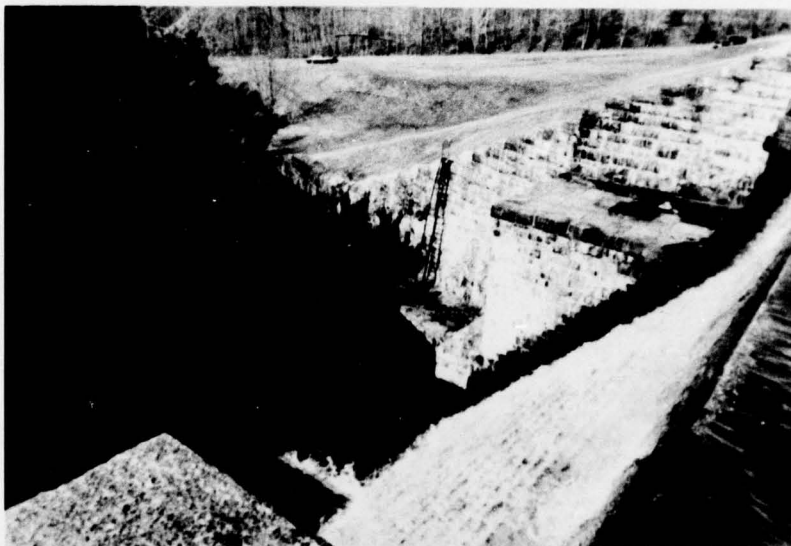
(1) The dam embankment is maintained adequately. The portion of the upstream face that was visible appeared to be in good condition and had no signs of distress. Except at one area, the sod on the downstream surface is intact and maintained. No trees or shrubs were growing on either surface. The downstream surface is somewhat irregular in slope and has some local high and low spots. The irregularities are not considered abnormal due to the age of the dam and the nonmechanized methods of construction. Along the main spillway right retaining wall, the embankment slope is much flatter than the wall slope. To make the transition, the embankment slope is warped downward to the wall over a short distance (Photograph G).

G. Valve House to Right of Main Spillway and with Retaining Wall in Background

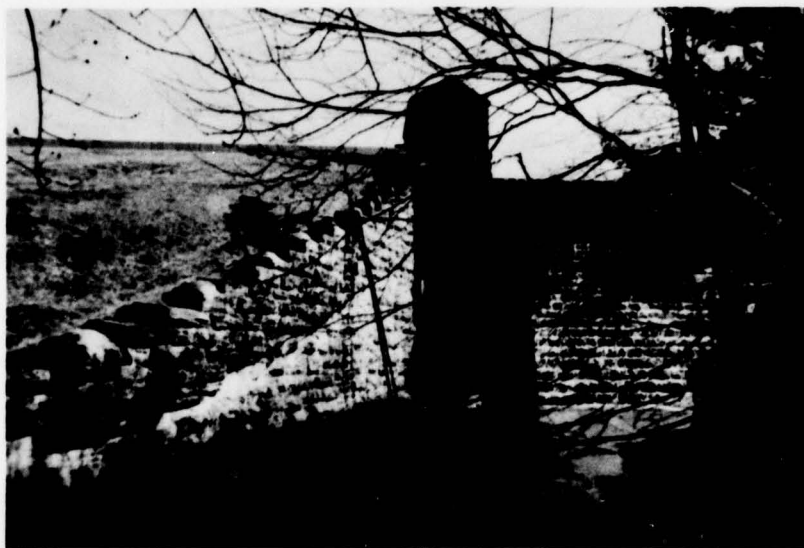
(3) The second wet area (Photographs I and J) is a 4-foot by 15-foot area located at Elevation 1340 and 12 feet right of the main spillway right retaining wall. This area is soft, saturated, and no sod is covering it. There was some clear, standing water, but no flow was exiting from the area. There has been some sloughing at the uphill side. Areas above and below were not affected. It was probed to a depth of 2 feet with a 1/2-inch diameter stick before encountering significant resistance. The underlying embankment material was examined and was found to be clay with some sand and fine gravel. The source of the water could not be determined.

(3) On the main spillway right retaining wall, 7 of the 11 concrete caps covering the tops of the post-tensioned steel bars that were installed in the 1962 repairs are disintegrating (Photograph I). The wall appeared to have a slight tilt toward the outlet channel. Survey points were marked on the wall, and the Owner said the wall is being monitored for movement.

(3) The continued disintegration of the concrete caps over the post-tensioned steel bars on the main spillway right retaining wall could cause corrosion and potential ineffectiveness of the bars that could result in failure of this critical feature.

I. Masonry Retaining Wall Between Embankment and Outlet Channel of Main Spillway Showing Repaired Diagonal Crack and Disintegration of Concrete Caps - Wet Area Shown Behind Retaining Wall

- (4) Repair damage to embankment with construction of French drains to remove water from the wet areas. Continue to monitor the main spillway right retaining wall for possible tilting.

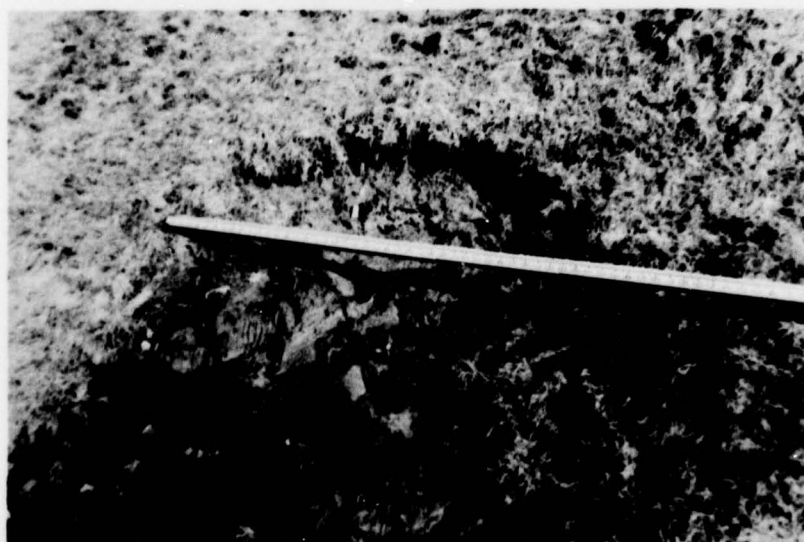
(2) It is unclear whether the wet area on the embankment adjacent to the main spillway was observed on previous inspections. The Owner indicated that it is not a recent event. However, the combination of local saturation, sloughing, and the proximity of this wet area to adjacent critical features, particularly to the main spillway right retaining wall that has a history of unsatisfactory performance, is such that the wet area is of general concern.

J. Wet Area Adjacent to Main Spillway Retaining Wall

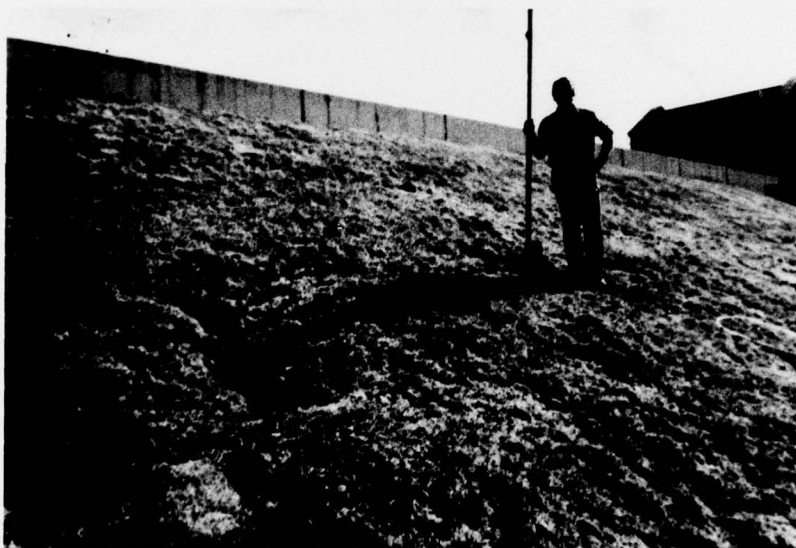
(4) Three holes, probably caused by groundhogs, were observed on the downstream surface about 80 feet to the right of the main spillway right retaining wall. There was no evidence of recent activity, and the holes are probably abandoned. The holes angled upstream at shallow depth and were dry. The holes are shown on Photograph K.

(3) No evidence of recent activity was observed in the holes that were caused by a burrowing animal. The holes were dry. Consequently, the holes are not considered to endanger the dam. However, they hinder mowing operations and could be re-inhabited.

K. 1916 Piezometer and Groundhog Burrowing on
Downstream Embankment Surface

(8) Fill holes in embankment caused by burrowing animals.
