**DELAWARE RIVER BASIN
WILD CREEK, CARBON COUNTY**

**PENNSYLVANIA
ID NO. PA.00608**

PENN FOREST DAM

PHASE I INSPECTION REPORT NATIONAL DAM INSPECTION PROGRAM

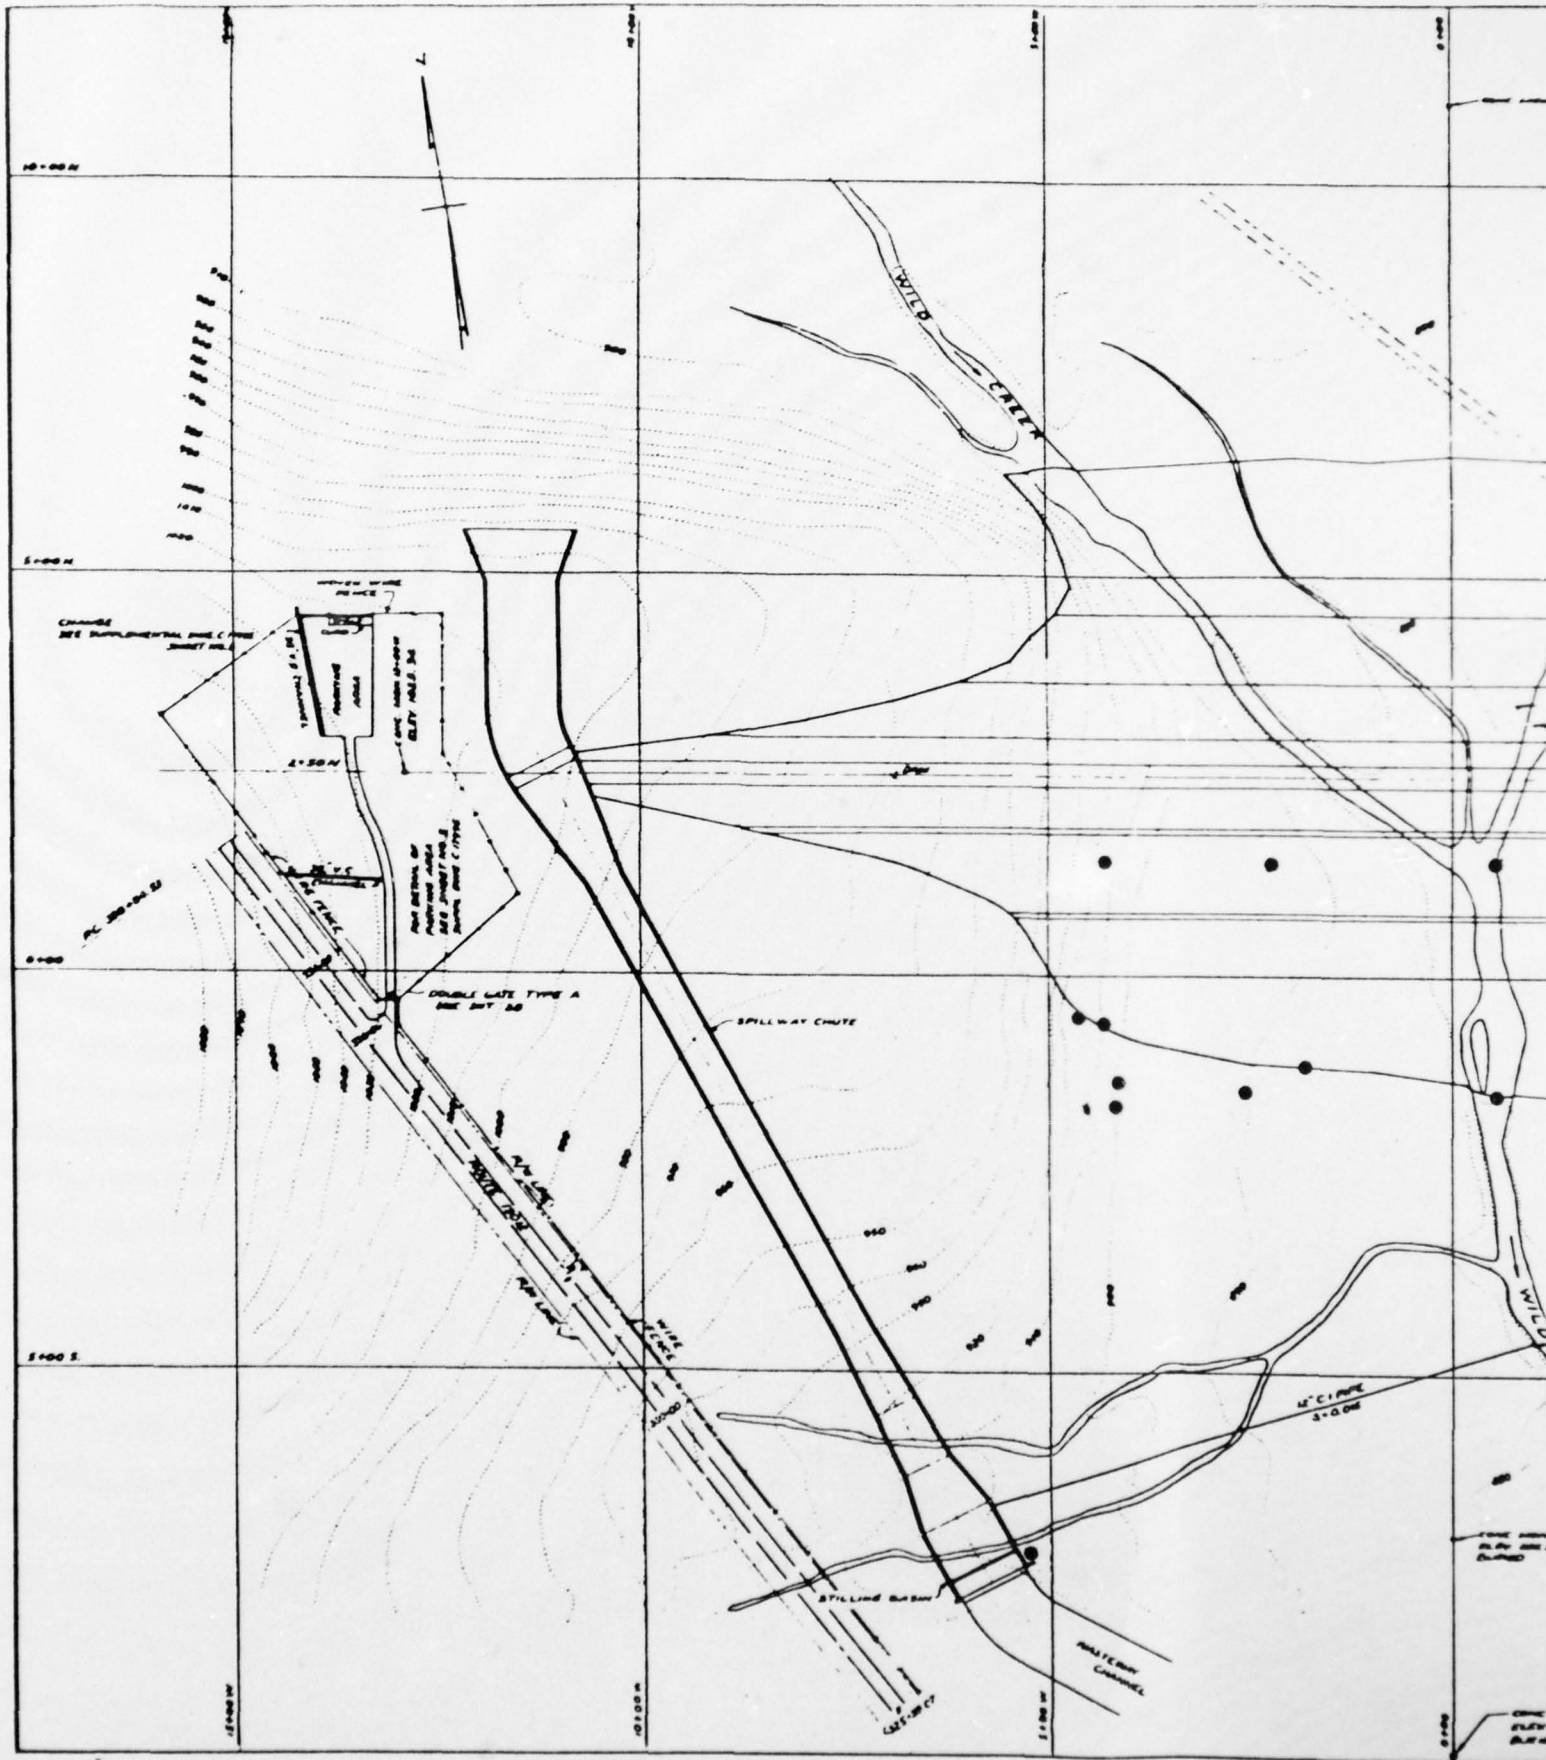
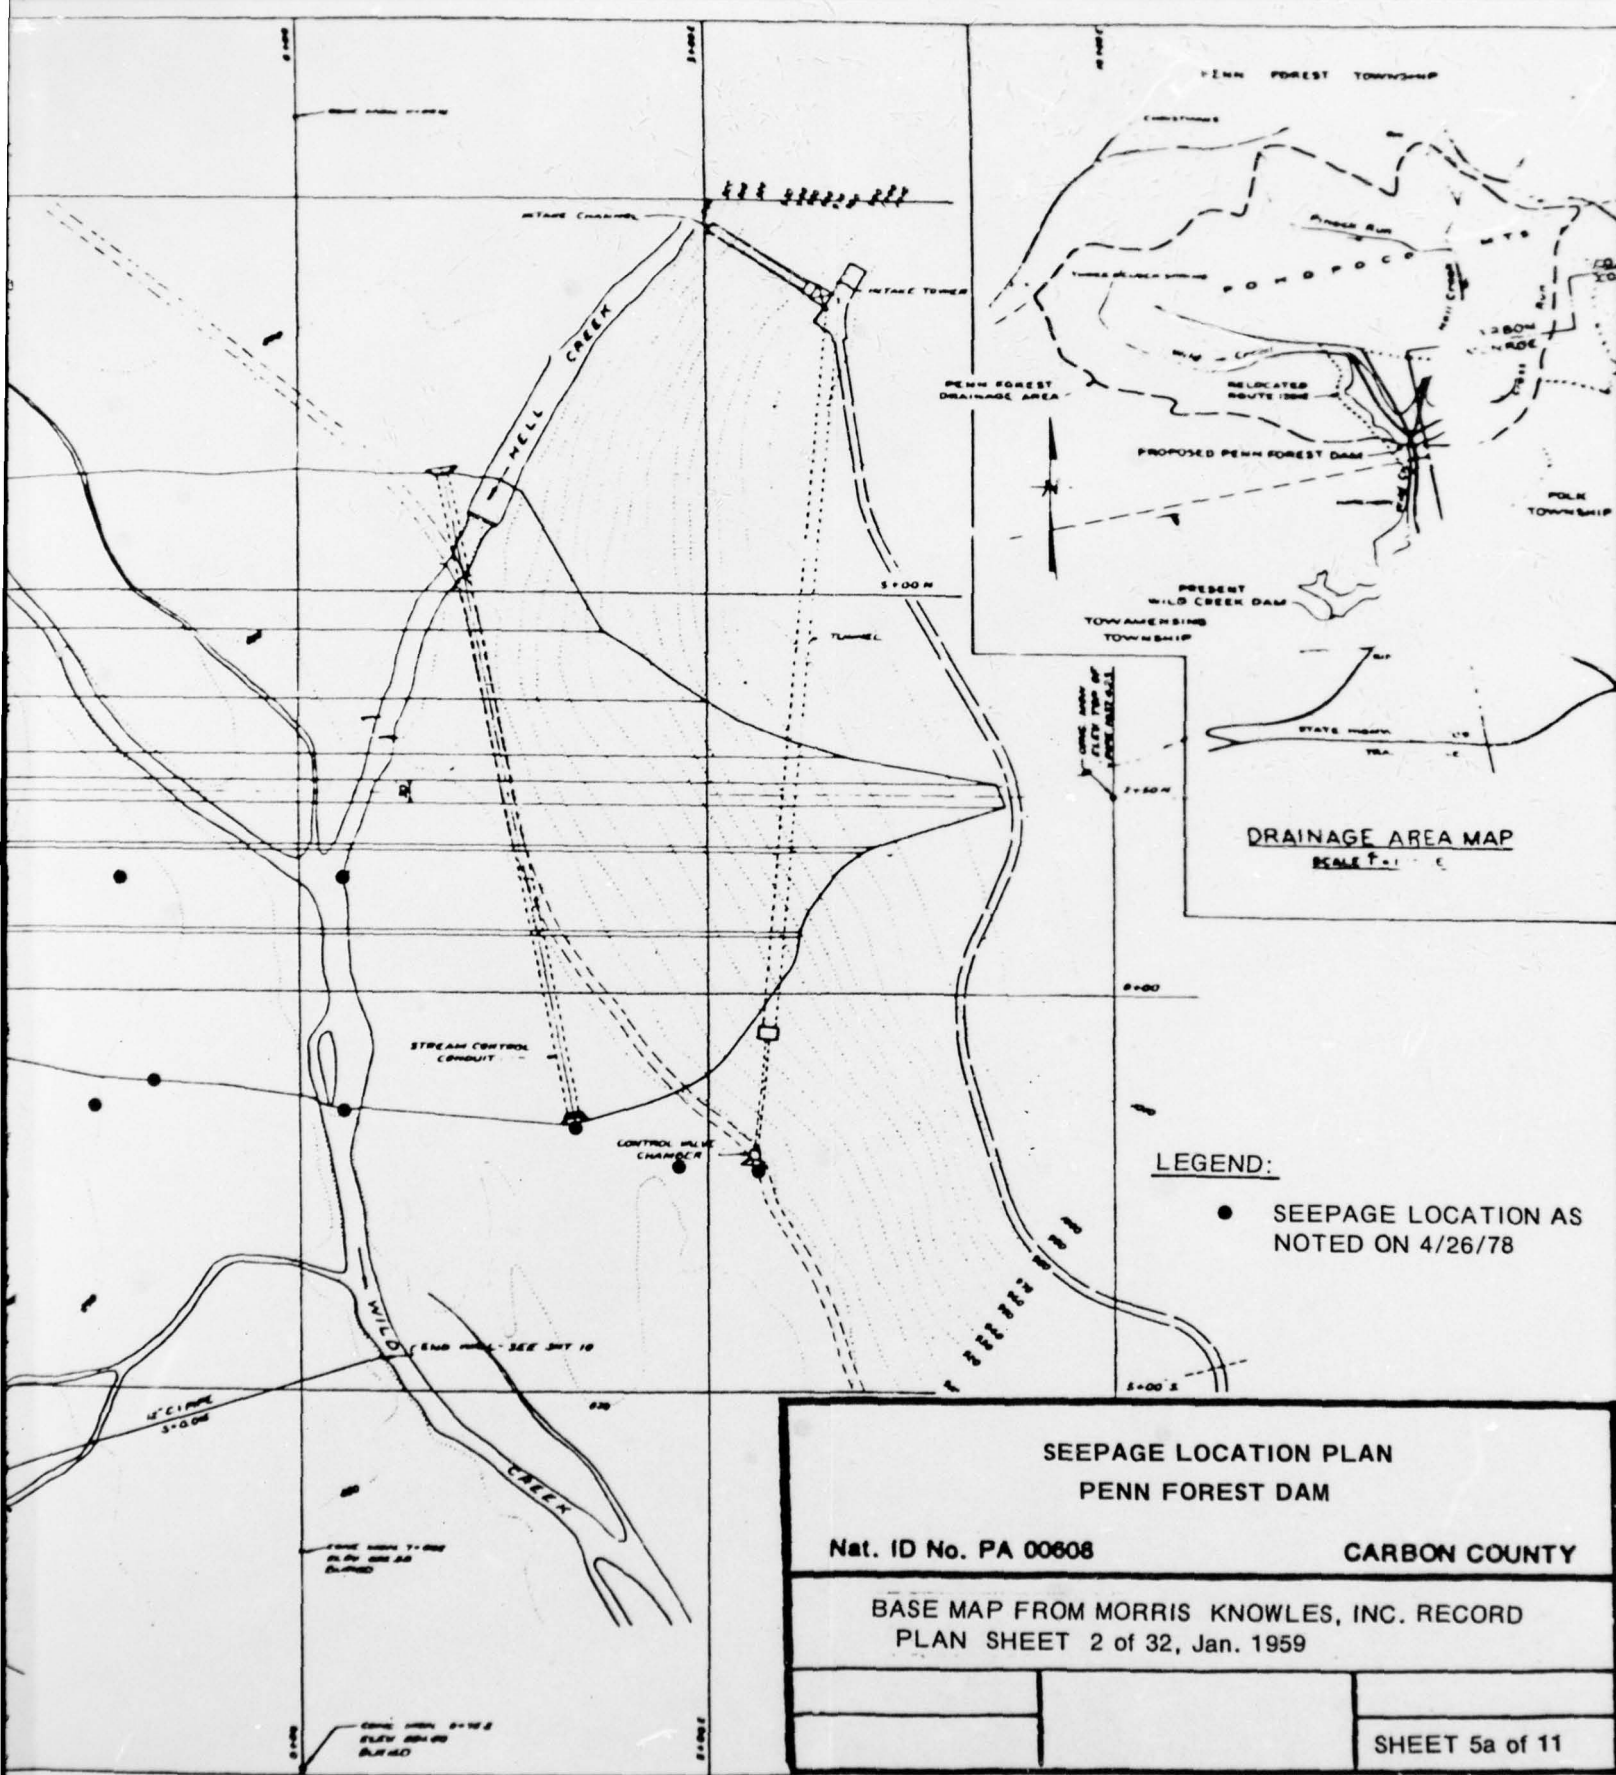
**SEEPAGE LOCATION PLAN
PENN FOREST DAM**

Clear running seepage was observed at several locations on the downstream side of the dam. Near the right abutment and just below the dam toe there is a marshy area that is fed by seepage from at least three discrete locations along the access road normal to the dam. Slight seepages were observed in the gutter and in the access road at the dam toe. At about the original streambed location at the dam toe there is a major leakage where several sections of the gutter drain were removed and a trench was excavated for about 15 feet into the dam toe. This leakage flows into the gutter and then across a measuring weir that appeared to be in a state of disrepair. Documents in the DER file indicate that the weir was installed in conjunction with the 1964 monitoring program. Leakage was also observed slightly downstream from the dam toe in the vicinity of this measuring weir. Water flowing from the weep holes around the diversion tunnel outlet appeared to have a greater volume than the water flow observed in the tunnel. Water was also flowing from the weep holes at the operating discharge outlet. Additional seepage was observed downstream from the dam on the left abutment of the valley. A small seep of clear water was also observed at the left wall of the stilling basin. The flow rate at these seeps was difficult to estimate during the visual inspection.

The water seepage observed at the toe of the dam and at the stilling basin is consistent with documented observations of Penn Forest Dam since 1961. The clarity of the seepage water indicates that piping or erosion within the dam is not presently occurring. However, the seepage observed downstream of the left abutment was not previously recorded in the available files.

Of less concern is the seepage at the downstream toe of the dam and at the left downstream abutment. It is recommended that the additional seepage areas be added to any on-going observation and monitoring program at the dam to detect any possibly changes in the seepage as described in Section 7.2 of the report.

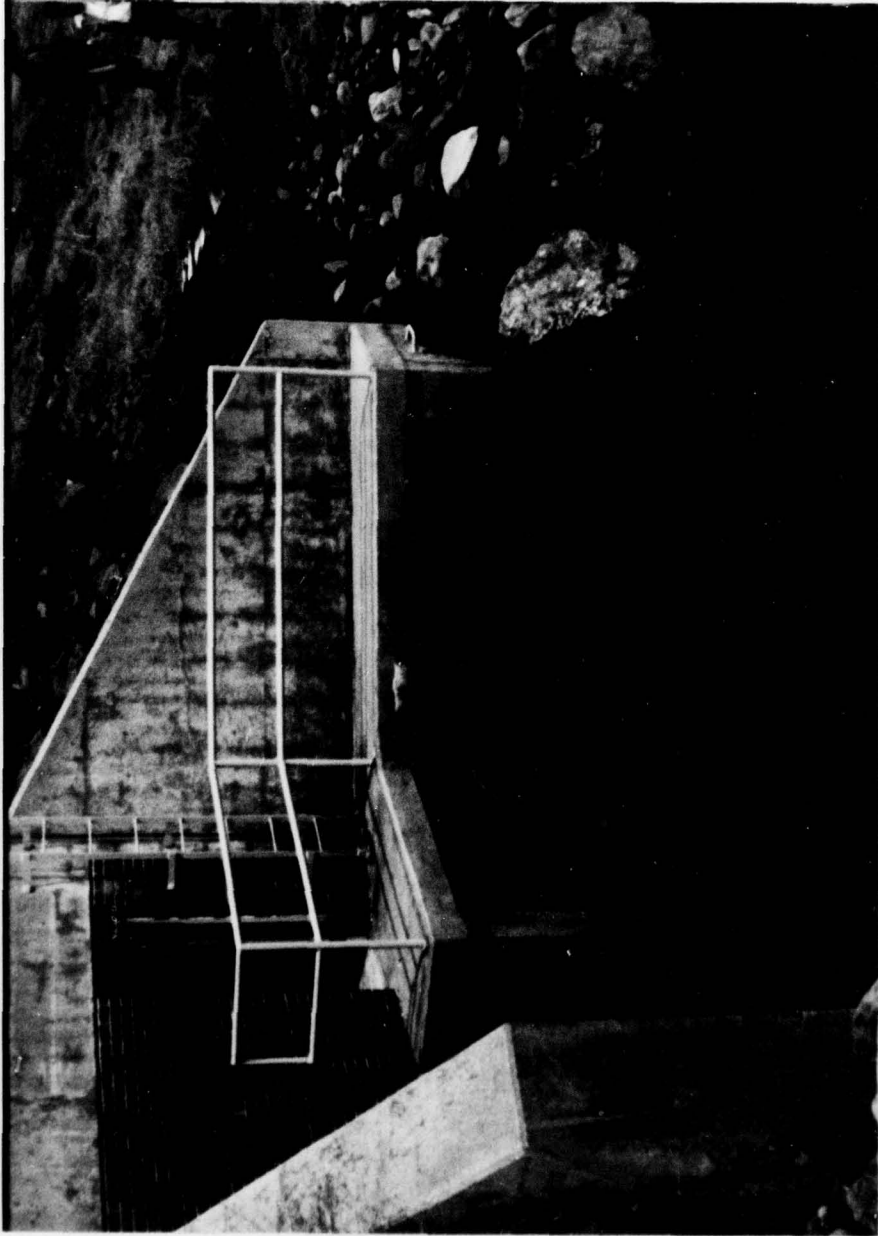
PHOTO NO. 3

DRAWDOWN DISCHARGE STRUCTURE WITH 36-INCH OUTLET PIPE
(See Photo No. 2 for orientation).

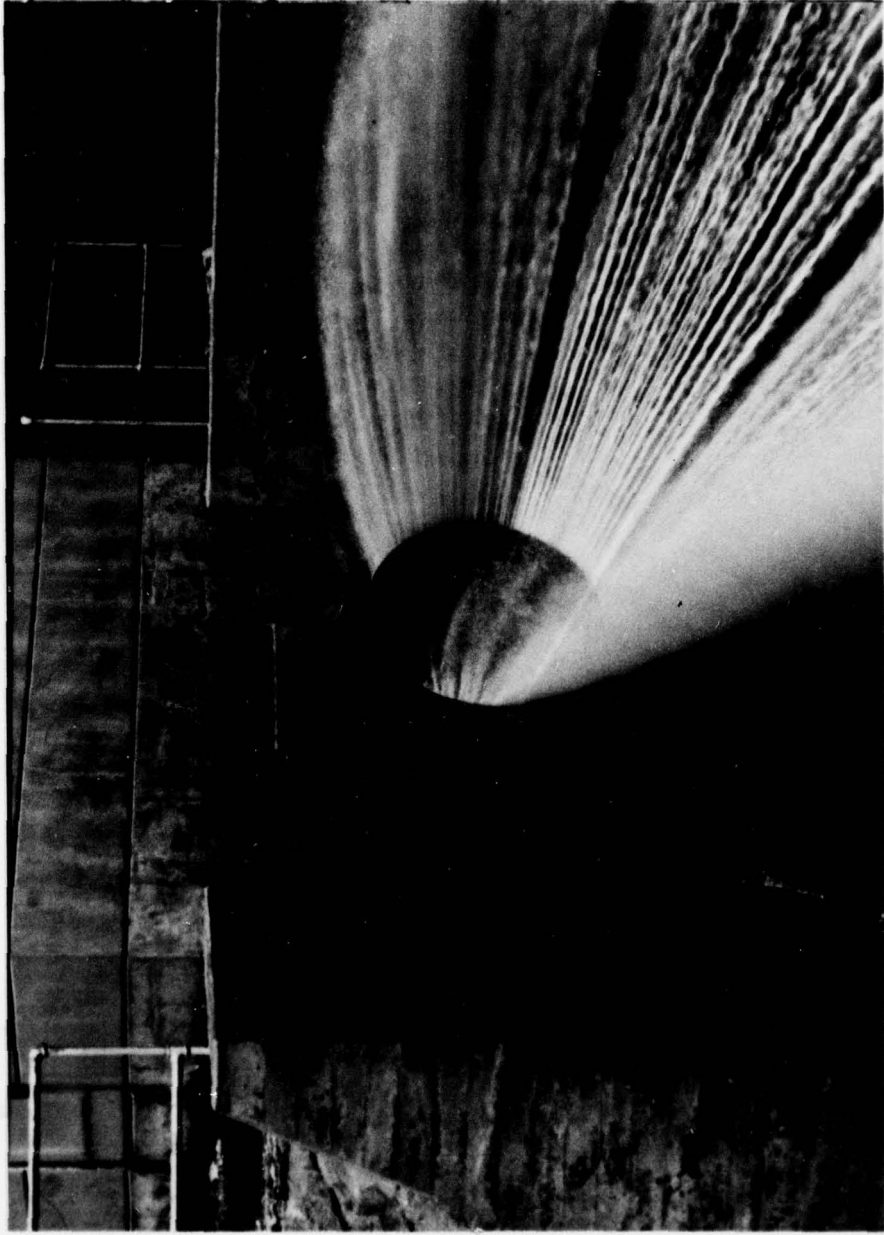
PHOTO NO. 4

The outlet structure enclosing the 48-inch Howell-Bunger valve appeared to be in generally good condition. The valve was exercised and all controls appeared to be operational.

OPERATING DISCHARGE STRUCTURE WITH 48-INCH SPRAY VALVE.
(See Photo No. 2 for orientation).

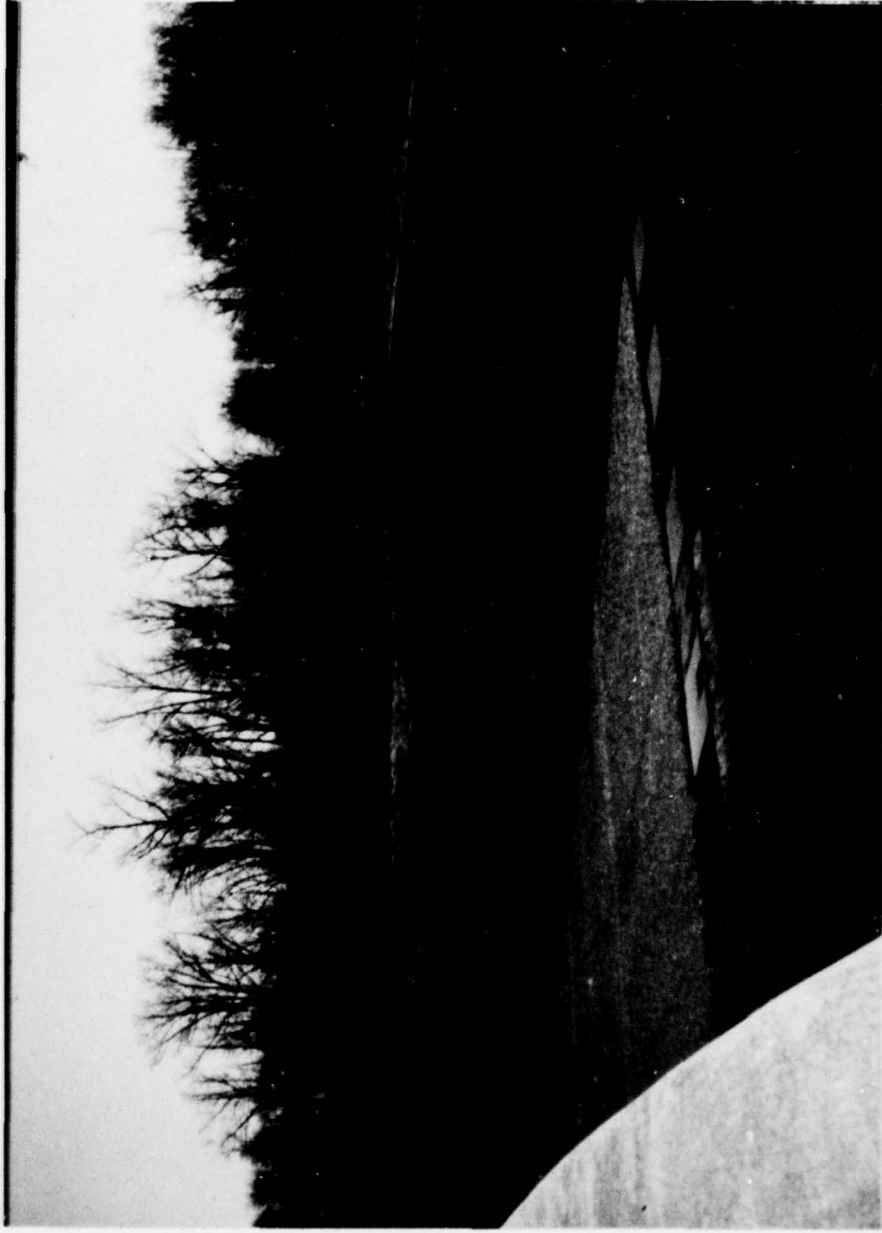
PHOTO NO. 5

c. Appurtenant Structures. At the time of the inspection, not more than one inch of water was flowing over the spillway. This spillway flow was observed to be reasonably smooth and uniform over the crest and down the spillway channel. Some minor concrete spalling was observed at occasional joints in the floor slab of the spillway and in the spillway walls. The spillway walls were observed to be in a straight line and showed no evidence of displacement or rotation. Throughout the spillway structure, minor shrinkage cracks were observed together with occasional scaling, pop-outs, and erosion of concrete. It was noted that concrete deterioration and occurrence of cracking appeared to be more severe around the stilling basin where calcium carbonate precipitate was also observed.

VIEW OF SPILLWAY CREST LOOKING DOWNSTREAM

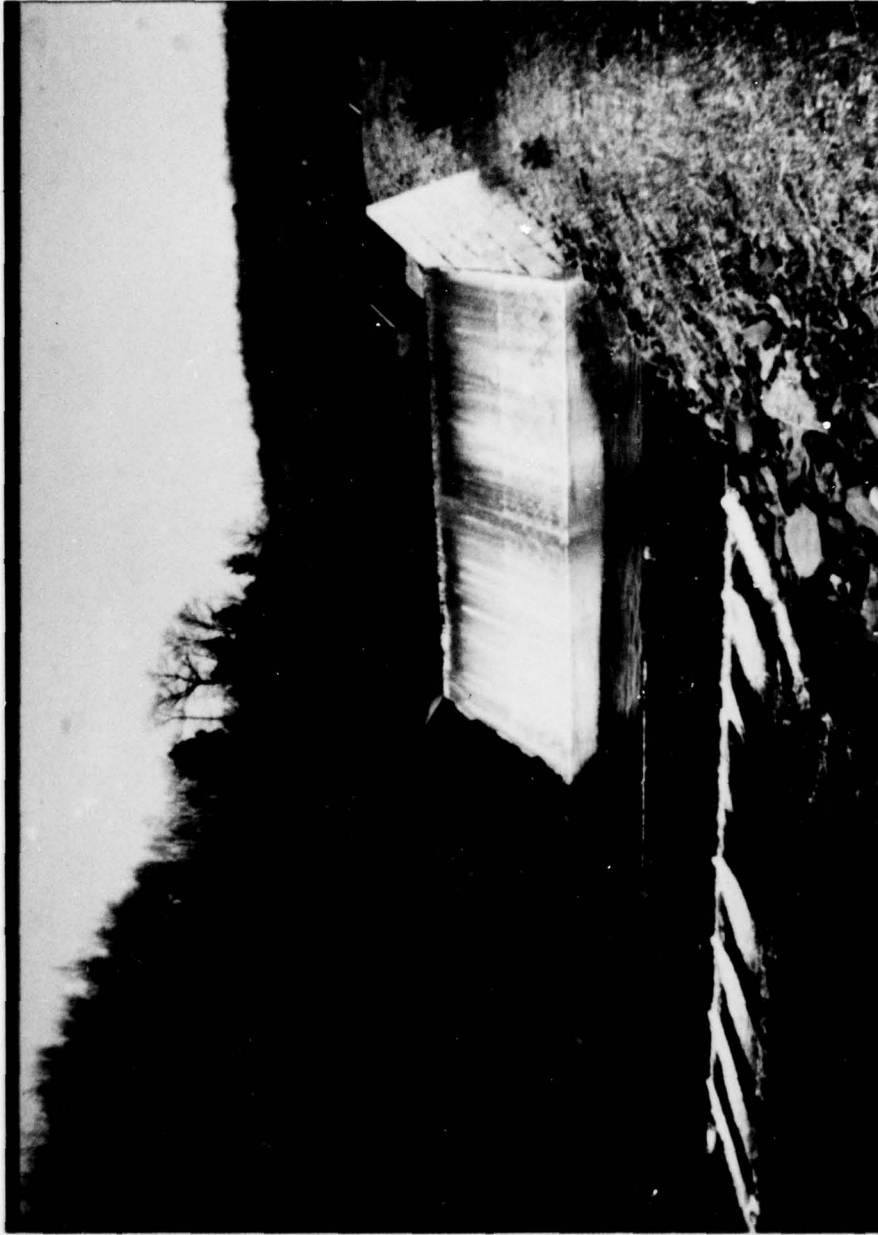
PHOTO NO. 6

VIEW OF STILLING BASINS

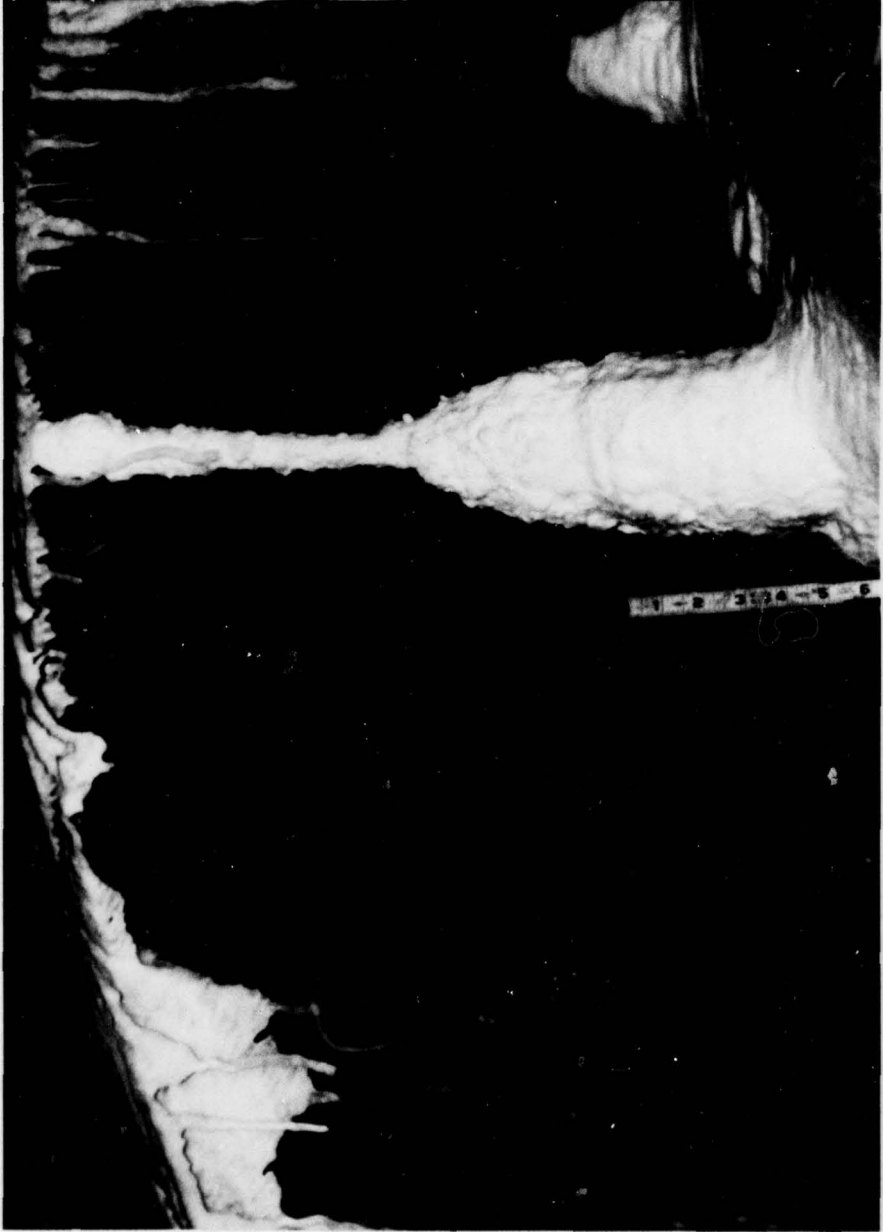
PHOTO NO. 10

CALCIUM CARBONATE PRECIPITATE FORMATION OVER 54-INCH CONCRETE INTAKE PIPE IN INTAKE TUNNEL. NOTE PRECIPITATE ACCUMULATION ALONG CRACK IN TUNNEL ROOF.
