National Dam Inspection Program. Still
Creek Dam (National I.D. Number PA-~~00700~~),
Schuylkill River Basin, Still Creek,
Schuylkill County, Pennsylvania. Phase I
Inspection Report,

STILL CREEK DAM
 SCHUYLKILL COUNTY, PENNSYLVANIA
 NATIONAL I.D. NO. PA 00700

PHASE I INSPECTION REPORT
 NATIONAL DAM INSPECTION PROGRAM

WOODWARD-CLYDE CONSULTANTS
 5120 Butler Pike
 Plymouth Meeting, Pennsylvania 19462

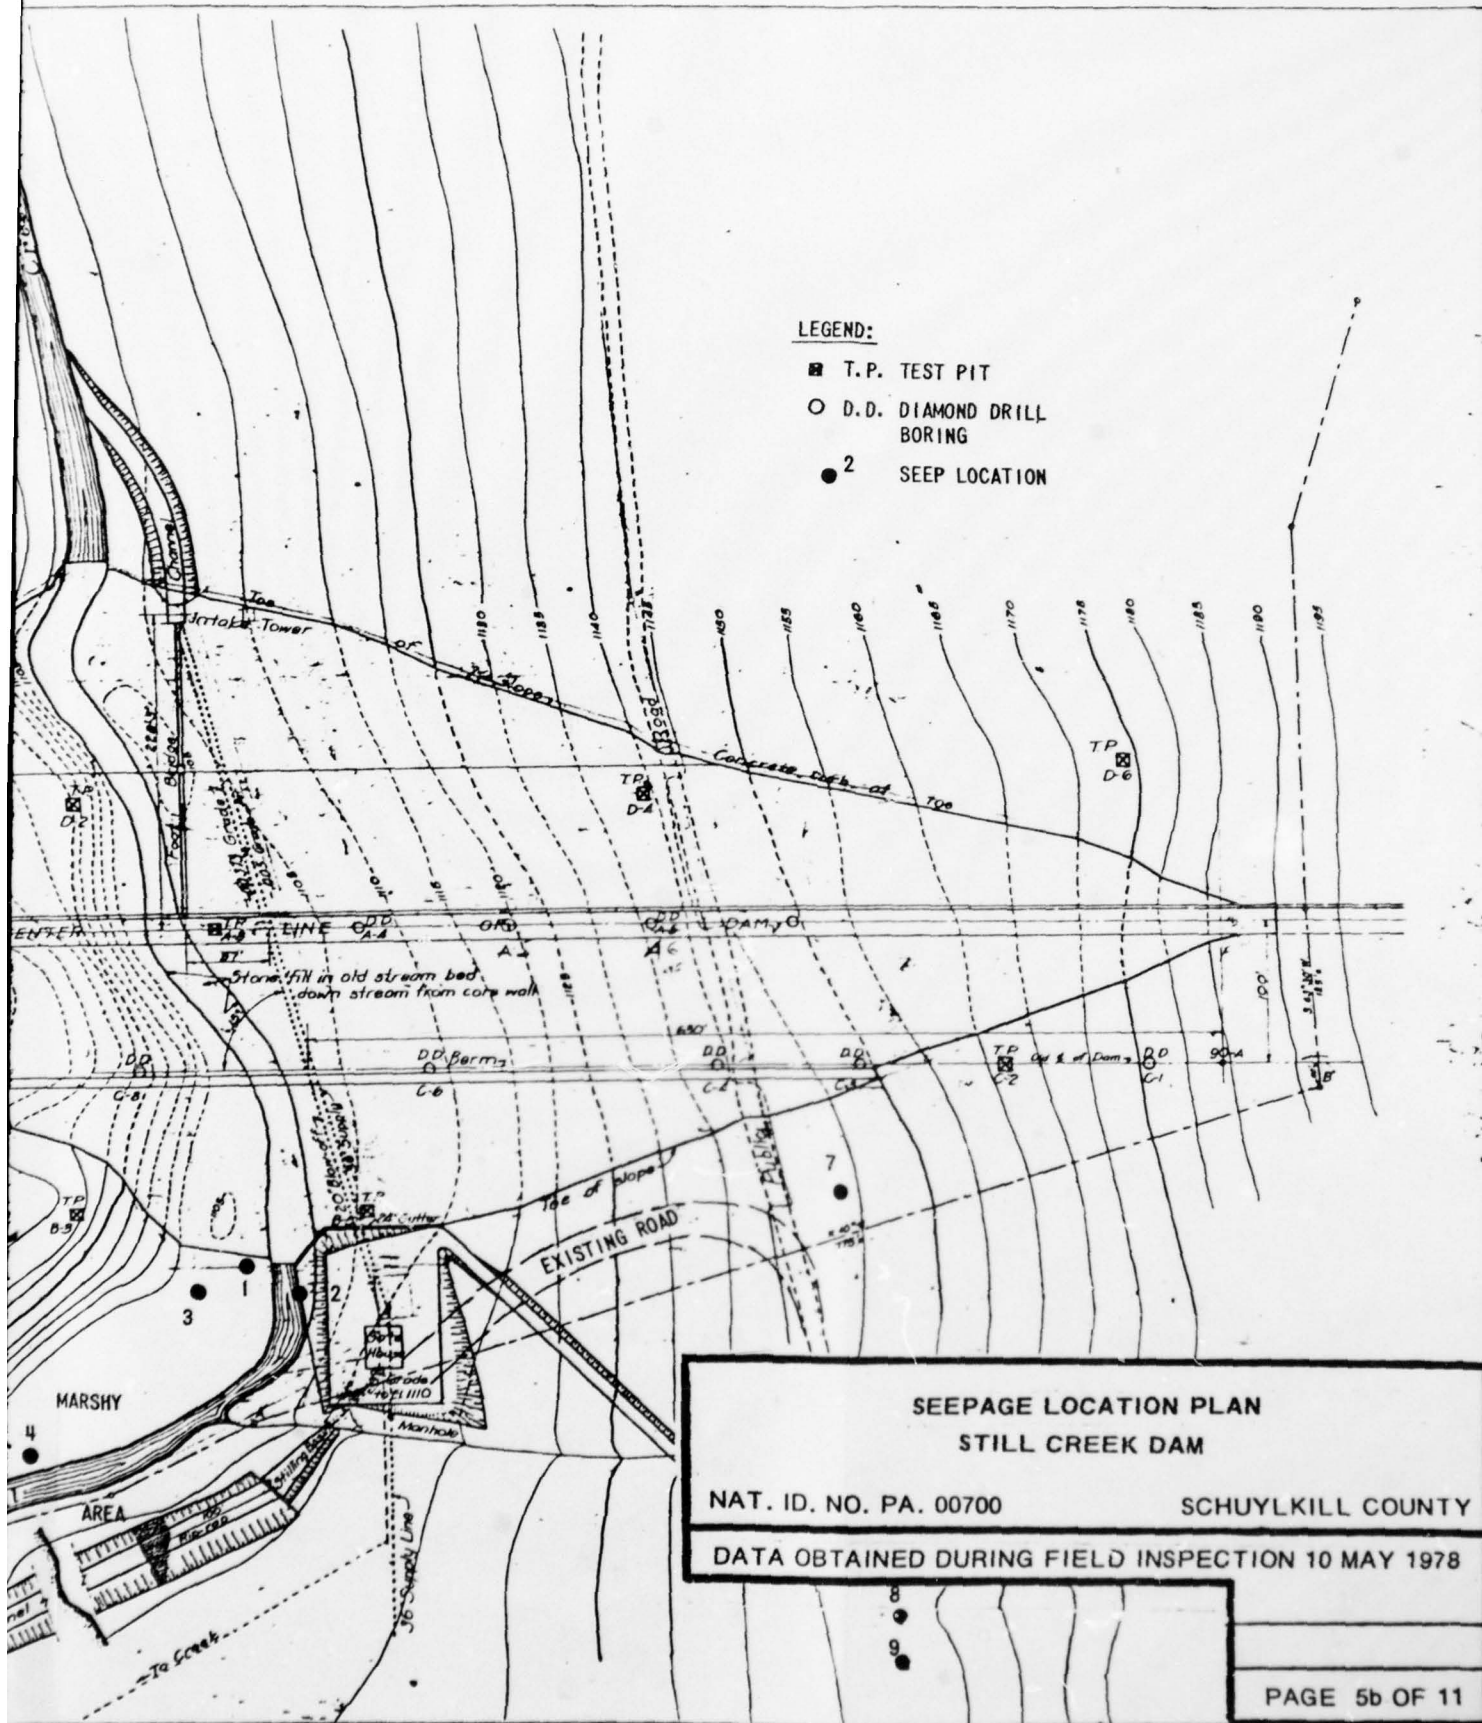
**SEEPAGE LOCATION PLAN
STILL CREEK DAM**

Yes. Seepage was observed at the downstream toe and beyond the toe in several locations as shown on the attached page 5a. Since the rock is fractured, bedded and susceptible to possible seepage as described in Appendix F, the seepage is probably predominantly through the foundation materials. Some seepage was also observed near the right abutment as shown on Page 5b. A detailed description is noted on Page 5a.

Several seepage areas were observed in the southeast abutment area. One is (Location 7) located in the woods adjacent to the dirt access road. Two additional water seeps (possible springs) were observed on both sides of a pipeline (Locations 8 and 9) where it crosses the paved road which leads to Route 309.

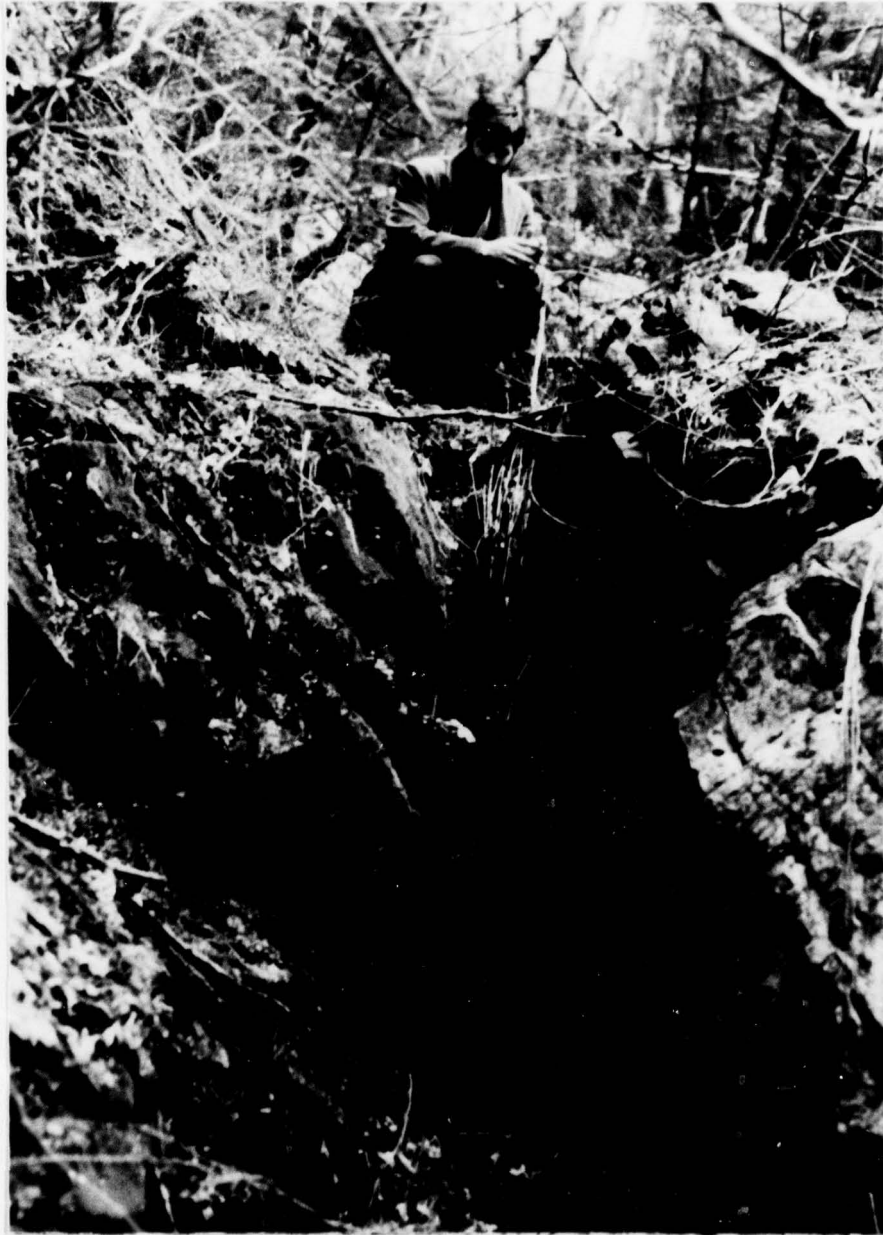
Factors which may be conducive for water seepage in the Still Creek Reservoir area include the north-northeast strike and south-southeast dip of the bedrock, the northeast strike and low angle dip of one set of bedrock joints. Also, the general thin-bedded nature of the rock would contribute to water seepages.

SOME SEEPAGE EMERGES THROUGH THE JOINTED
ROCK DOWNSTREAM OF THE DAM. THIS PHOTO
WAS TAKEN ON THE SOUTH DIPPING LIMB OF THE
DELANO ANTICLINE OUTCROP OF THE MAUCH CHUNK
SANDSTONE.

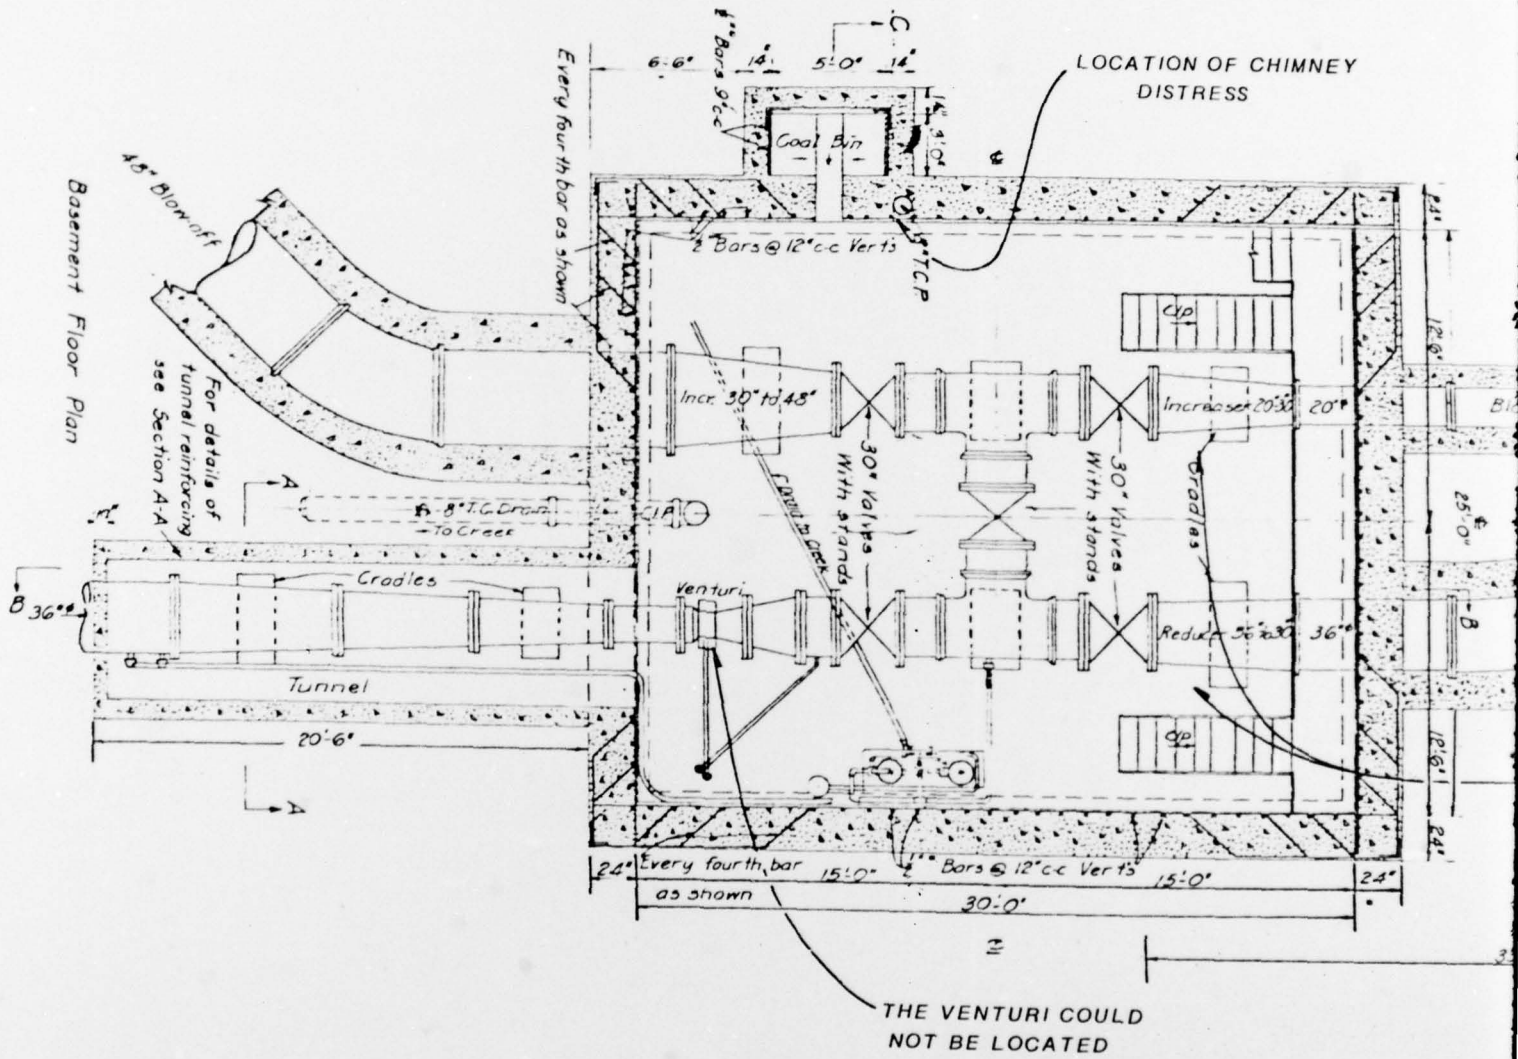
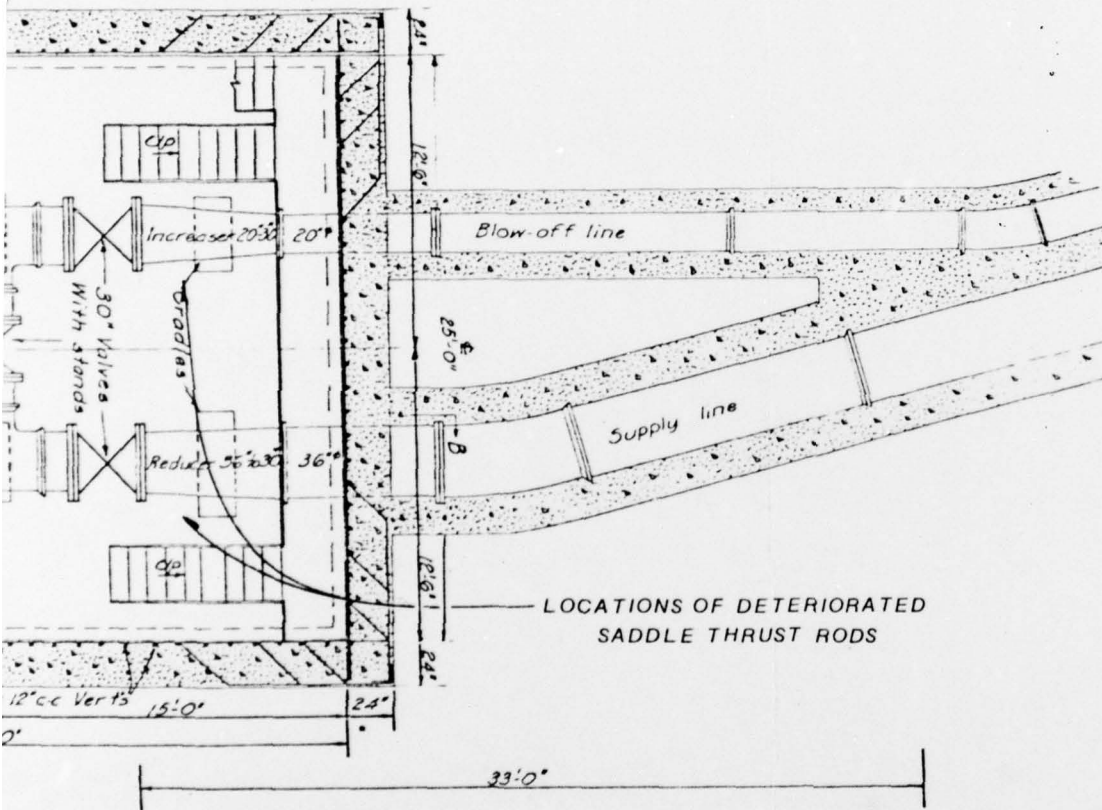
PUMPHOUSE FLOOR PLAN STILL CREEK DAM		
NAT. ID NO. PA. 00700		SCHUYLKILL COUNTY
DATA OBTAINED FROM GANNETT, SEELYE & FLEMING ENGINEERS DRAWING SHEET 8 OF 15, DATED APRIL 1924		
2	DESIGN DWG. AS-BUILT NOT AVAILABLE	PLATE 6

The Valve House was inspected and noted that the thrust bars on the 30-inch valve were completely deteriorated. Although not part of this inspection, it was noted that the chimney in the pumphouse is cracked and deteriorating. A discussion of the chimney is described in Appendix B, Sheet 7 of 11, under Outlet Structures.

LOCATION OF CHIMNEY
DISTRESS

5. The structural integrity of the chimney is questionable considering that the steel used to repair it several years ago has deteriorated and buckled. The chimney should be repaired.
