2 TUBMILL DAM

(ID NO. PA. 488)

4 PHASE I INSPECTION REPORT  
NATIONAL DAM INSPECTION PROGRAM

1268pr D'APPOLONIA CONSULTING ENGINEERS

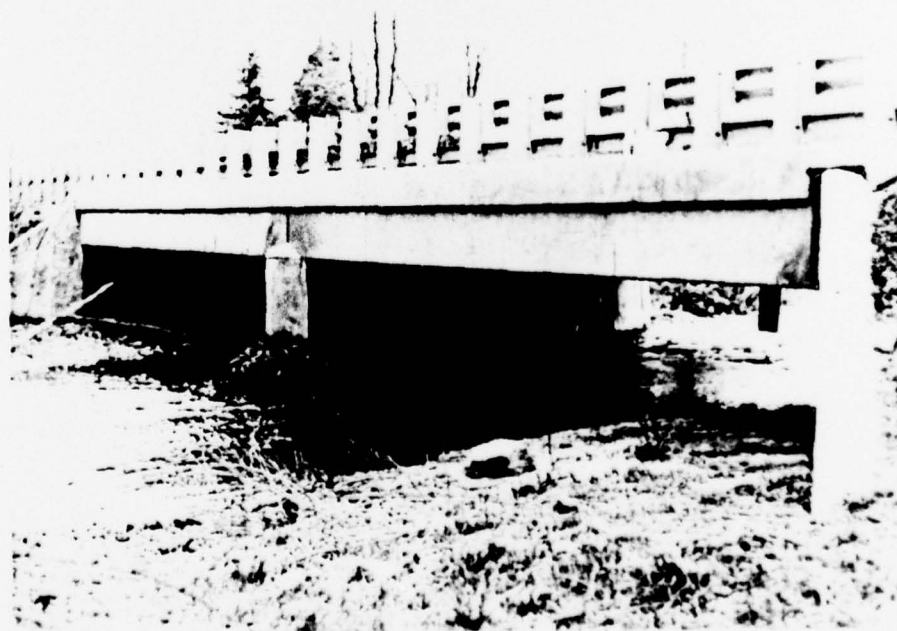
Photograph No. 12

Bridge on Route 711.
