2 LAKE STONEYCREEK DAM

(NDI I.D. NO: 227)

4 PHASE I INSPECTION REPORT  
NATIONAL DAM INSPECTION PROGRAM

D'APPOLONIA CONSULTING ENGINEERS

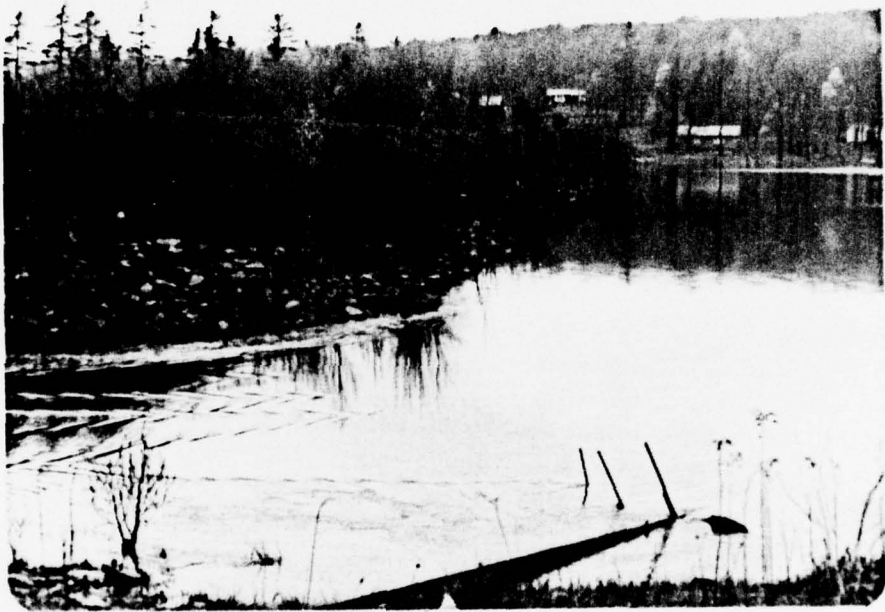
Upstream Face

4.2 Maintenance of the Dam. The maintenance condition of the dam is fair. The upstream face of the dam was covered with patches of brush and trees from 5 to 8 feet high. There is no formal dam tender responsible for the maintenance of the dam.

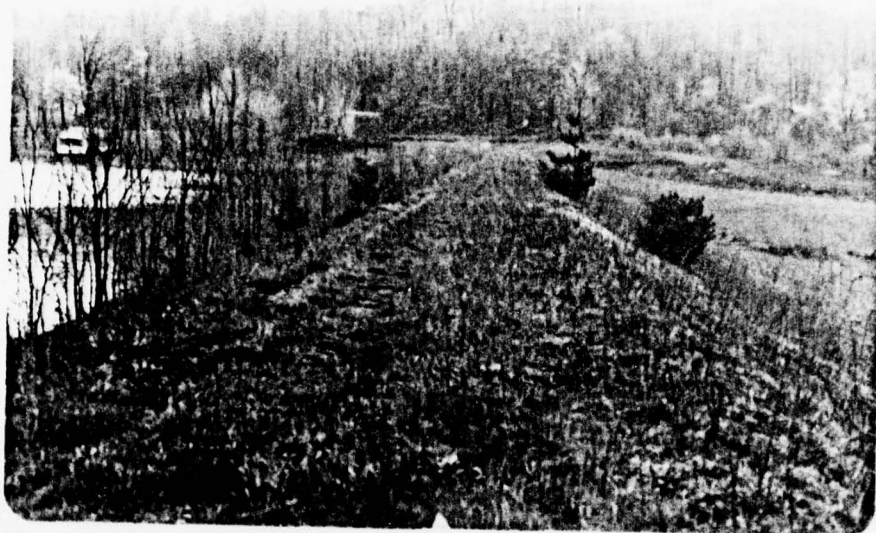
Photograph No. 1  
Dam crest.

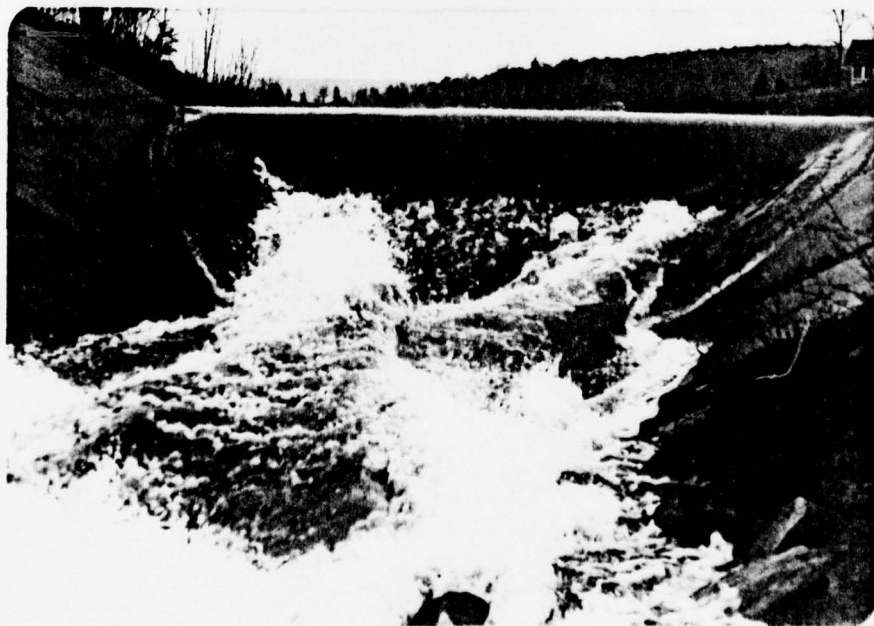
(2) Appurtenant Structures. The structural condition of the primary spillway is considered to be adequate. However, additional riprap on the sides of the approach channel is required to prevent undermining and damage to the concrete sections during high flows.

Photograph No. 2  
Primary spillway.

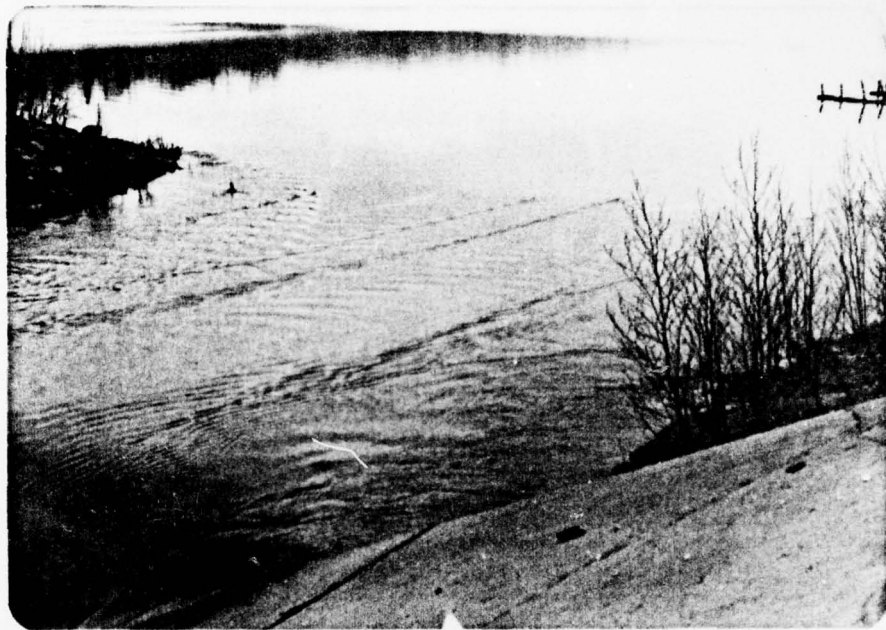
Riprap at the entrance channel of the primary spillway is considered to be inadequate to provide sufficient erosion protection during high flows.

Photograph No. 3  
Primary spillway approach channel.

It is recommended that the owner should take appropriate action as soon as possible to provide adequate erosion protection in the emergency spillway, evaluate the adequacy of the riprap at the entrance of the primary spillway, and remove the brush on the upstream face of the dam. It is also recommended that the owner should evaluate the need for placing an upstream control at the outlet pipe and installing instrumentation in the embankment.

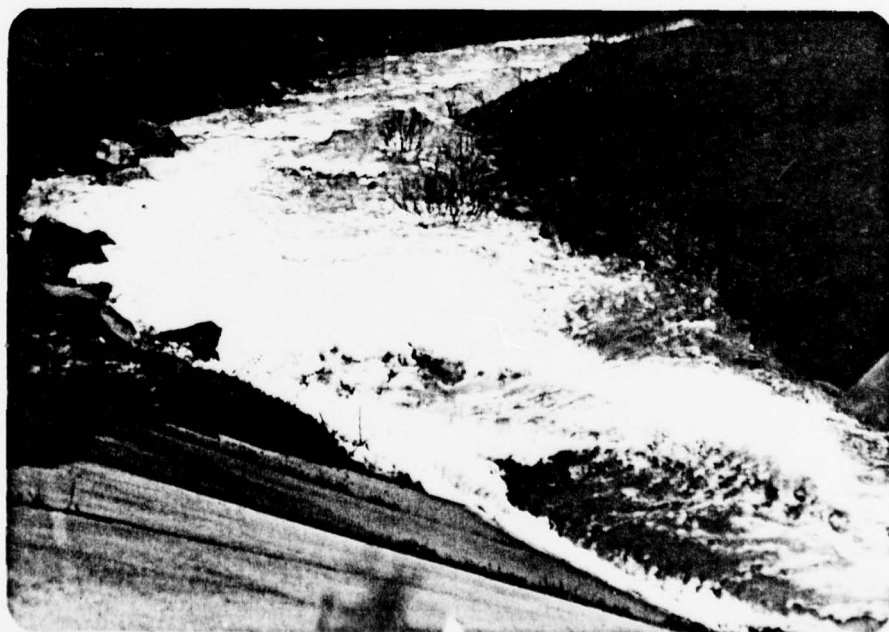
Photograph No. 4  
Primary spillway discharge channel.

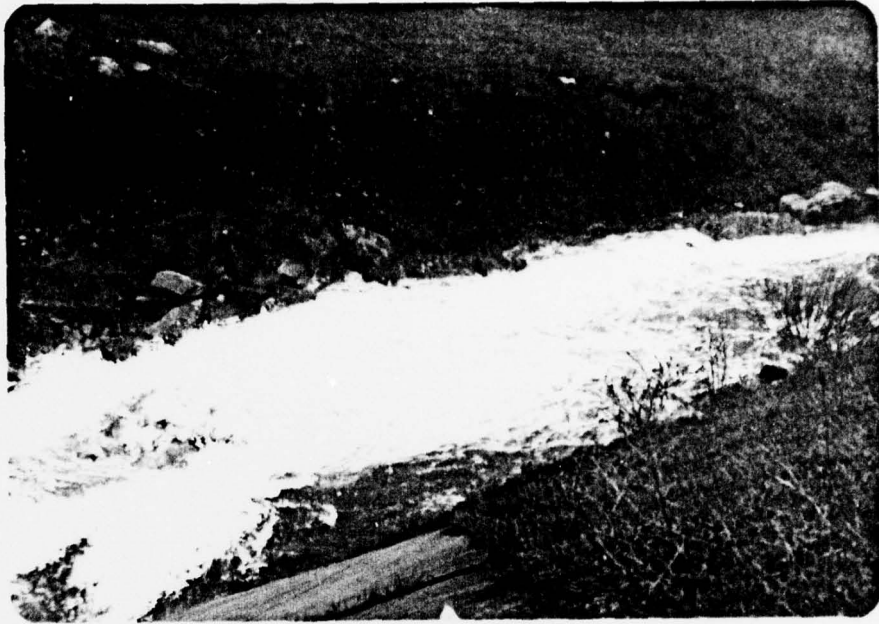
Photograph No. 5  
Erosion in primary spillway discharge channel.

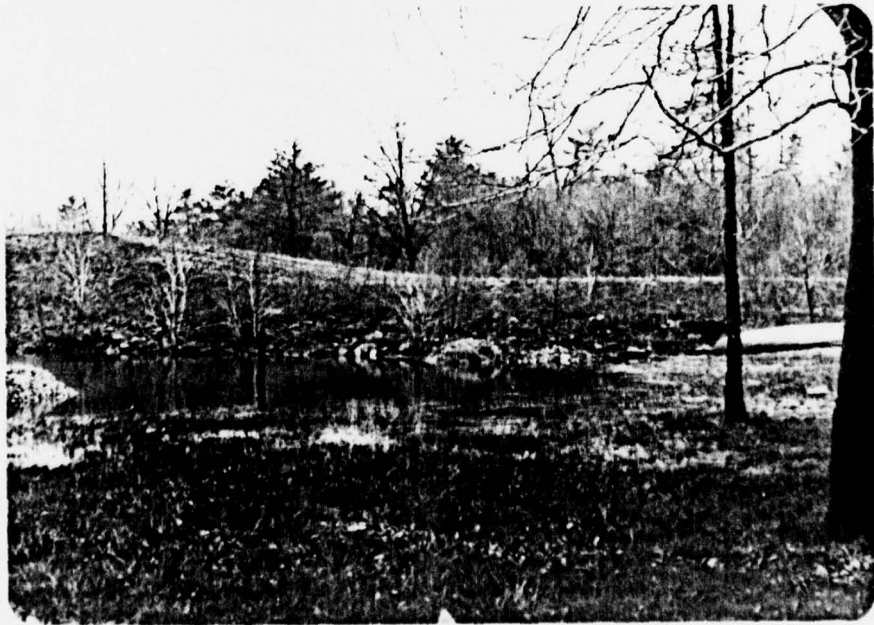
3.2 Evaluation. In general, the condition of the dam is considered to be fair. The most significant condition at the dam is the lack of erosion protection in the emergency spillway channel. This condition is considered to be a threat to the integrity of the embankment in the event of flow over this spillway.

Photograph No. 6  
Emergency spillway crest at right abutment.

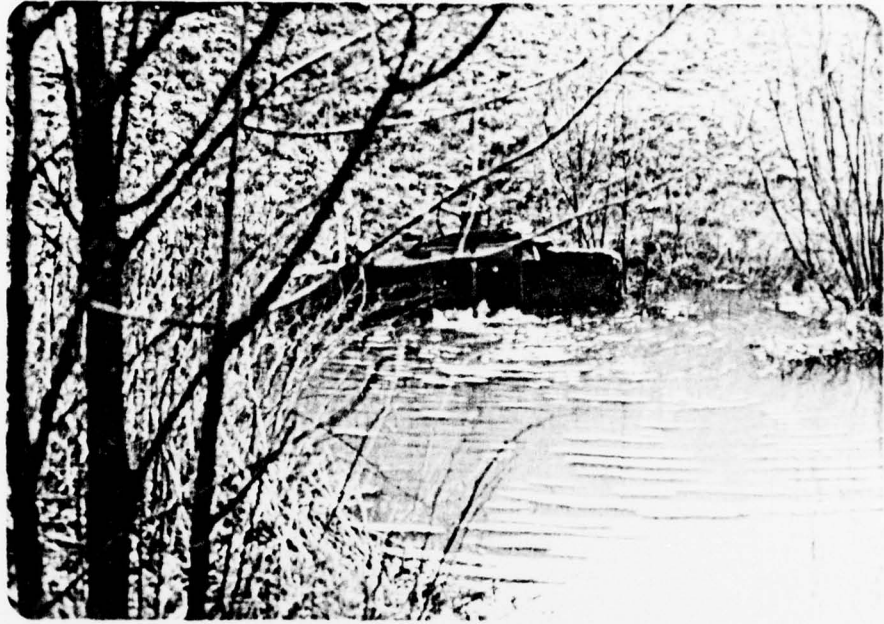
4.3 Maintenance of Operating Facilities. The only operational feature of the dam is the drainpipe gate. On the date of inspection it was operated and found to be functional. However, significant leakage was observed between the gate and gate guide, indicating that the sluice gate is not adequately seated.

Photograph No. 7  
Blow-off pipe valve (opened for inspection).

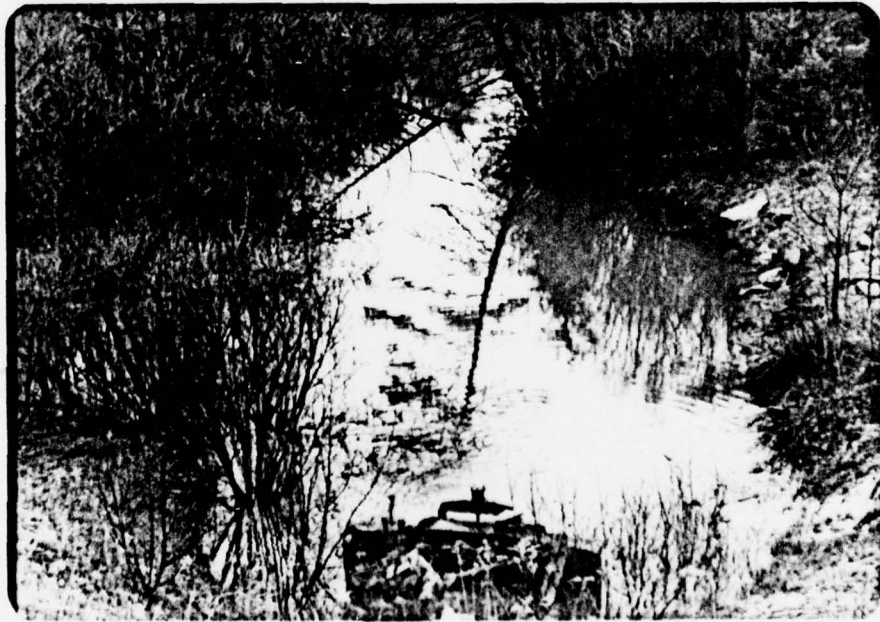
Photograph No. 8  
Blow-off pipe discharge channel.

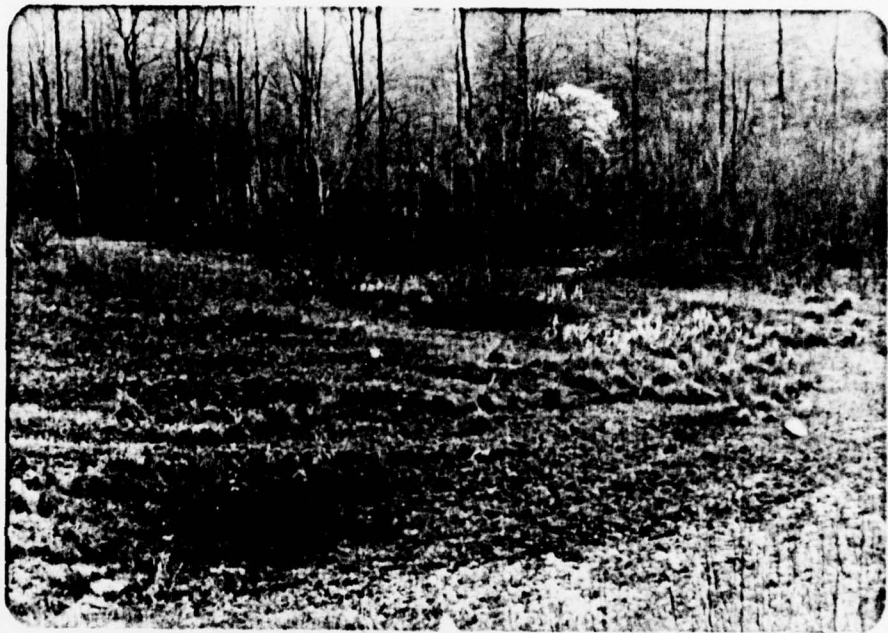
1. Numerous swampy areas were observed below the toe of the dam. No perceivable seepage flow was associated with these wet areas.
2. One concentrated seepage point was found on the slope of the primary discharge channel. Flow was estimated to be two to three gallons per minute.
3. It was observed that the emergency spillway was not built according to the plans. It lacks erosion protection and has no defined discharge channel.
4. The upstream face of the dam was covered with brush and trees five to eight feet high and one to two inches in diameter.

Photograph No. 9  
Wet areas below toe.

6. The dam and appurtenant structures should be inspected regularly and any unusual conditions should be reported to the appropriate authorities. During these inspections, special attention should be directed to the wet areas below the toe of the dam to assure that major seepages through these areas are not developing.
