**OHIO RIVER BASIN
SOUTH FORK LITTLE CONEMAUGH, CAMBRIA COUNTY**

LLOYDELL DAM

(ID NO. PA. 500)

**PHASE I INSPECTION REPORT
NATIONAL DAM INSPECTION PROGRAM**

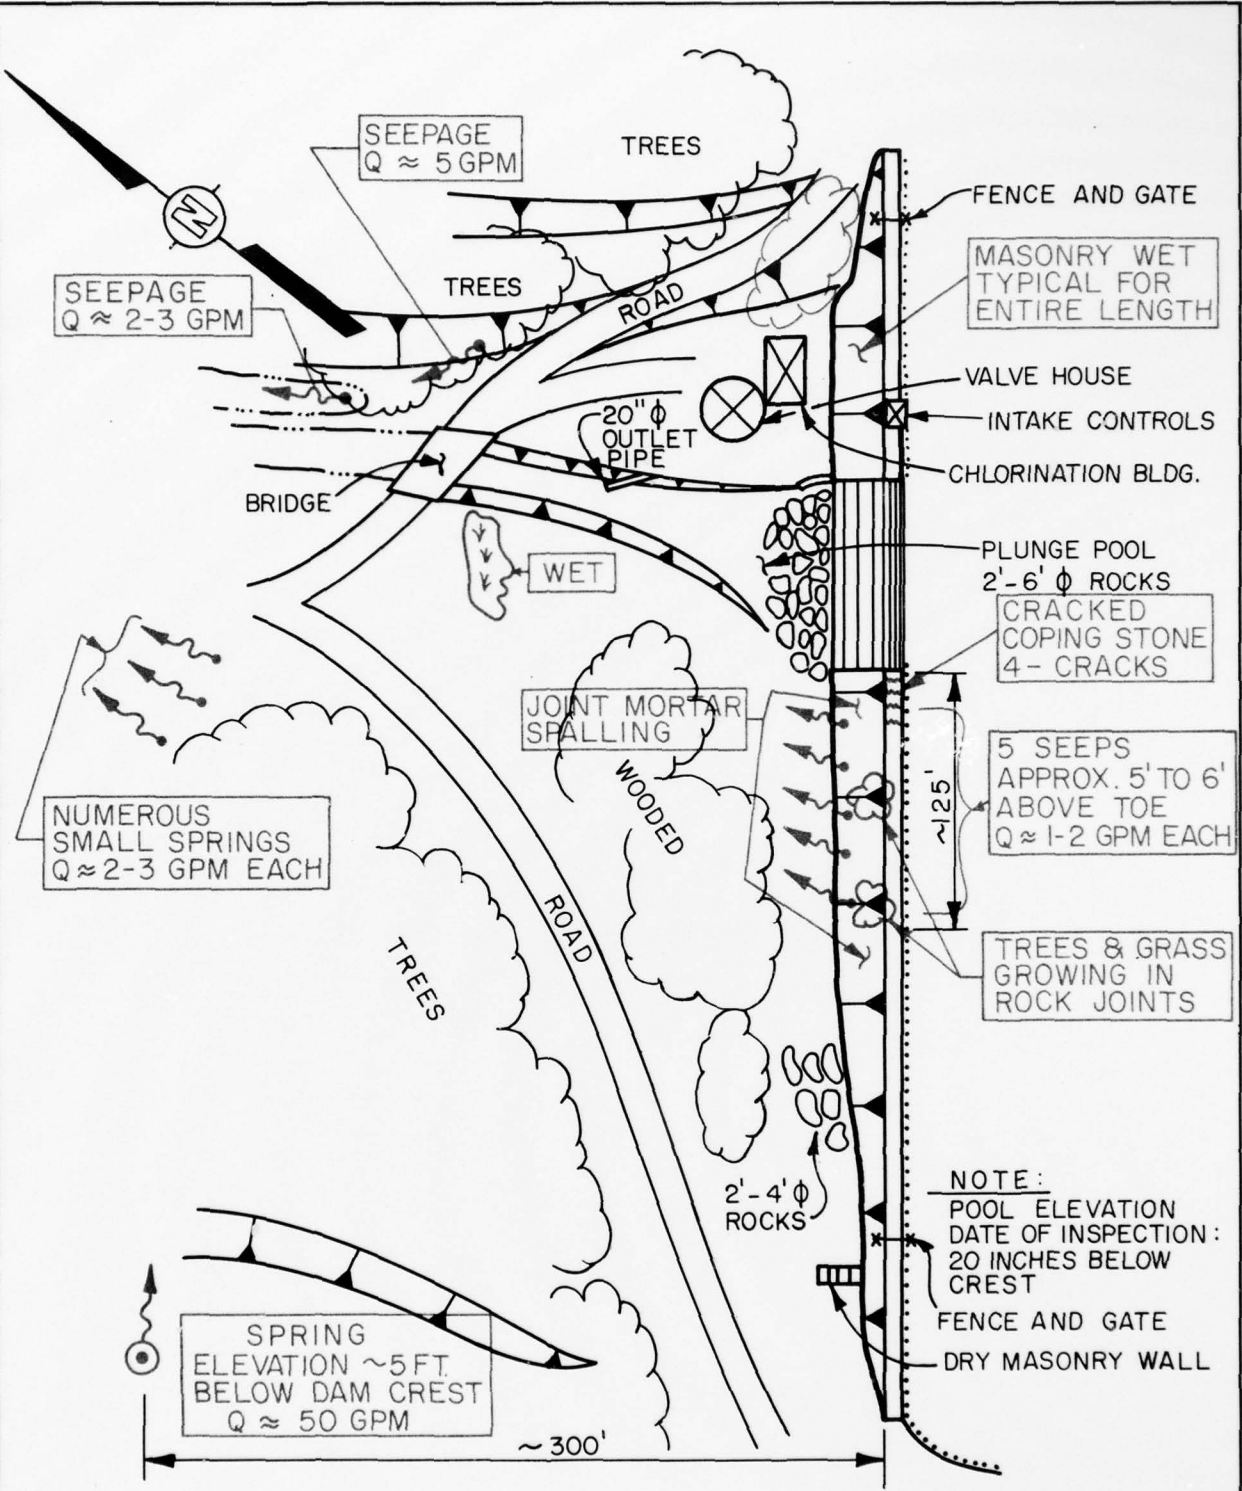
NOTE:
 POOL ELEVATION
 DATE OF INSPECTION:
 20 INCHES BELOW
 CREST

VISUAL EXAMINATION OF	OBSERVATIONS	REMARKS OR RECOMMENDATIONS
ANY NOTICEABLE SEEPAGE	5 CONCENTRATED SEEPS OVER ~125 FT LEFT OF SKILLWAY @ 2 IN. GAP/EACH	SEE PLATE 4
STRUCTURE TO ABUTMENT/EMBANKMENT JUNCTIONS	NO VISUAL SIGNS OF DISTRESS. NO SEEPAGE	
DRAINS	NONE FOUND	
WATER PASSAGES	NONE	
FOUNDATION	NO PERCEIVABLE SIGN OF DISTRESS.

VISUAL EXAMINATION OF	OBSERVATIONS	REMARKS OR RECOMMENDATIONS
SURFACE CRACKS CONCRETE SURFACES	A- CRACKS ON THE CREST CAPPING STONE (LEFT OF SPILLWAY)	SEE PLATE 4 FOR LOCATION.
STRUCTURAL CRACKING	NONE FOUND	
VERTICAL AND HORIZONTAL ALIGNMENT	NO PERCEIVABLE MISALIGNMENT.	
MONOLITH JOINTS	MASONRY DAM ∴ N/A.	
CONSTRUCTION JOINTS STAFF GAGE OF RECORDER:	(NO CONSTRUCTION JOINTS) NONE FOUND.

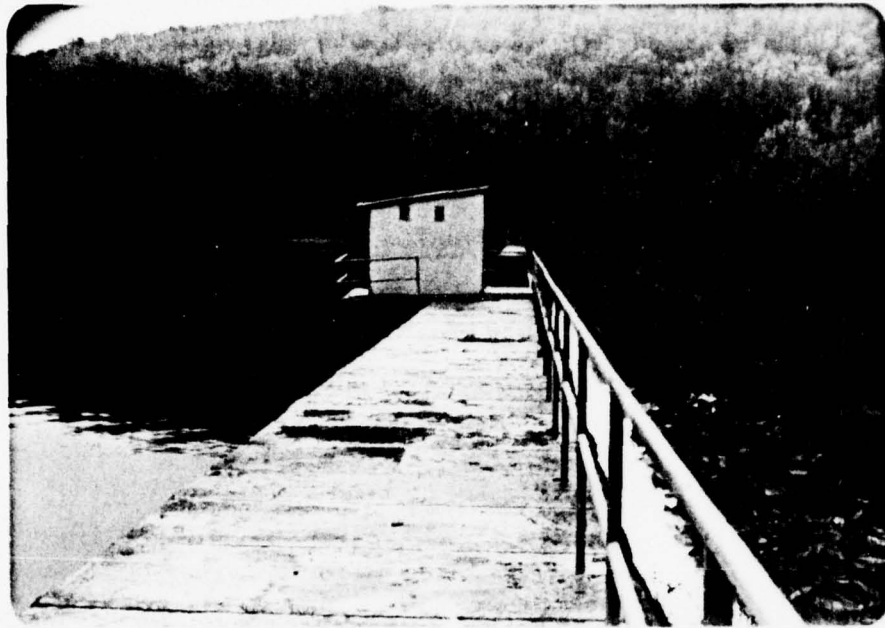
Photograph No. 1
Dam crest.

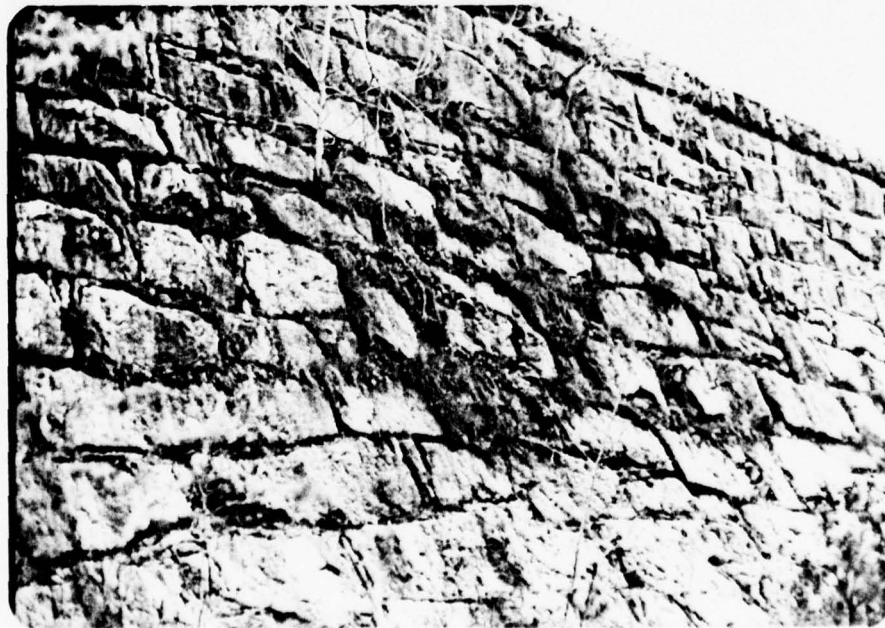
1. The entire downstream face of the dam was found to be wet. Approximately five concentrated seeps were observed through the dam over a distance of approximately 125 feet on the left of the spillway. The discharge from the seeps was estimated to be in the range of 2 to 5 gallons per minute (gpm).
2. Over a distance of approximately 100 feet on the left side of the spillway, the joint mortar on the facing stones was found to be spalled and grass and small trees were growing on the joints.
3. Four coping stones adjacent to the left side of the spillway were cracked and appeared to be loose.

Photograph No. 2
Downstream slope.

1. Since the dam may overtop during unusually high runoff, it is recommended that during such periods the owner should provide around-the-clock surveillance for early detection of problems, such as erosion of the abutments. It is also recommended the owner should take necessary measures to improve the accessibility of the site during high flow conditions.
2. It is recommended that as soon as practicable appropriate repairs be undertaken to correct the joint mortar spalling and seepage condition on the face of the dam. Also, trees and brush should be removed from the face of the dam.
3. It is recommended that brush and trees in the toe area should be cleared over a distance of approximately 50 feet from the toe to permit adequate future inspection of the toe area.

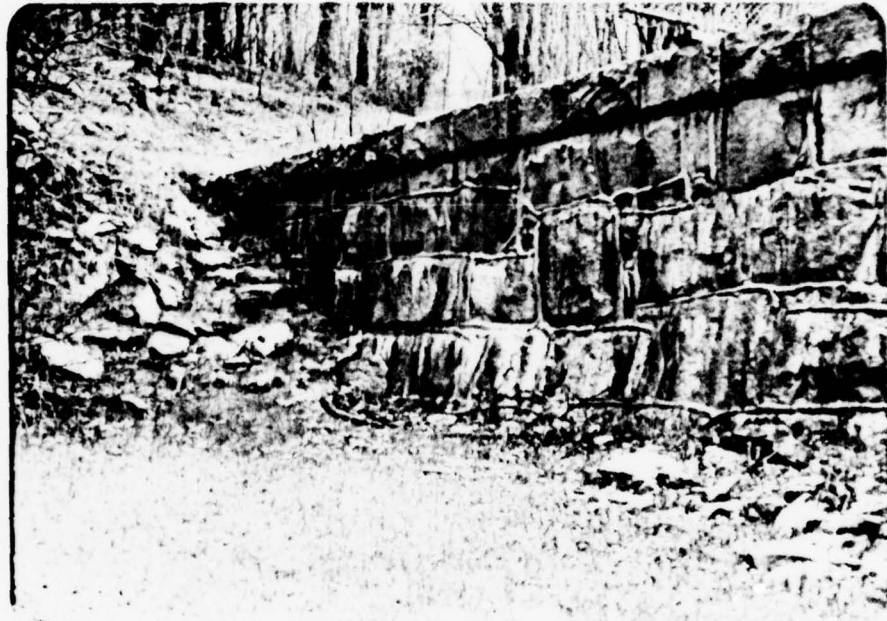
Photograph No. 3
Right abutment.

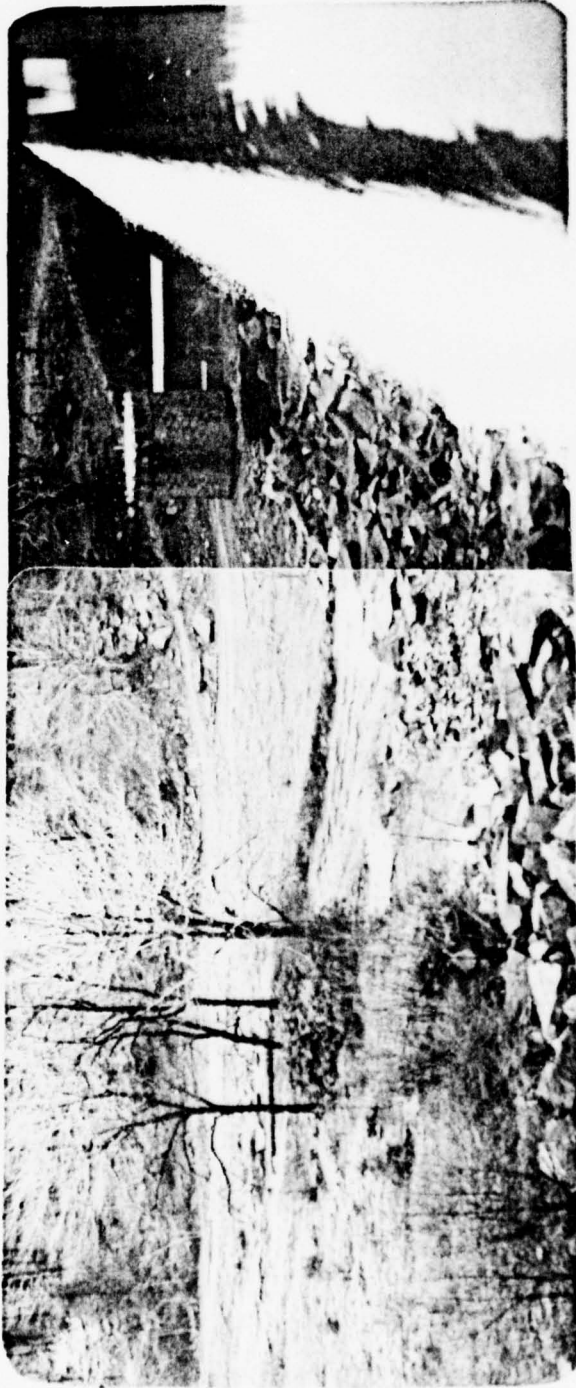
c. Appurtenant Structures. The spillway crests and plunge pools were examined for deterioration or other signs of distress and obstructions that would limit flow. No signs of apparent distress or erosion were observed.

Photograph No. 4
Spillway, plunge pool, and spillway discharge channel.

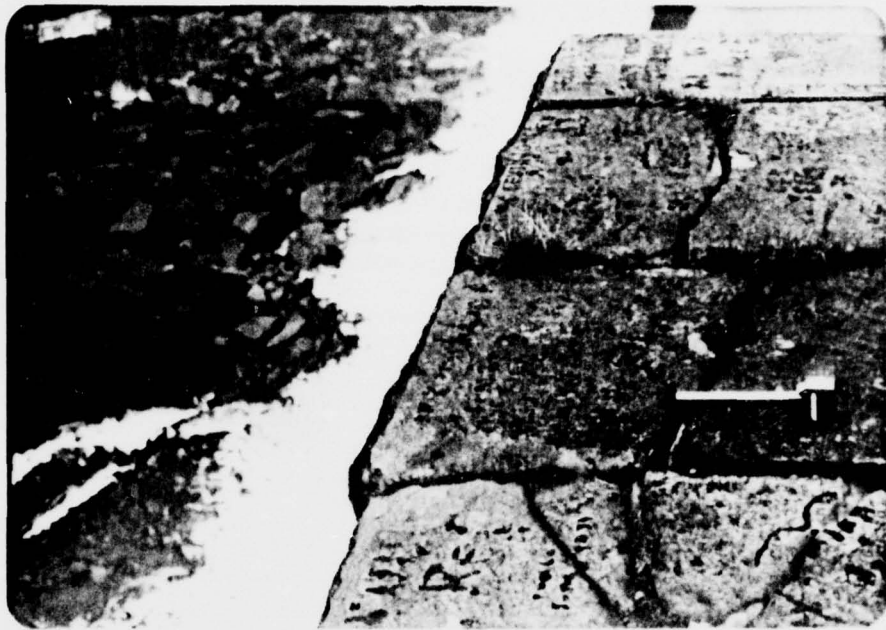
Photograph No. 5
Cracks in capping stone (left of spillway).

3.2 Evaluation. In general, the condition of the dam is considered to be good. However, repairs to the stone facing joints would be required to avoid further damage due to frost action. Clearing of brush from the face and toe area of the dam is also required to permit adequate continued inspection of the toe area.

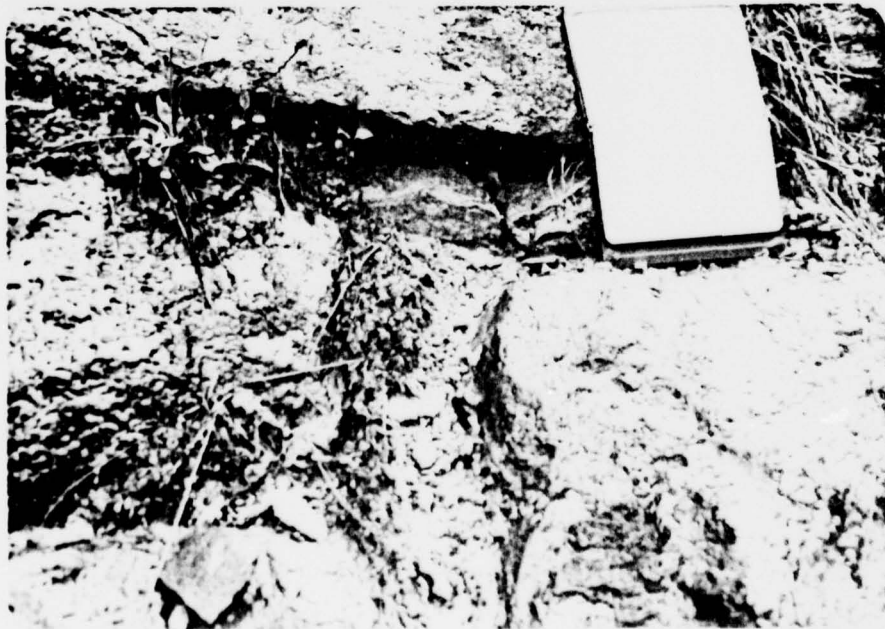
Photograph No. 6
Seepage through joints on downstream slope.

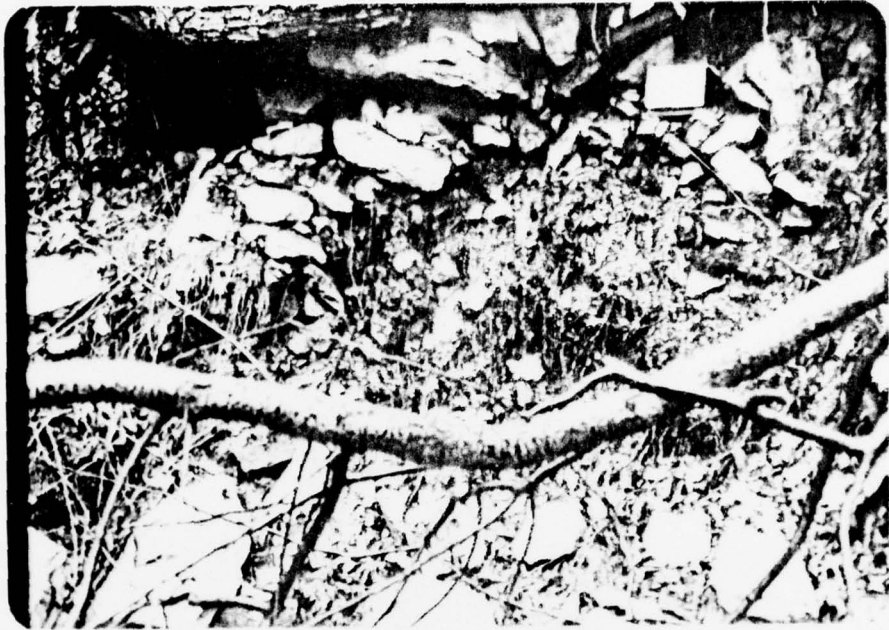
4. A major spring discharging approximately 50 gpm was found on the left abutment approximately 300 feet downstream from the dam at an elevation approximately 3 feet below the dam crest.
5. One concentrated seepage point was found on the right abutment. It was located approximately at the toe level and 100 feet downstream from the dam. The flow was estimated to be 5 to 10 gpm.
6. Numerous grout holes were observed on the crest of the dam. The appearance of the grout material suggests that the grouting was done at various times in the past.

Photograph No. 7
Seepage at right abutment.

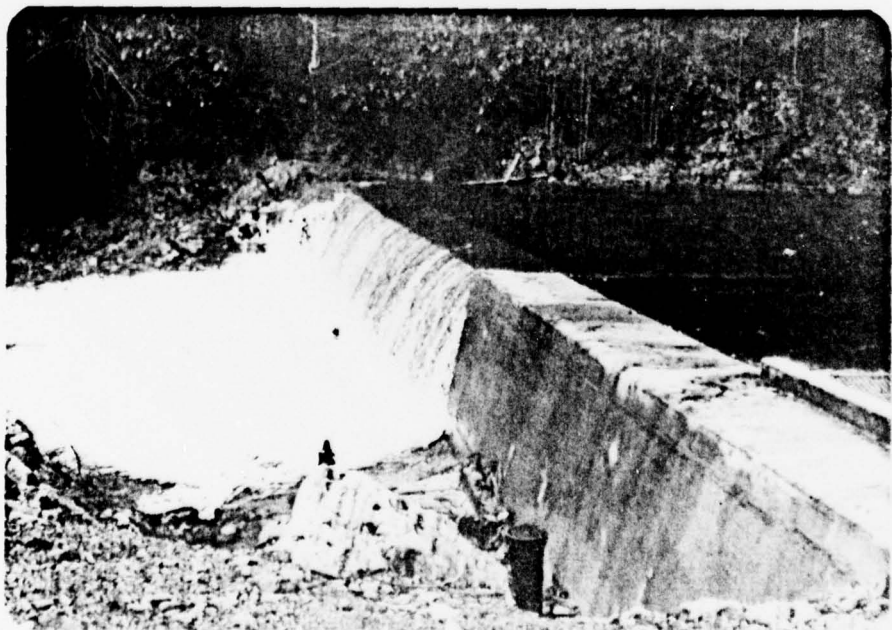
Photograph No. 8
Distribution pond located 2 miles downstream.

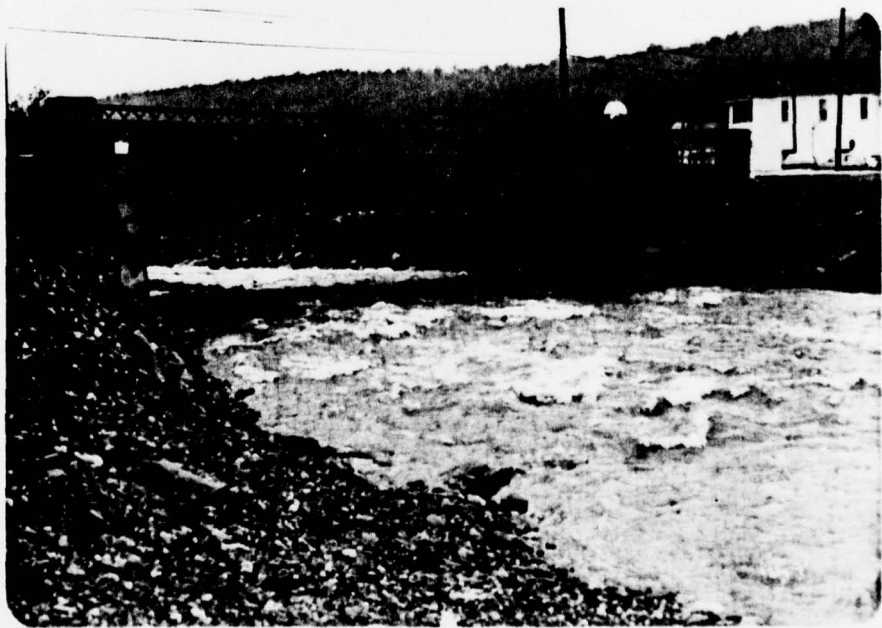
Photograph No. 10
Bridge No. 2.
