OPOSSUM LAKE DAM

INVENTORY NUMBER NDS 584

PHASE I INSPECTION REPORT

Name of Dam: OPOSSUM LAKE DAM
 State Located: PENNSYLVANIA
 County Located: CUMBERLAND COUNTY
 Stream: OPOSSUM CREEK
 Date of Inspection: APRIL 5, 1978

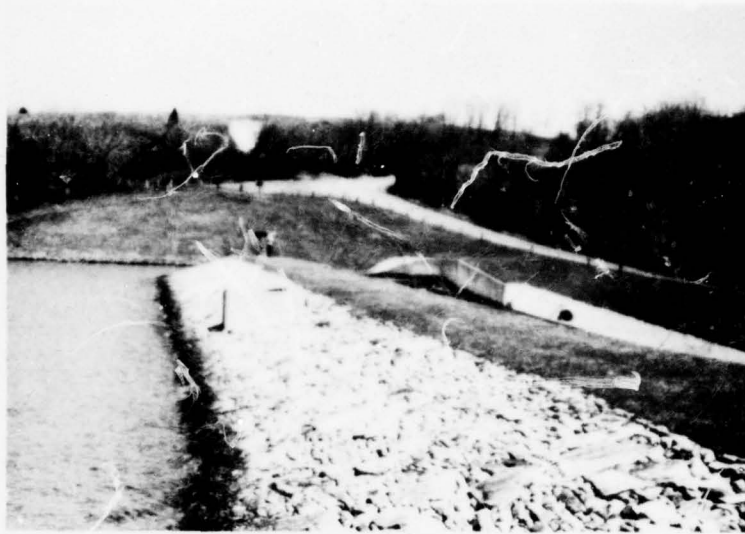
On the left abutment some of the hand laid riprap has been disturbed and should be repaired. This was caused by vandalism, rather than structural distress.

Upstream
Embankment

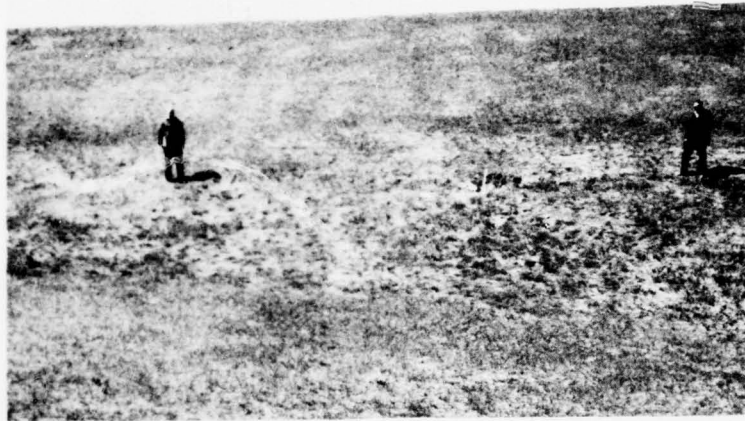
The inspection of the downstream slope revealed a seepage condition beginning approximately thirty feet horizontally from the toe of the embankment (Appendix D, Plate VII and VIII). This condition is accompanied with what appears to be sloughing. Discussions with a representative of the owner, in charge of maintenance and repairs explained that the disturbance on the slope surface was due to measures taken during the summer of 1976, when a subsurface drainage system was installed to control an apparent annually increasing seepage from this portion of the slope. As near as can be determined, the remedial action involved trenching near the toe of the slope and parallel to the dam axis over a distance of about 150 feet. This area crosses over the outlet pipe. Several lateral trenches, perpendicular to the main trench, were cut into the slope. A four inch perforated plastic pipe and stone backfill were placed in the trench and covered with topsoil. The lateral trenches appear to be coincidental with the observed sloughing areas. The primary drain was carried to the outlet channel and day-lighted just below the outlet works end wall. The measures taken are not entirely satisfactory as water still seeps from the toe of the embankment, even though the pipe discharging to the outlet channel is continuously flowing. (No measurement of flow made at this time).

Seepage Area

1. The owner should maintain a continuous surveillance of the dam until the dam has been rehabilitated to correct the serious seepage condition.

2. The quantity in gallons per minute of seepage exiting from the drainpipes should be measured and recorded daily and the turbidity of the water should be observed and recorded. If the seepage quantity increases by fifty percent from the initial readings or if the seepage is found to be cloudy, murky or containing fines; or if scarps or cracks develop on the embankment slope, the reservoir should be drawn down until the seepage stops.

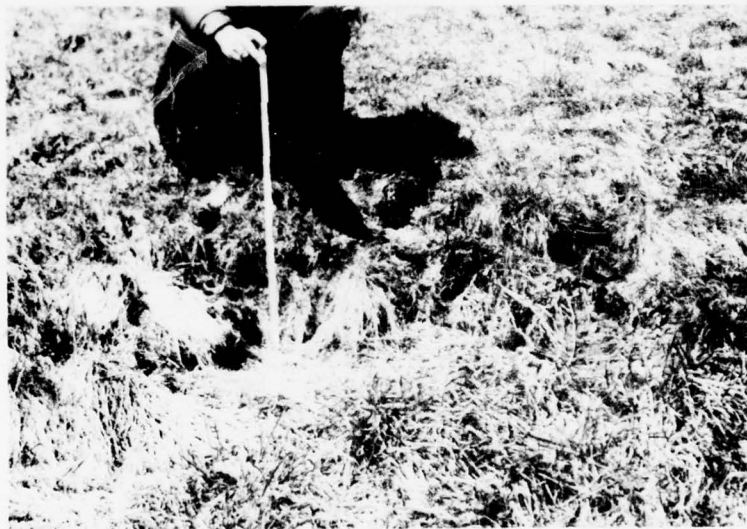
Of great concern was the noticeable seepage on the embankment slope over a considerable length and the wet areas in the filled-in area. The sloughage on the embankment was caused by the construction of the drain in 1976. The trench was filled with No.2 crushed stone and a perforated pipe. No graded filter was installed and the effectiveness of the drain has been reduced on the right side of the conduit and on the left side of the conduit the foundation drain is completely ineffective.

Some sloughage areas are in evidence on downstream slope, accompanied by some seepage. Discussions with Owner's representative indicated that a drain system was constructed on the downstream during the summer of 1976, to relieve an apparent increasing seepage problem in this area. There had been some seepage observed since 1965.

"Sloughage" and
Settlement due
to installation
of Drain

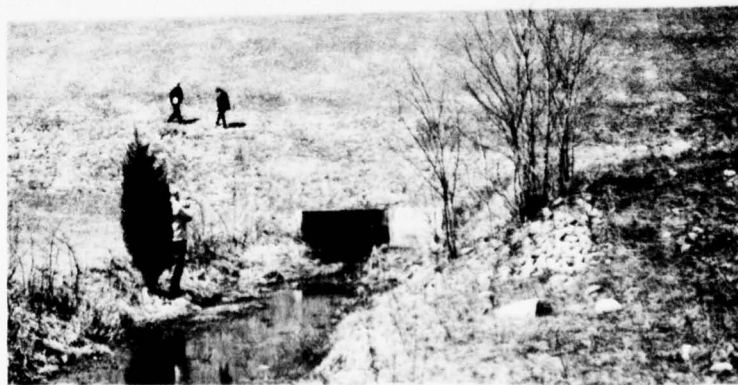
OUTLET WORKS	OBSERVATIONS	REMARKS & RECOMMENDATIONS
A. INTAKE STRUCTURE	Concrete tower in embankment with stop logs.	
B. OUTLET STRUCTURE	Seepage from embankment adjacent to outlet wing (right side) looking upstream	
C. OUTLET CHANNEL	Satisfactory - grassed, no large trees	
D. GATES	None - stop log control	
E. EMERGENCY GATE	None	
F. OPERATION & CONTROL	Removal of stop logs for fish management (up to 8' removed)	
G. BRIDGE (ACCESS)	None

Outlet Structure

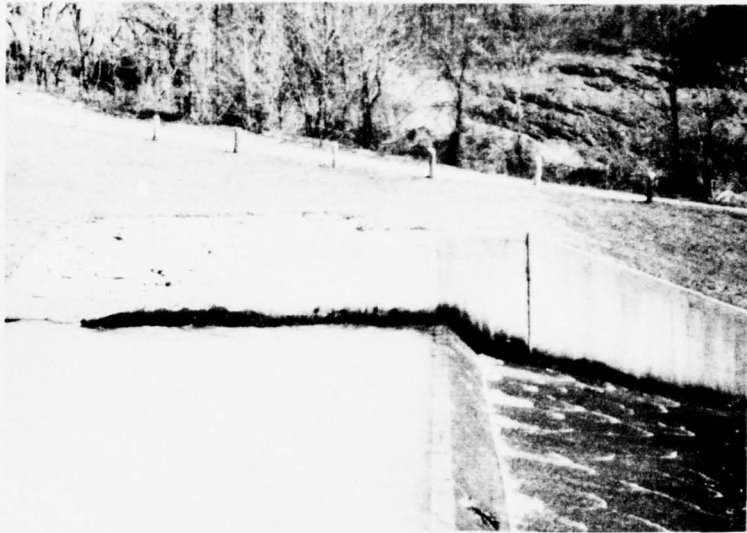
The spillway weir and chute are in good repair with the exception of considerable erosion of the left bank, just downstream from the end of the concrete retaining wall. The stilling pool is clean and appears to be performing its function in a satisfactory manner.

Spillway

The other aspects of the dam seem to be adequate. Under normal conditions the embankment is stable and the spillway capacity is more than sufficient for a 100-year discharge occurrence and will pass a maximum of 33 percent of PMF. Further erosion at the end of the stilling basin should be prevented.

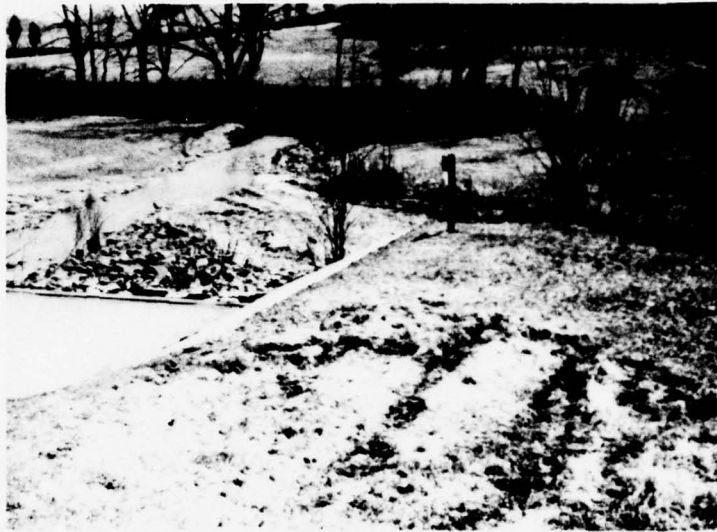
Downstream Channel
and Wet Area
