Name Of Dam: HUNGRY MOTHER STATE PARK DAM

Location: SMYTH COUNTY, VIRGINIA

Inventory Number: VA 17309

# PHASE I INSPECTION REPORT NATIONAL DAM SAFETY PROGRAM

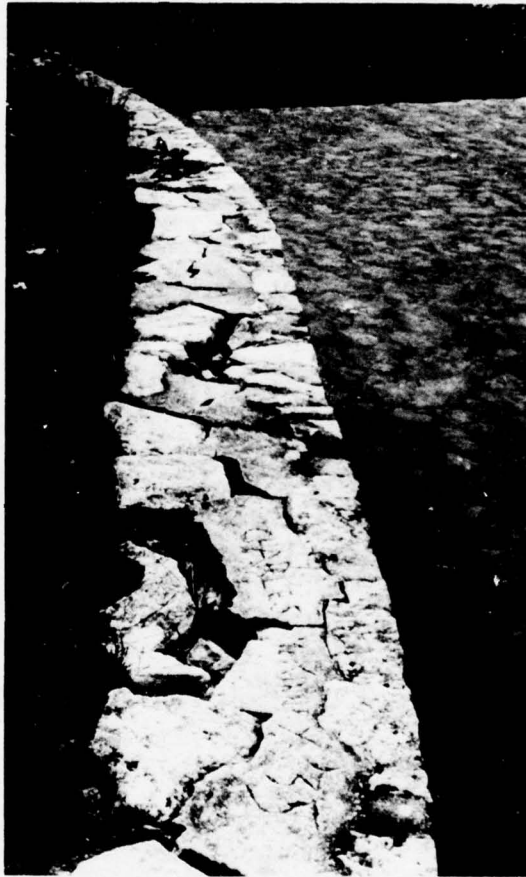
The spillway channel retaining walls consist of hand-placed field stone, laid in a concrete mortar base. The south retaining wall has begun to deteriorate such that the top stones have come loose. The walls appeared to be in good condition near the base.

TOP OF SOUTH WALL OF SPILLWAY SHOWING  
DETERIORATED ROCK SURFACE

4.5 Evaluation: Although the maintenance program has kept up the appearance of the dam, it has not kept up with some of the deteriorating conditions which should be attended to. Specifically, the spillway retaining walls are in need of repair, the one gate valve in the gate tower should be repaired, the downstream side slopes immediately after the spillway should be dressed to protect against erosion, and the riprap should be cleared of brush and then reinforced.

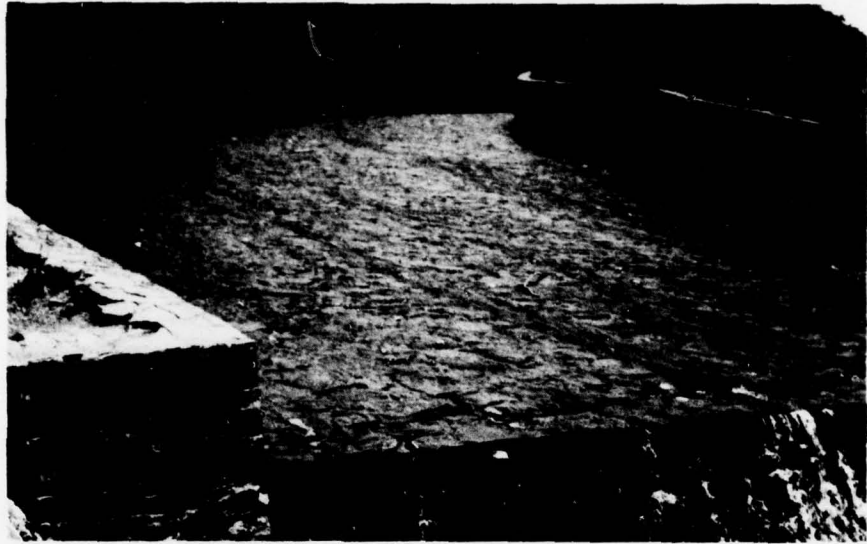
VIEW FROM BOTTOM OF SPILLWAY CHUTE
