Name Of Dam: FALLS MILLS DAM

Inventory Number: VA 18503

PHASE I INSPECTION REPORT NATIONAL DAM SAFETY PROGRAM

AUGUST, 1978

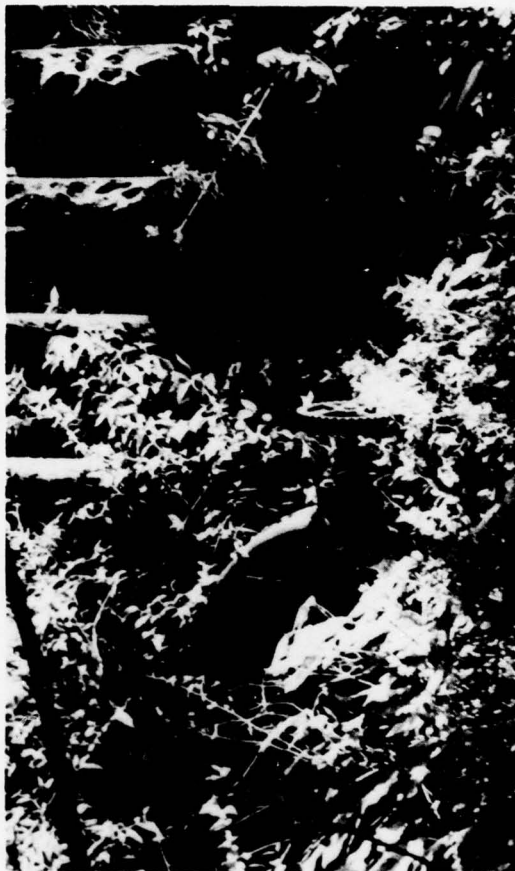
7.1.3 The drain valves did not appear to be operable and therefore cannot be used to lower the reservoir elevation below the spillway crest during emergency conditions.

DETAIL OF DISCHARGE VALVE

7.2.3 It is recommended that at least one of the drain valves be made operable within the next year. It is suggested that because of the depth of sediment, the southerly drain valve may be more effective in lowering the water level at the right abutment.

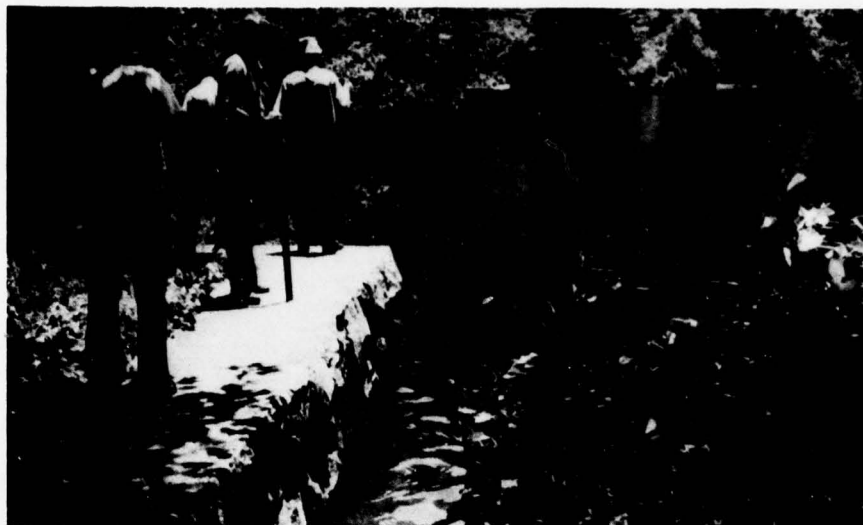
VIEW FROM LEFT ABUTMENT

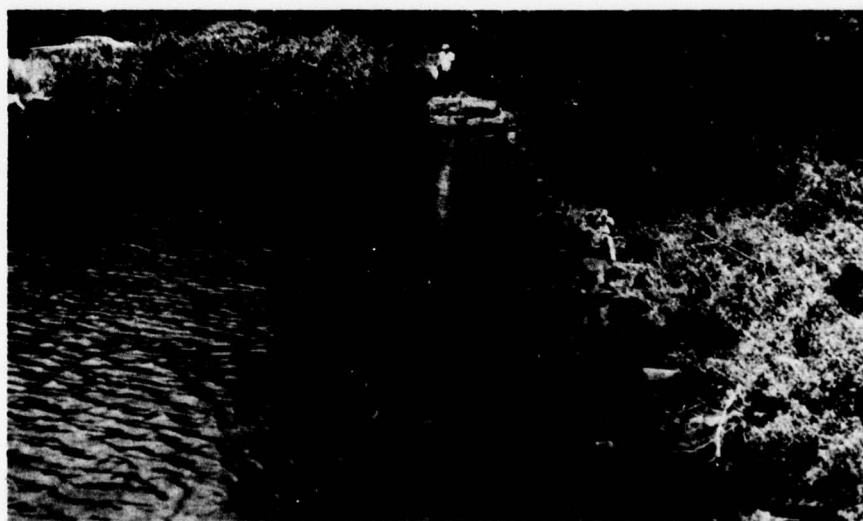
VIEW FROM RIGHT ABUTMENT
NOTE: TOP WIDTH OF DAM
