Name Of Dam: UPPER NORTON RESERVOIR DAM

Location: WISE COUNTY, VIRGINIA

Inventory Number: VA 19508

PHASE I INSPECTION REPORT NATIONAL DAM SAFETY PROGRAM

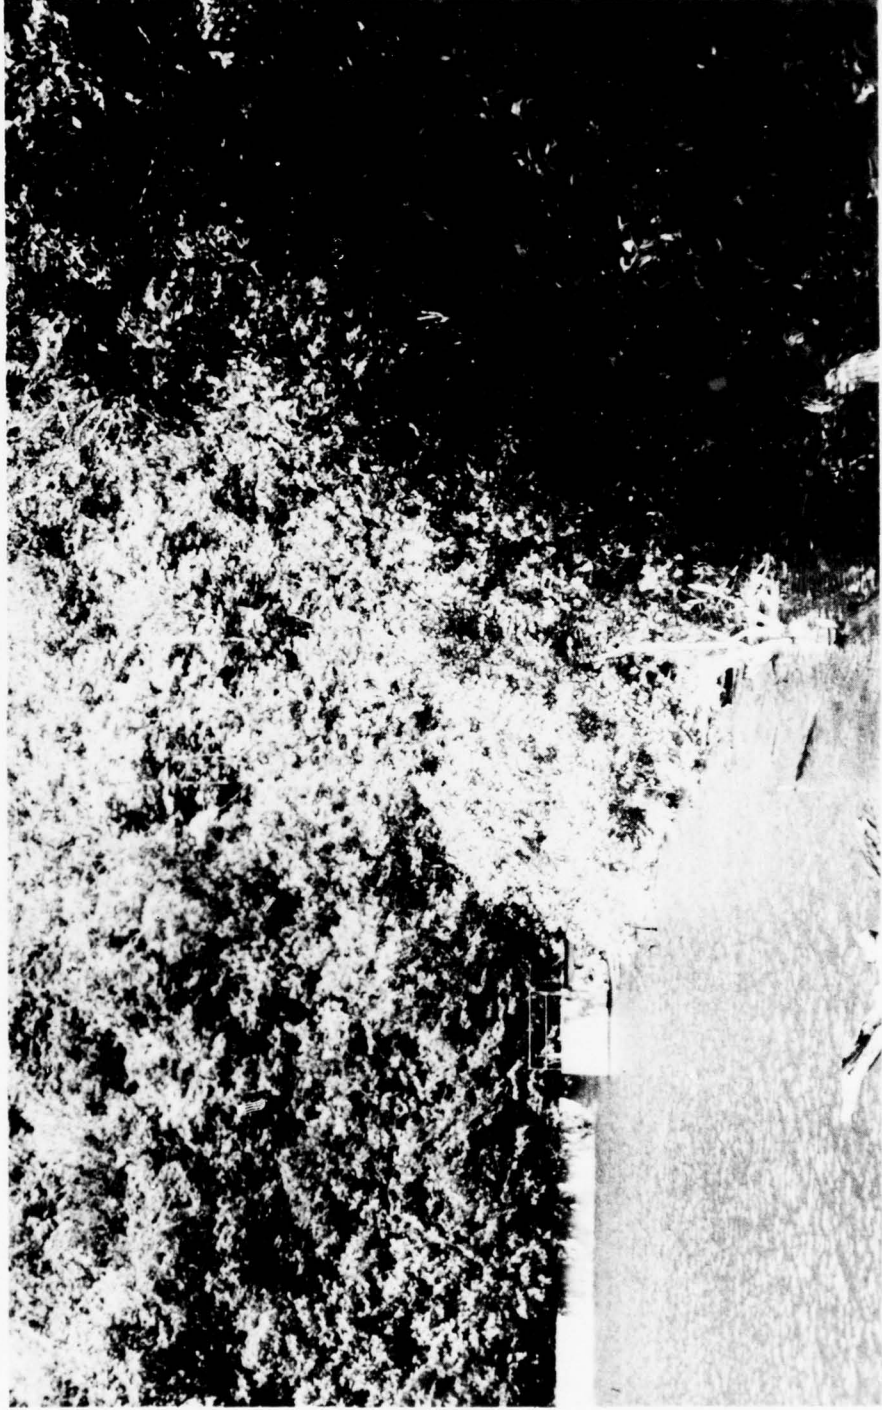
OVERALL VIEW OF UPPER NORTON RESERVOIR DAM

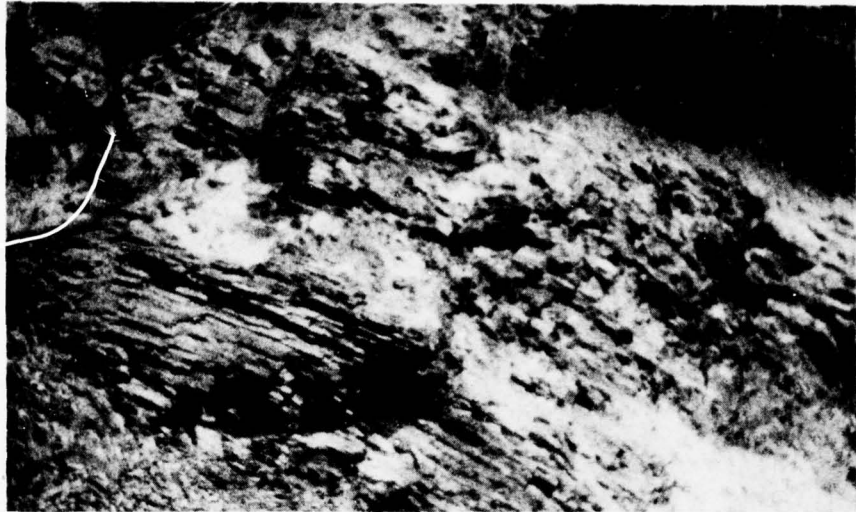
3.1.3 Reservoir Area: The reservoir shoreline was densely wooded and no major active landslide areas could be seen. However, a small shallow slide (see photos - Appendix II) was observed on the west shoreline about 400 feet from the spillway weir. The width of the slide area was approximately 25 feet, and its depth 3 to 4 feet. The length of the slide was approximately 60 feet upwards from the waterline, with the bank sloping approximately 2.5 horizontal to 1.0 vertical. The exposed material at the top of the slide area was visually identified as weathered soft shale comprised predominantly of silt with little clay. The clay fraction appears to be lean. The slide appeared to have occurred recently. This was confirmed by the City Manager who reported the slide occurred in 1977. Similar material was observed exposed along the west shore near the overflow weir. The shoreline slopes on the east side were relatively flatter and stable.

CLOSE-UP AT TOP OF SLIDE. NOTE: EXPOSED LAYERS OF
WEATHERED SOFT SHALE

7.2.2 The owner should obtain all existing computations for stability of the slopes adjacent to the spillway of this dam within 30 days of receipt of this Report. The potential for blockage of the spillway inlet by fallen and floating trees as well as slope failures should be investigated commencing within 30 days.

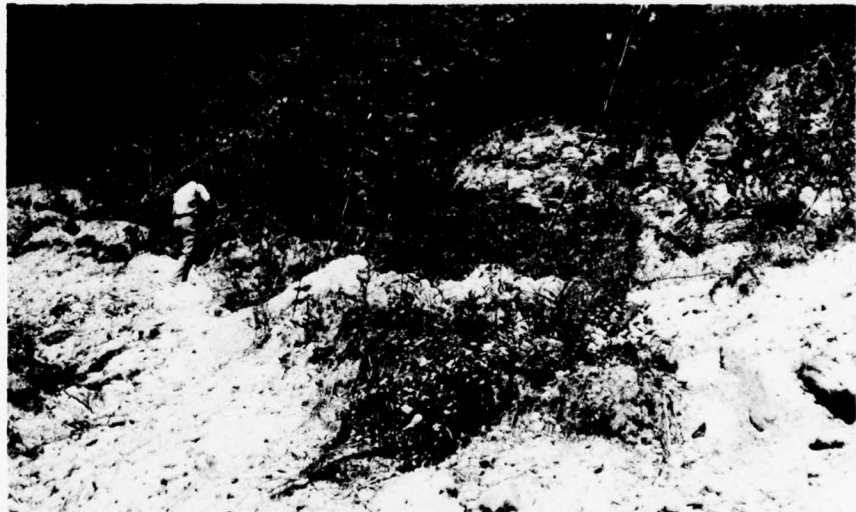
VIEW OF TOP AREA OF SLIDE

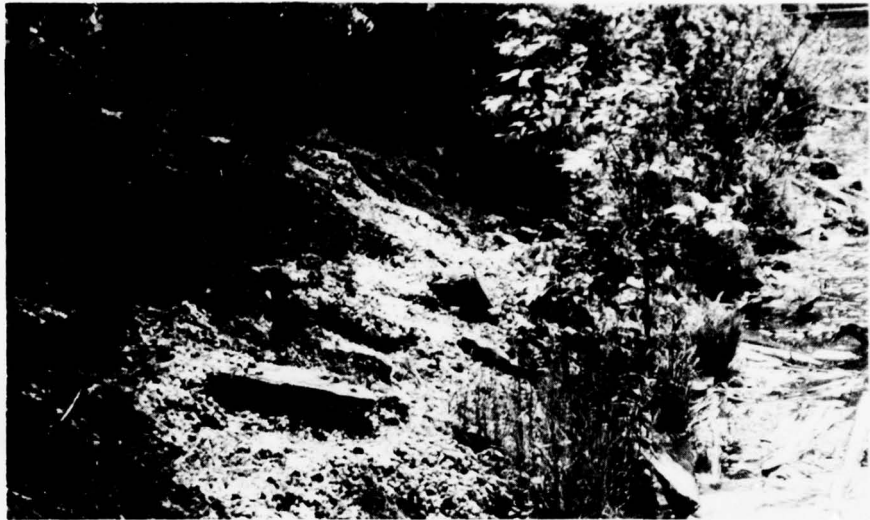
GROUTED RIPRAP ON UPSTREAM FACE OF LEFT ABUTMENT

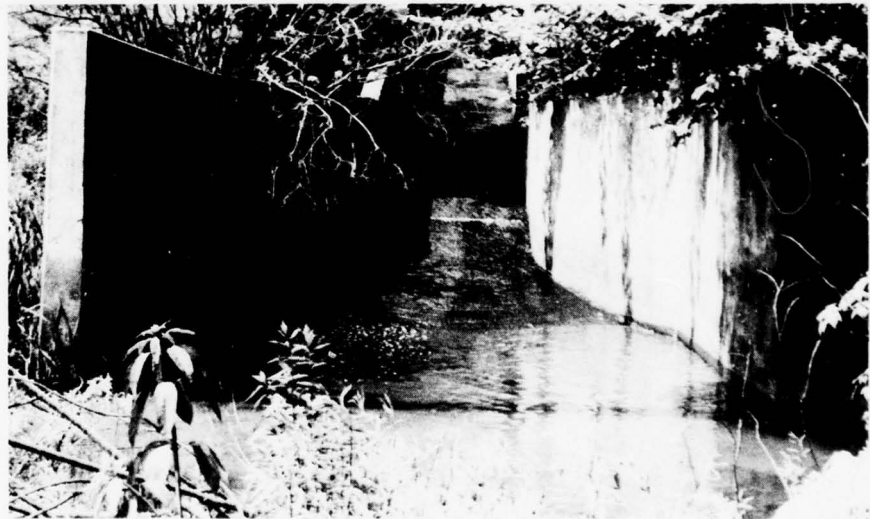
SPILLWAY OUTLET - LOOKING UPSTREAM

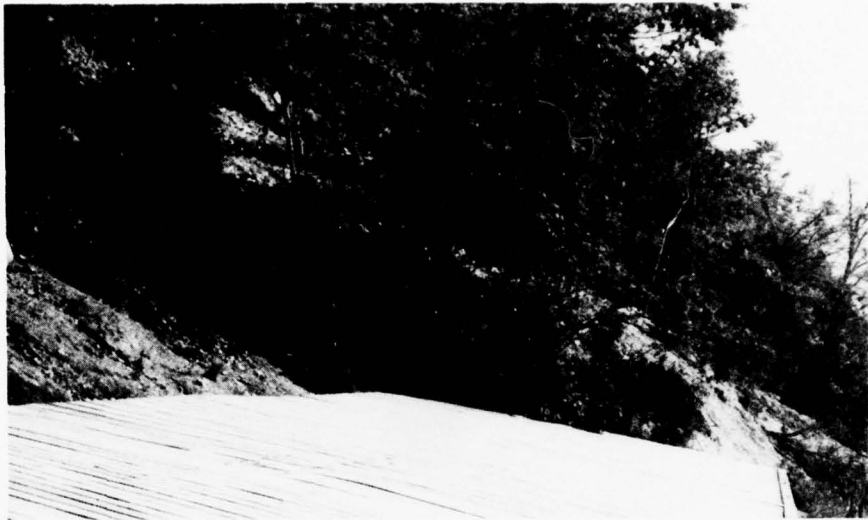
7.1.1 A minor slope failure had occurred on the reservoir shoreline within several hundred feet of the principal spillway.

RESERVOIR SHORE LINE SLOPE FAILURE

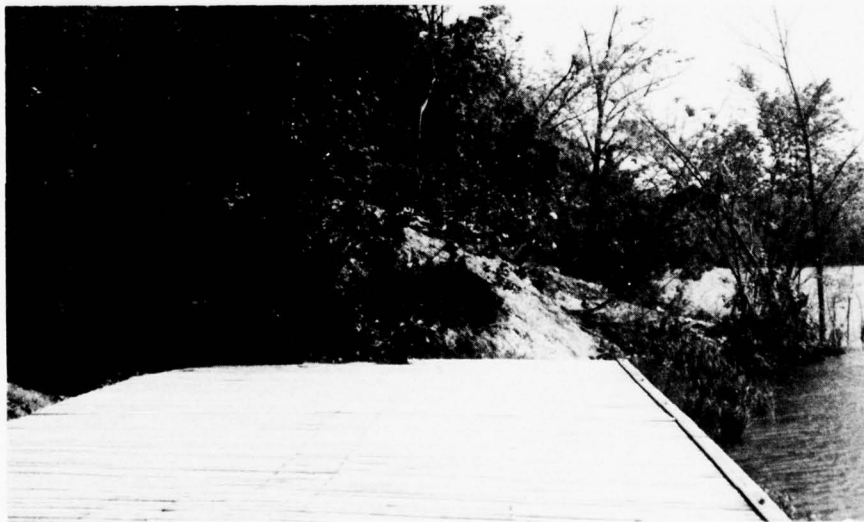
SLOPE FAILURE AREA NEAR BOATING DECK -
NOTE EXPOSED MATERIAL

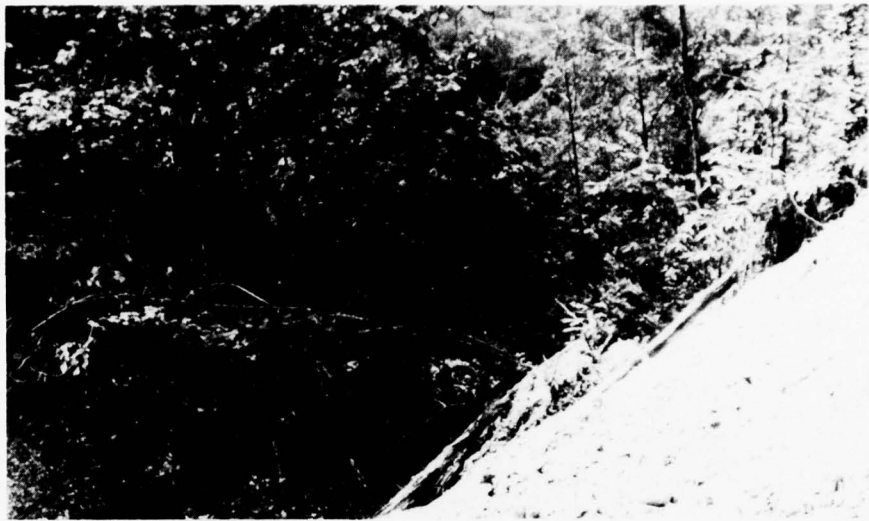
RESERVOIR SHORELINE SLOPE FAILURE - NOTE BENT TREES

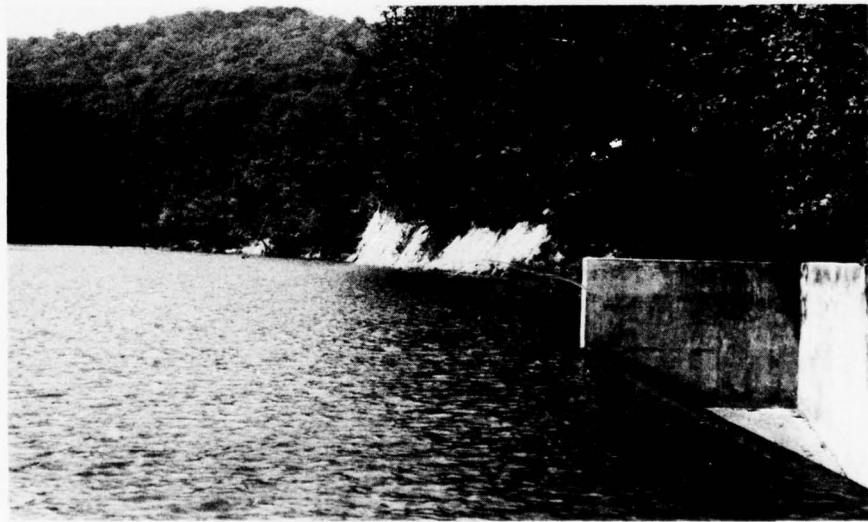
EXPOSED SLOPES AND OVERFLOW WEIR,
NOTE SLOPE FAILURE AREA IN BACKGROUND

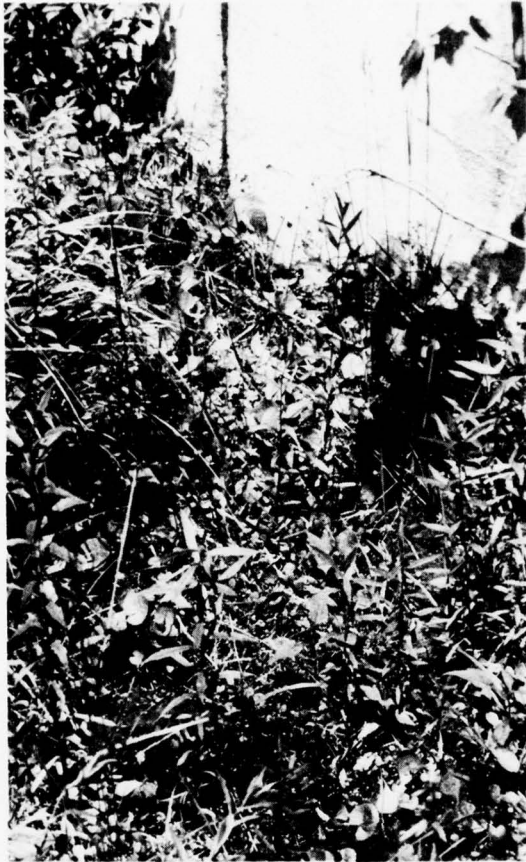
NOTE LEAKAGE FROM SPILLWAY AREA

7.2.4 The source of the seepage at the spillway-embankment junction and the erodibility of the contact zones should be investigated with a monitoring program within 90 days. It is further recommended that the owner obtain all existing computations regarding design and allowable seepage through the dam within 60 days of receipt of this Report.

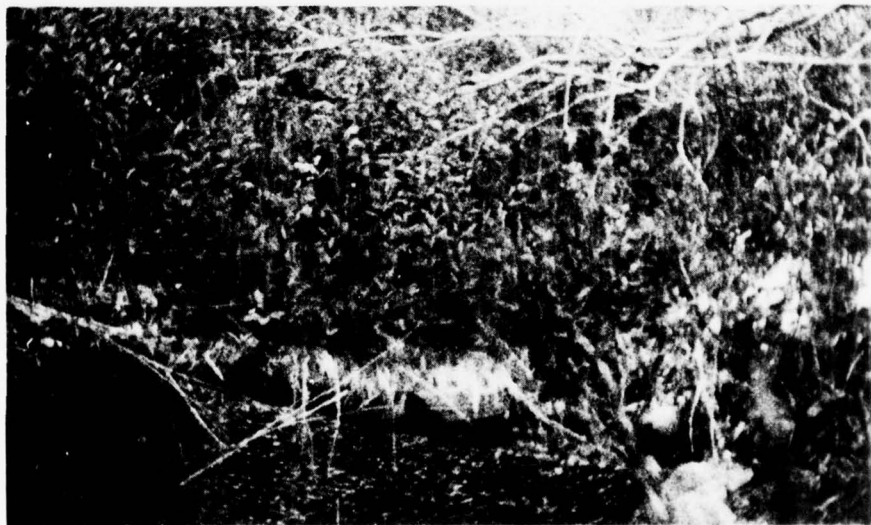
NOTE LEAKAGE FROM SPILLWAY BASE

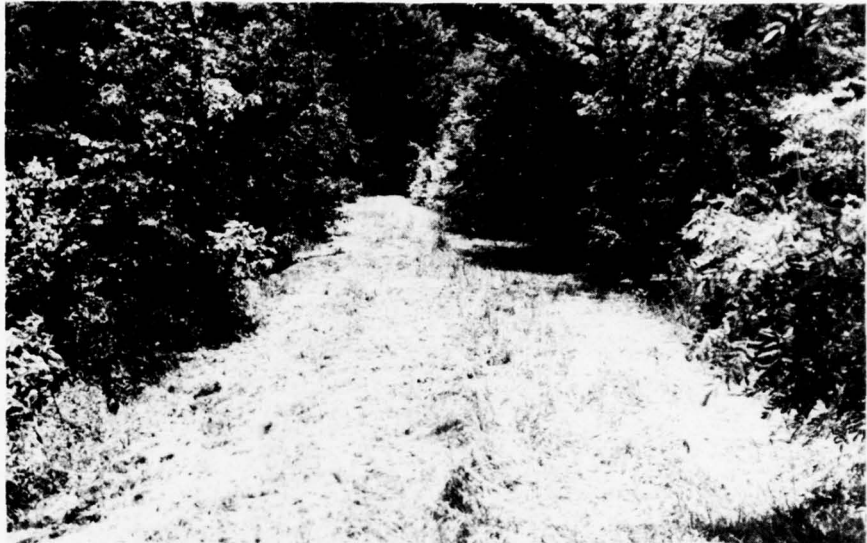
3.1.2.1 Dam: Significant portions of both the upstream and downstream slopes were covered with a dense tree growth. Many trees were 30 to 40 feet tall with trunk diameters up to 9 inches. No areas of significant settlement were observed. Several small erosion gullies up to 6 inches deep were observed near the downstream toe; the gullies were vegetated except for a few bare spots. The surficial embankment soil was brown, silty, fine sand with a trace to little clay. The visible upstream riprap was generally slab shaped siltstone and/or sandstone rock 2 to 4 inches thick, and varying in width and length from 2 inches up to 3 feet. Much of the riprap was covered with vegetation and there was some minor dislocation of stones as shown in the photographs. A portion of the riprap adjacent to the spillway was covered with cement grout. The slopes and dam crest were generally uniform and in agreement with the slopes and dimensions shown on the design drawings.

TOP OF DAM LOOKING TOWARD RIGHT ABUTMENT.
NOTE: TREES GROWTH ON BOTH UP AND DOWNSTREAM FACES OF DAM

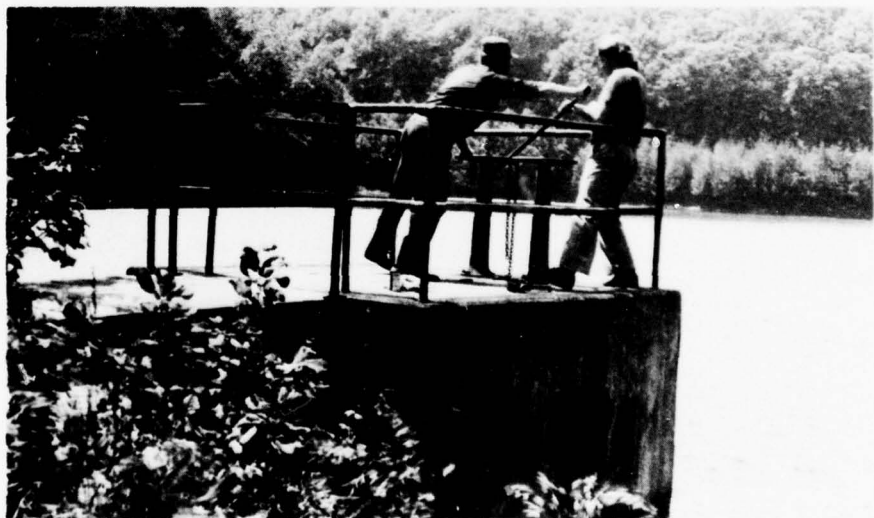
OPERATORS FOR THE VALVES - NOTE RIGHT
SIDE VALVE BEING OPERATED
