Name Of Dam: KEOKEE DAM
Location: LEE COUNTY, VIRGINIA
Inventory Number: VA 10502

PHASE I INSPECTION REPORT NATIONAL DAM SAFETY PROGRAM

PREPARED FOR
NORFOLK DISTRICT CORPS OF ENGINEERS
803 FRONT STREET
NORFOLK, VIRGINIA 23510

BY
GILBERT ASSOCIATES, INC.

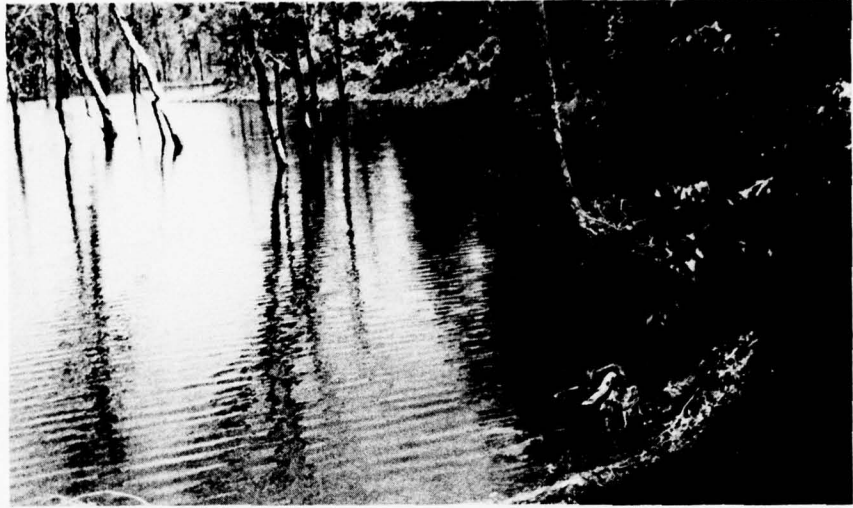
RESERVOIR SHORELINE AT LEFT:
NOTE DEAD TREES IN WATER

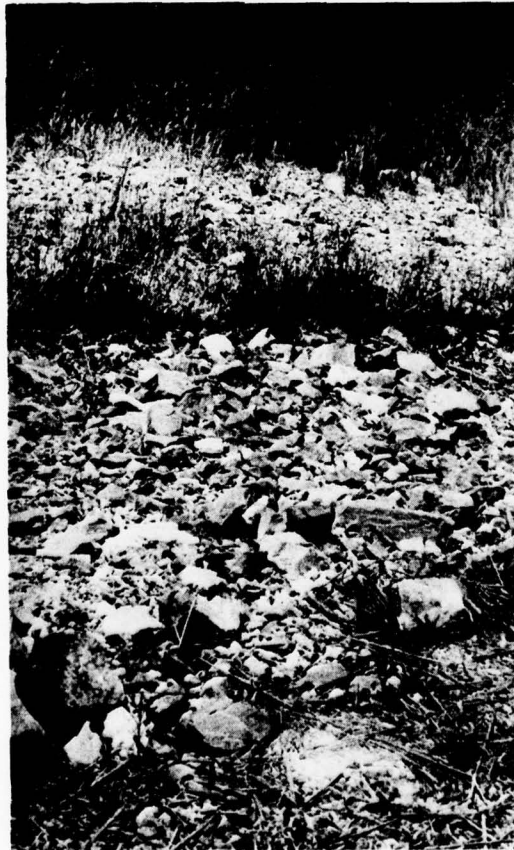
RIPRAP ON UPSTREAM SLOPE
OF DAM

d. If bank erosion is noted due to the low water level over an extended period of time, riprap should be considered for the shoreline at the dam.

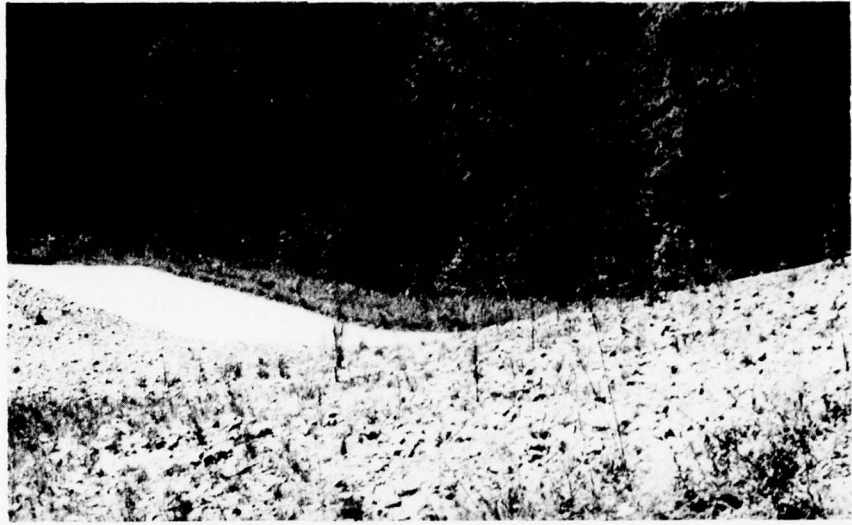
a. There is excessive tree growth immediately downstream of the emergency spillway which could contribute to reducing the flow capacity significantly under certain conditions.

EMERGENCY SPILLWAY
NOTE: DENSE TREE GROWTH BLOCKING ITS DISCHARGE CHANNEL

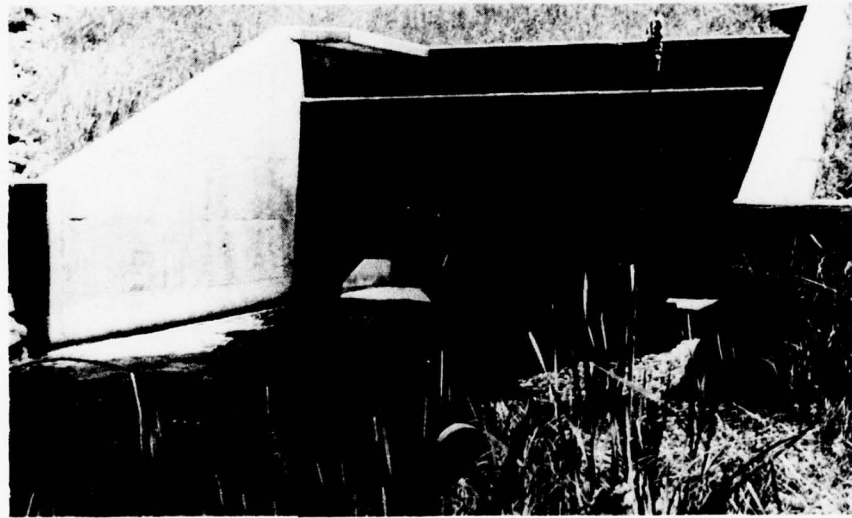
IMPACT STILLING BASIN AND SEINE BOX

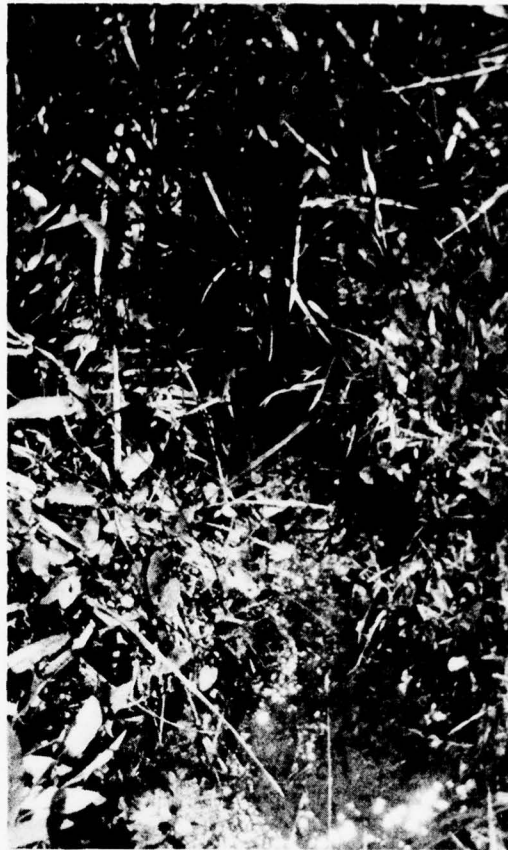
c. There is an area of leakage at the left abutment which has not been repaired, although the owner has lowered the reservoir, temporarily stopping the leak. He has a plan for sealing a portion of the reservoir with bentonitic clay where he believes the leak to be originating based on a dye test (See Appendix VI-B). The leakage could be detrimental to the safety of the dam if allowed to continue. An eroded area caused by this seepage exists on the downstream valley wall.

CLOSE-UP OF THE LEAK AREA AT
LEFT ABUTMENT

c. The owner should successfully complete his attempt at sealing the reservoir to stop or reduce the downstream left abutment seepage soon. In any event, the leakage should be permanently stopped prior to raising the reservoir level.

f. Also, the leakage potential of the rock strata at shallow depths needs further verification. Very soon after repairs are made on the leakage area, the eroded downstream area should be repaired.

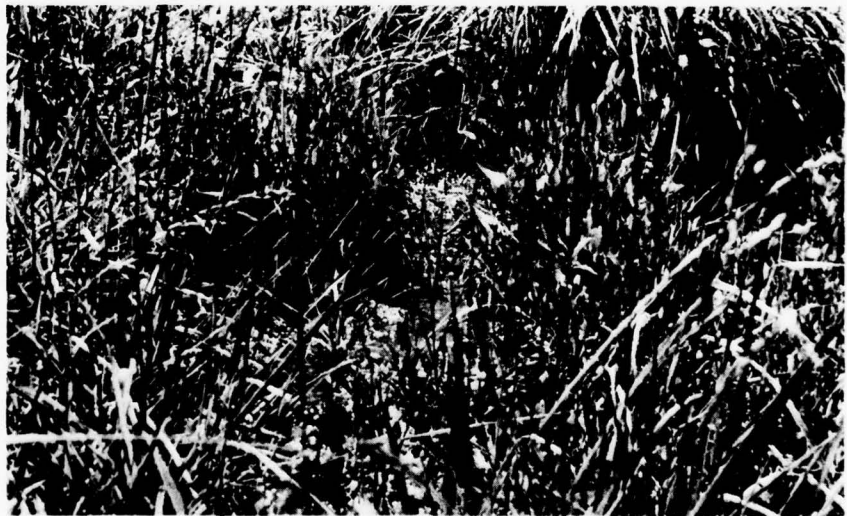
LEAK AREA AT LEFT ABUTMENT

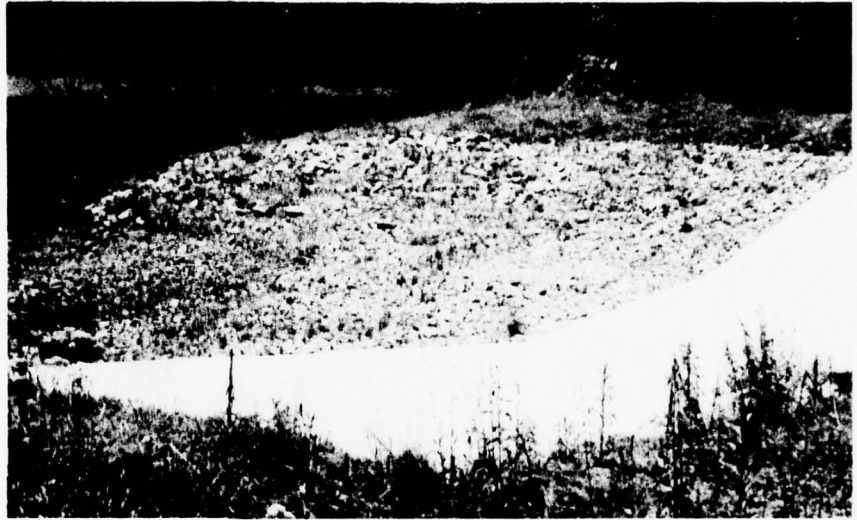
RESERVOIR SIDE OF EMERGENCY SPILLWAY
NOTE: RIPRAP, ALSO DEAD TREES IN WATER

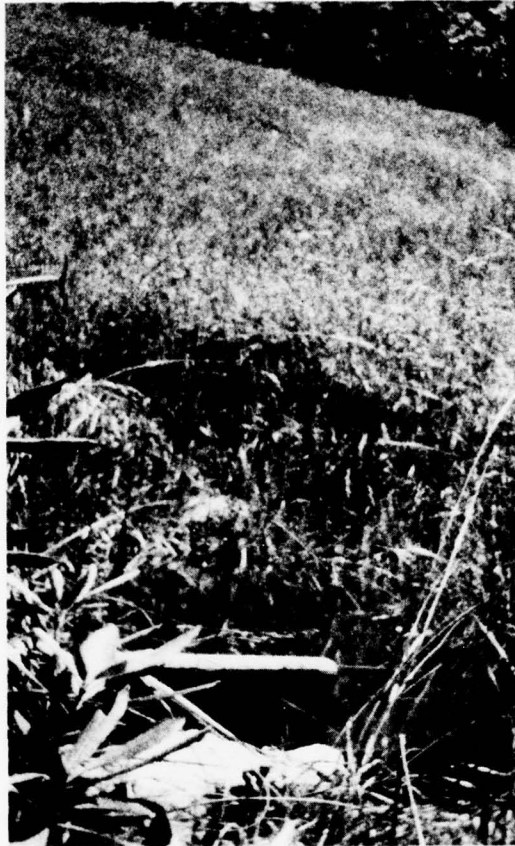
WOODEN MEASURING WEIR

VISUAL EXAMINATION OF	OBSERVATIONS	REMARKS OR RECOMMENDATIONS
MONUMENTATION/SURVEYS	None	
OBSERVATION WELLS	None	
WEIRS	A 2-foot long x 1-1/4-foot deep x 1-5/8-inch thick weir board was temporarily installed near the the downstream toe at the left side end to measure the flow quantity at the leakage area. Water was flowing from under the board also.	The flow at the bottom of the board should be stopped by plugging for correct assessment of the flow quantity.
PIEZOMETERS	None.	
OTHER	None.
