**Name Of Dam:** LOWER NORTH RIVER NO. 81C  
**Location:** ROCKINGHAM COUNTY, STATE OF VIRGINIA  
**Inventory Number:** VA 16506

# PHASE I INSPECTION REPORT

## NATIONAL DAM SAFETY PROGRAM

**BY**  
**MICHAEL BAKER, JR., INC.**  
**BEAVER, PENNSYLVANIA 15009**

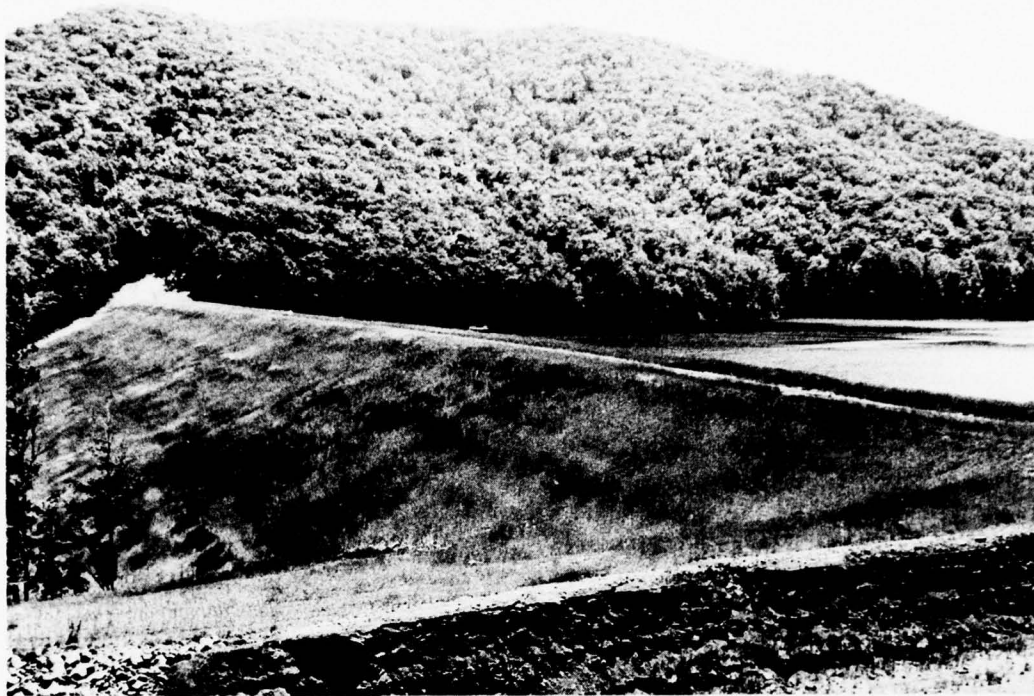
**PHOTO 1**

3.1.2 Dam: The embankment was in good physical condition except for small areas on the downstream face which have sparse topsoil and vegetation (see Photos 1 and 3) and tire tracks on the downstream bench which are holding water. These areas should be filled with topsoil and seeded.

- 7.2 Recommended Remedial Measures: In summary, it is recommended that reseeding and filling surface depressions on the downstream face be completed. The clear seepage should be inspected regularly for signs of increase or muddy discharge. The six inch hole located 30 feet from the downstream face should be filled with sand or silt and inspected during high water.

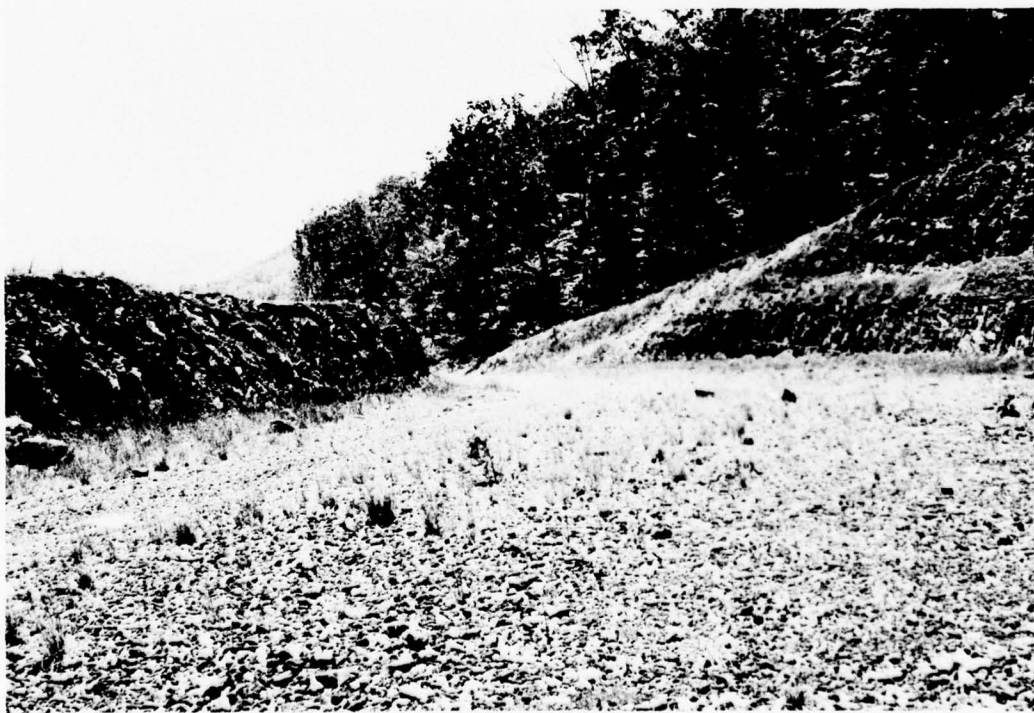
**PHOTO 2**

3.1.3 Appurtenant Structures: The inlet and outlet structures appeared to be in very good physical condition and functioning properly. The emergency spillway is also in good condition (see Photo 2).

VISUAL EXAMINATION OF		OBSERVATIONS	REMARKS OR RECOMMENDATIONS
CONCRETE WEIR		There are none.	
APPROACH CHANNEL		The approach channel to the emergency spillway is primarily rock-cut with some compacted fill with very little vegetation and on an adverse two percent slope. The bottom width is about 100 feet with 0.5:1 side slopes forming a trapezoidal shape. The bedrock consists of jointed hard sandstone and medium siltstone. See Photo 1.	
DISCHARGE CHANNEL		The discharge channel is cut in primarily sandstone and siltstone with trapazoidal shape 100 feet wide and on a positive two percent slope. The channel banks are ripped where bedrock is absent. The channel discharges along a small water course on the left abutment with an adjacent road (see Photo 1).	
BRIDGE AND PIERS		There are none.	
CUT SLOPES		Red and gray hard sandstone with some medium hard siltstone and thin soft clay shale seams were observed in the cut slopes. The bedding planes vary from a horizontal to 70 undulating dip. There are two sets of steep to vertical joint systems. The cut slopes on both sides were made at a 0.5:1 ratio and appear to be stable with minor amounts of small rock talus. See Photos 1 and 2.

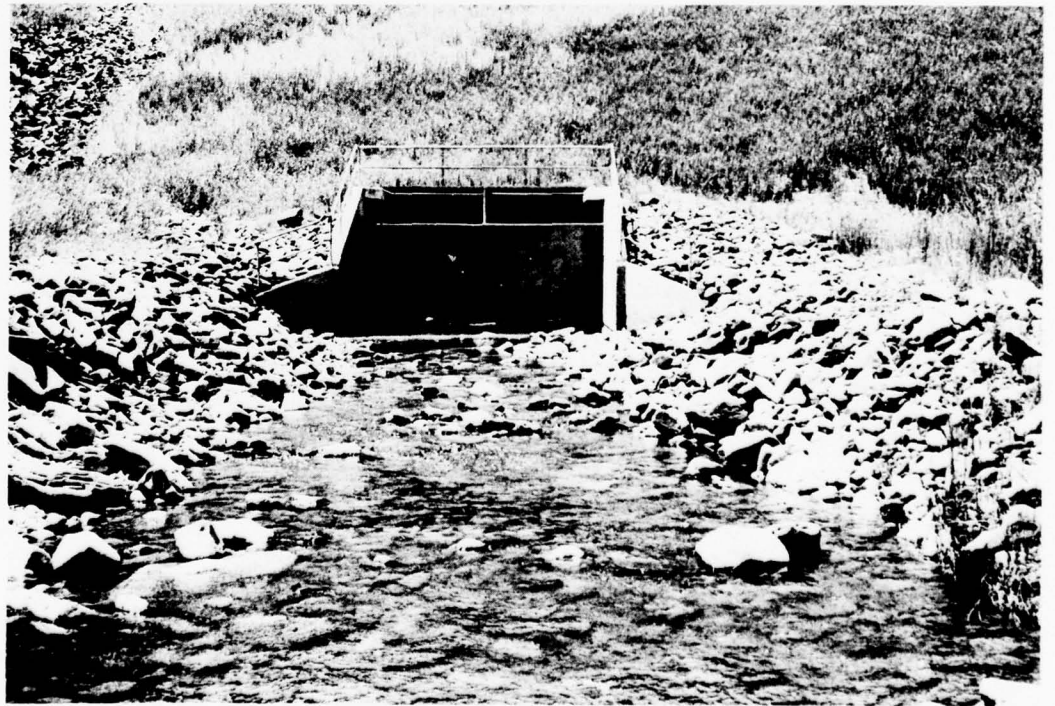
PHOTO 4

VISUAL EXAMINATION OF	OBSERVATIONS	REMARKS OR RECOMMENDATIONS
CRACKING AND SPALLING OF CONCRETE SURFACES IN OUTLET CONDUIT	The outlet conduit concrete surfaces are in very good condition. The outlet structure concrete walls, concrete floors, grating and railing are also in very good condition.	
INTAKE STRUCTURE	The intake structure is a standard S.C.S. fixed crest concrete riser. The intake structure also has five hand-operated water control gates including a 42" lake drain. The gates are operated by the city several times during the year. The pool level was about three or four feet below the top of the structure.	
III-6		
OUTLET STRUCTURE	The outlet structure is an energy dissipator located immediately downstream of the outlet pipe and physically located at the downstream right toe of the dam. The channel adjacent to the dissipator is ripped. See Photo 4.	
OUTLET CHANNEL	The outlet channel is a regular trapezoidal shape with riprap banks. The riprap appears to be adequately sized and well placed. There are no obstructions or measurable amounts of debris in the channel. See Photo 4.
