Name Of Dam: BONAVENTURE DAM
Location: RUSSELL COUNTY, VIRGINIA
Inventory Number: VA 16704

PHASE I INSPECTION REPORT
NATIONAL DAM SAFETY PROGRAM

BY
GILBERT ASSOCIATES, INC.
AUGUST, 1978

NATIONAL DAM SAFETY PROGRAM
PHASE I INSPECTION REPORT

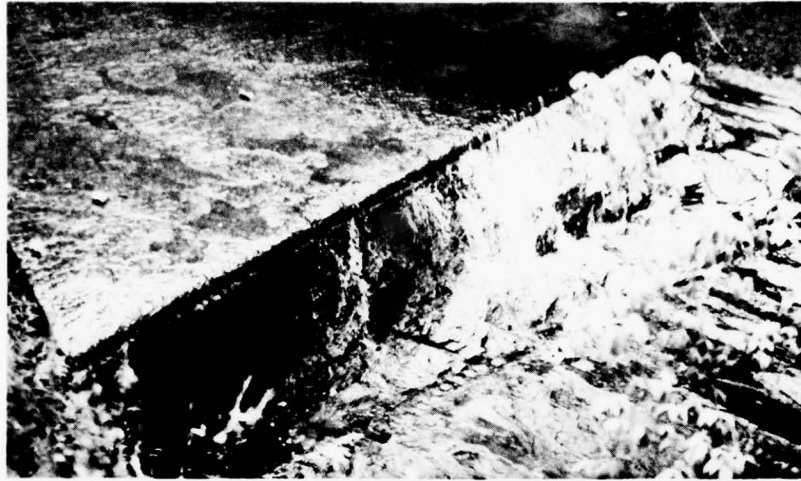
The spillway was in good condition. Minor erosion and weathering on the bedrock which formed the left side of the channel had occurred but was determined not to be of major significance. Minor backcutting beneath the floor of the spillway at the transition of the channel from concrete to bedrock had occurred to a maximum distance of 1-1/2 feet, but normally was only a few inches. This condition was also considered insignificant. The bedrock slopes appear to be in a stable condition with no evidence of incipient sliding.

DOWNSTREAM END OF CONCRETE SPILLWAY CHUTE. SOME
MINOR UNDERCUTTING HAS OCCURRED ON THE LEFT.

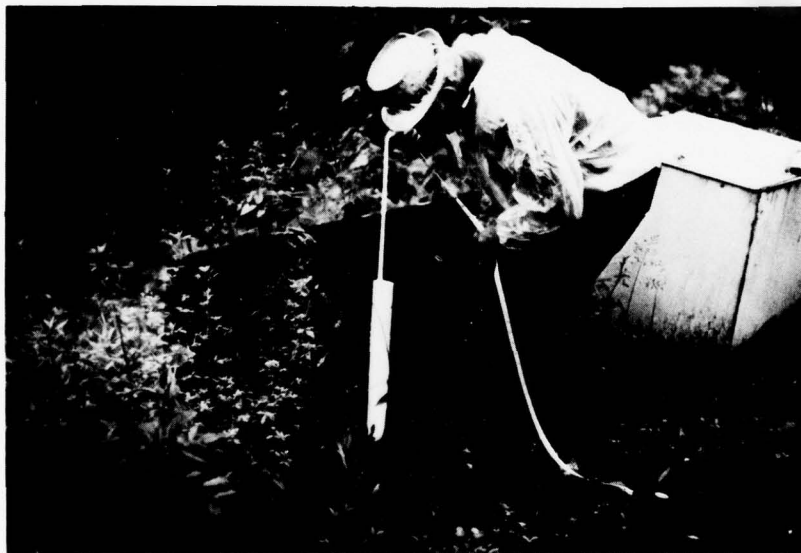
ONE OF THE PIEZOMETERS INSTALLED ON THE CREST OF THE
DAM. BOX IN BACKGROUND HOUSES ANOTHER.

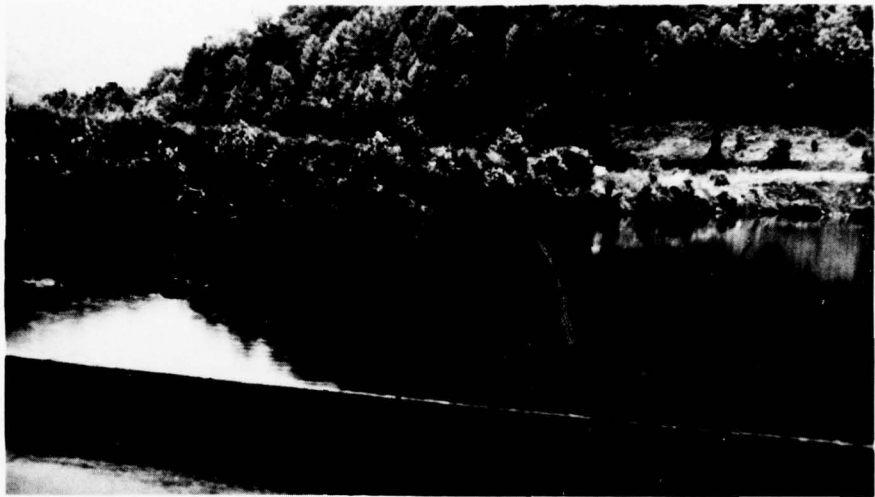
The upstream slope was also at 2 horizontal to 1 vertical. Some slight erosion was occurring at the water line, which is an indication of a riprap failure. The riprap was generally in relatively good condition but should be monitored for signs of further deterioration.

A VIEW OF THE UPSTREAM SLOPE OF THE DAM FROM
WITHIN THE SPILLWAY CHANNEL.

7.2.4 The owner should initiate an annual inspection program to monitor the general condition of the spillway and embankment. Particular attention should be given to the riprap on the upstream face of the dam. The riprap is showing signs of wear and eventually will need to be reinforced.

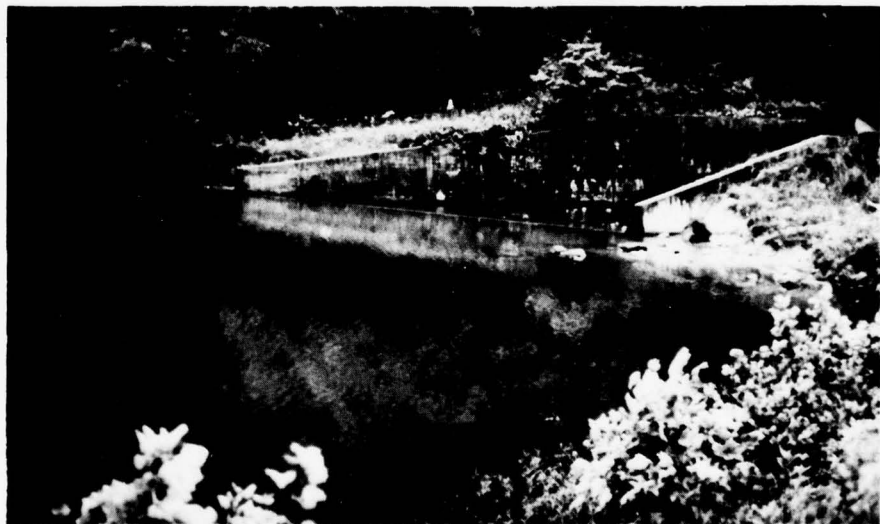
SPILLWAY CREST AND CONCRETE SPILLWAY CHANNEL

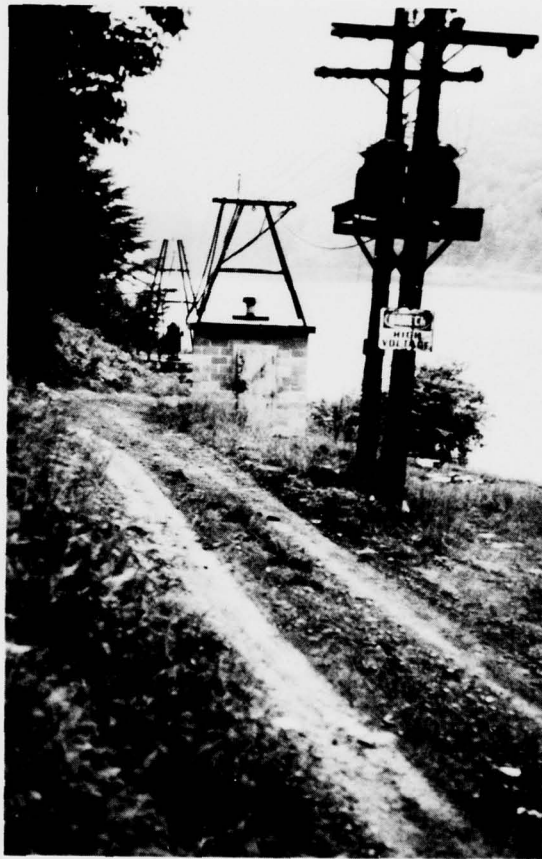
PROCESS WATER PUMPS. ONE PUMP IS SHOWN IN
BACKGROUND ANOTHER IS HOUSED WITHIN STRUCTURE.
