**Name Of Dam:** STONY CREEK NO. 9

**Location:** SHENANDOAH COUNTY, STATE OF VIRGINIA

**Inventory Number:** VA 17101

# LEVEL PHASE I INSPECTION REPORT NATIONAL DAM SAFETY PROGRAM

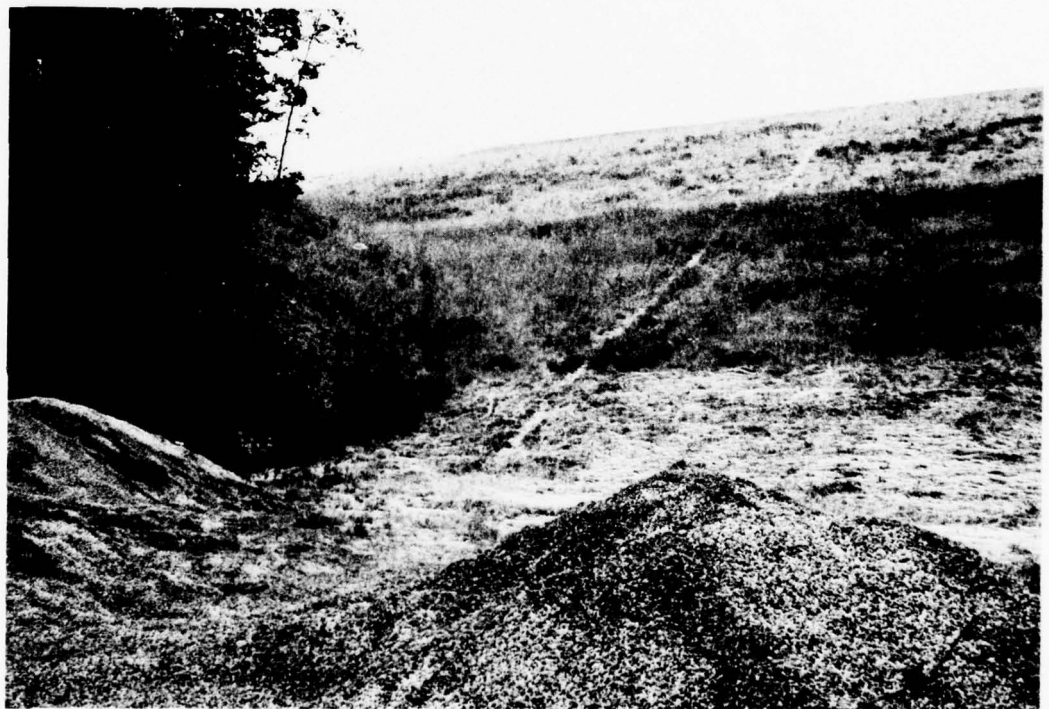
**PHOTO 6**

3.1.2 Dam: Erosion problems are present at three places on the downstream face of the embankment. One is a pedestrian path straight up the face of the embankment (see Photo 6). The other two places are the abutment contact areas. The pedestrian path should be filled and reseeded. Rubble gutters should be installed on the contact areas to prevent further erosion. Also, the upstream shore of the embankment is being wave eroded and should be riprapped if the condition worsens and creates a slope stability problem.

- 6.2.3 Operating Records: The yearly inspections indicate no deteriorating conditions beyond minor surface erosion (see Photo 6) which has been controlled by seeding. High water marks on the upstream slope above the normal pool indicate that the water elevation has risen without any significant damage to the dam.

- 1) The repair of erosion development, possibly by stone gutters, on the right downstream abutment.
- 2) Reseeding a major portion of the downstream and upstream face where indicated.
- 3) Repair of the lift pedestal and trash racks on the principal spillway.
- 4) Installation of a locking manhole cover as specified on the plans.
- 5) Stability analyses using as-built conditions.
- 6) Further investigation of the clear seepage at the downstream toe.
- 7) Development of a warning system that will alert downstream residents when the reservoir level approaches the emergency spillway.
