JAMES RIVER BASIN

Name of Dam: Sugar Hollow

Location: Albemarle County, State of Virginia

# PHASE I INSPECTION REPORT NATIONAL DAM SAFETY PROGRAM

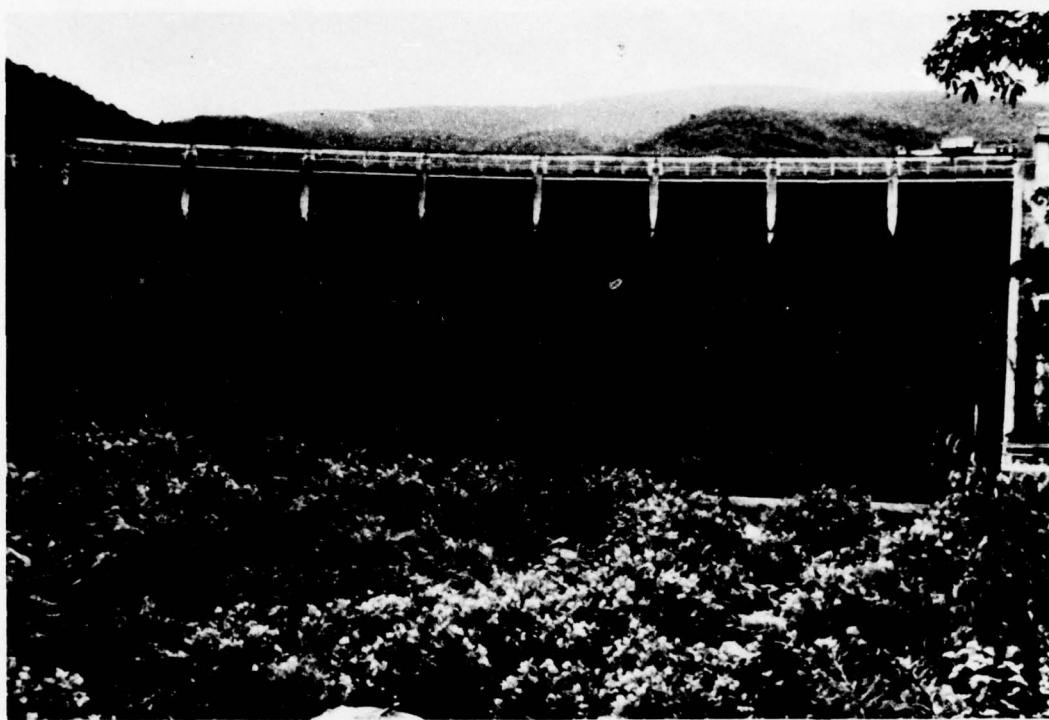
**PHOTO 1.** View of Main Overflow Spillway Gate Hoist in Upper Right Corner

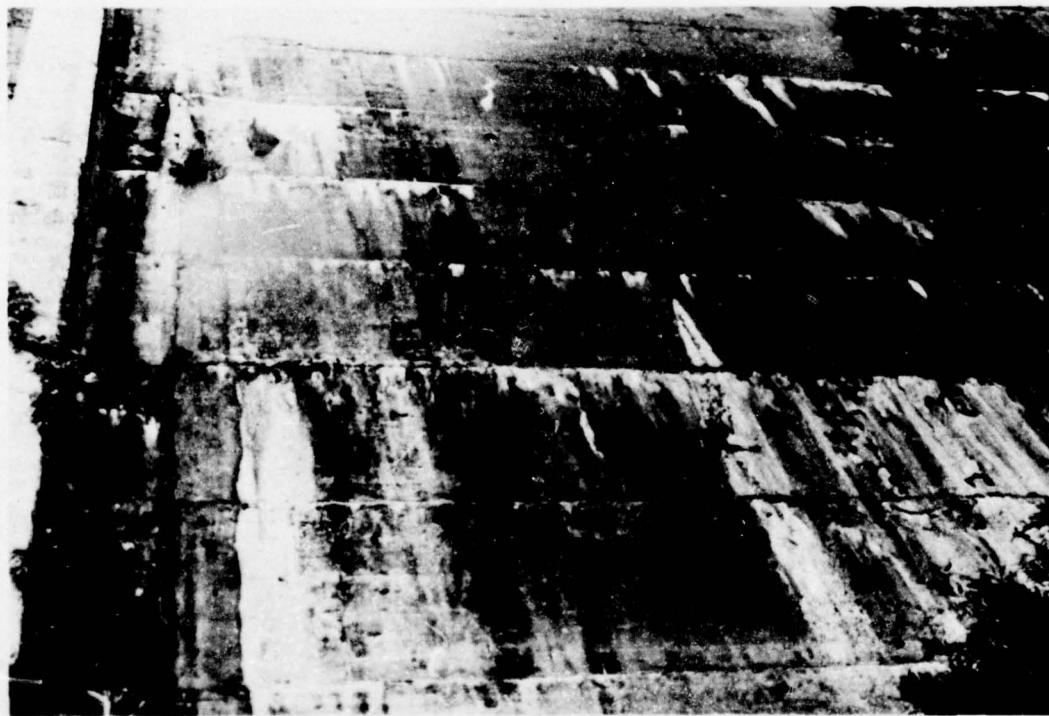
- Evidence of spalling, cracking and seepage was observed on the downstream face of the left non-overflow section. Clear seepage was observed at the construction joints. Vegetation was observed to be growing on the downstream face of the left non-overflow section.

- 3.2 Evaluation
- 3.2.1 Dam: The concrete in the spillway and right non-overflow area is in good condition and requires no further investigation. The concrete in the left non-overflow area adjacent to the main spillway shows evidence of clear seepage. The Rivanna Water and Sewer Authority should monitor these seepage areas.

**PHOTO 2.** Clear Seepage, Calcite Stains, Cracked and Spalled Areas of Non-Overflow Section

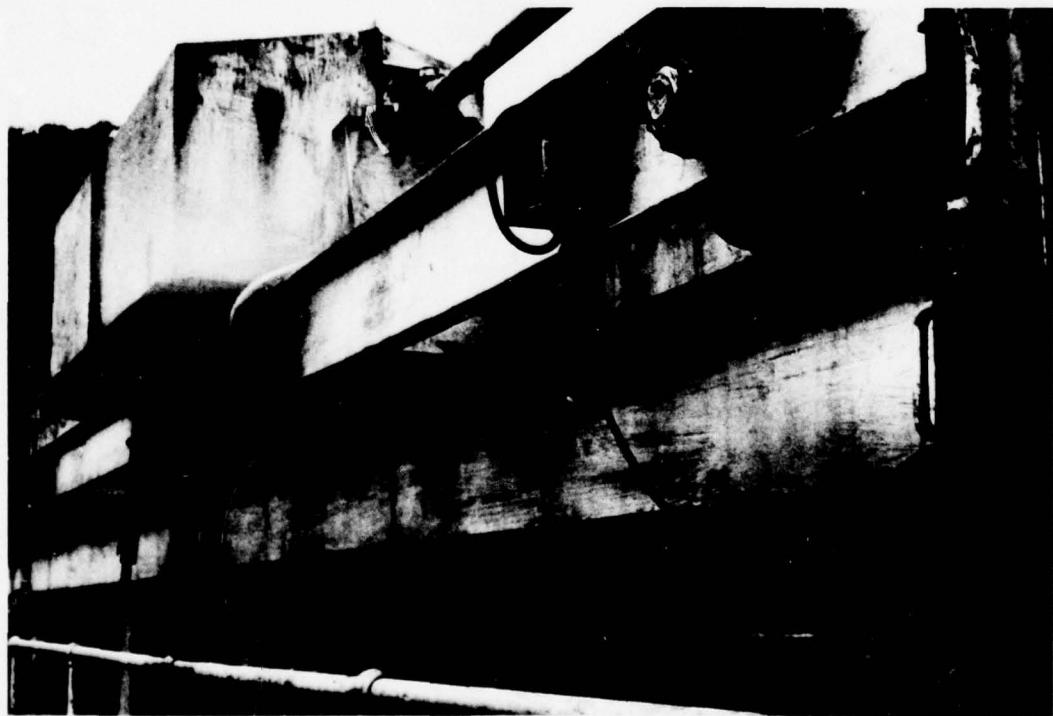
- 3.1.3 Appurtenant Structures: Some minor spalling and surface cracks were present on the intake tower and the walkway along the crest of the dam. Neoprene sealant had been "squeezed" out of the expansion joints along the crest; approximately one-fourth to one-half of an inch of expansion material is remaining. The crest gates were in good condition with no leakage present. It was reported during the time of inspection that the gates were not regularly operated. This was verified by the fact that the tracked gate hoist had a light coating of rust on the tracks and the hoist.

It was reported at the time of inspection and visually verified that the lift gates have not been operated for some time. It is recommended that regular operations of the lift gates' equipment be done to insure their working order.

**PHOTO 4. View of Gate Hoist**

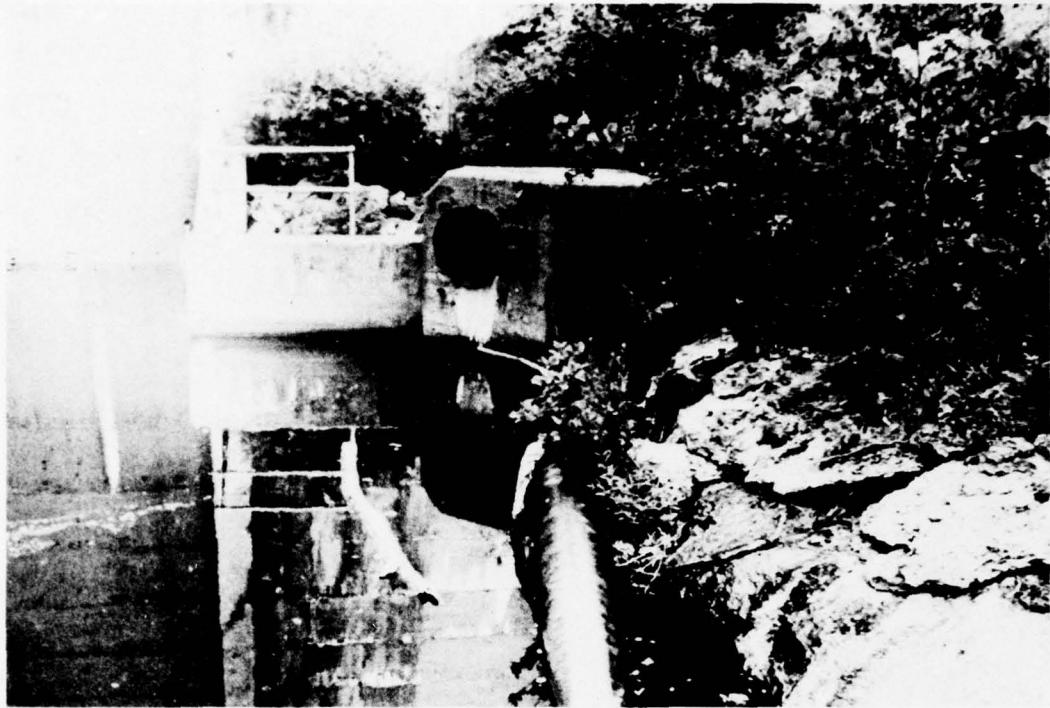
**PHOTO 5.** View of 30 Inch Blowoff Pipe (Left) and 24 Inch Water Supply Main (Right)

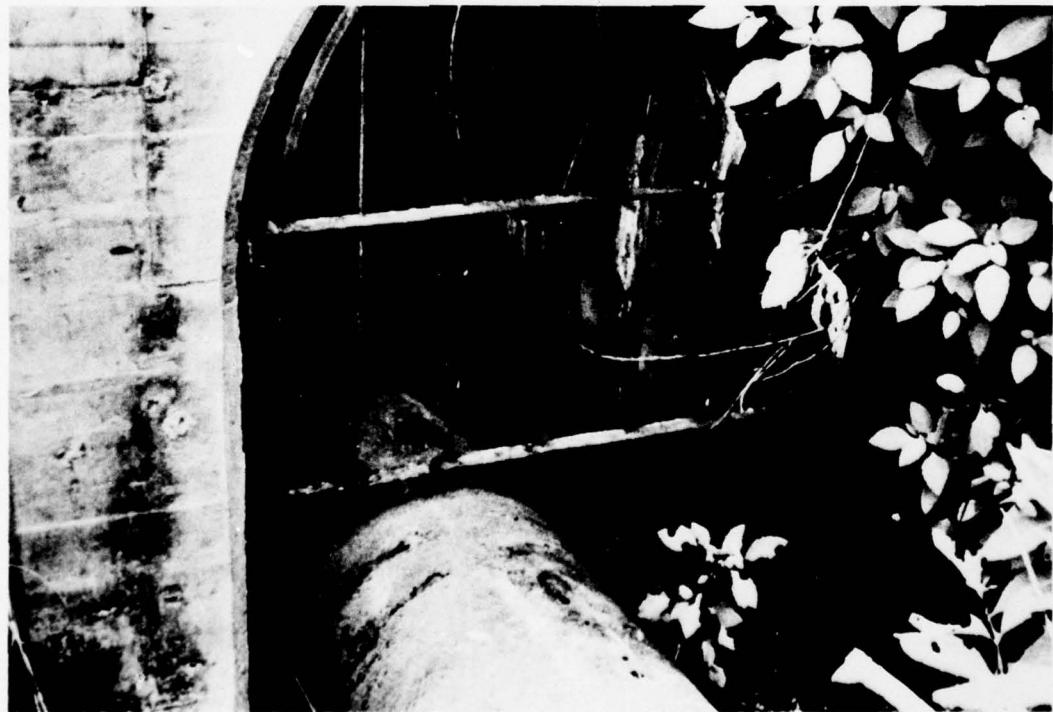
**PHOTO 6.** View of 24 Inch Water Supply Main at Exit From Drainage Gallery

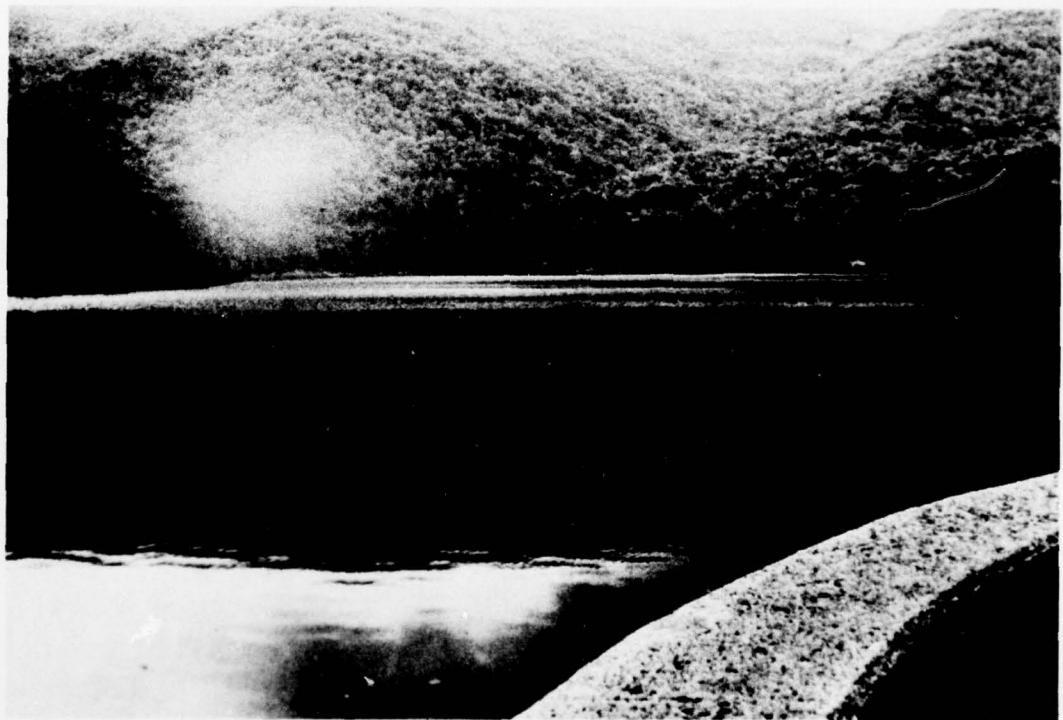
**PHOTO 8. Reservoir Looking Upstream From Dam**

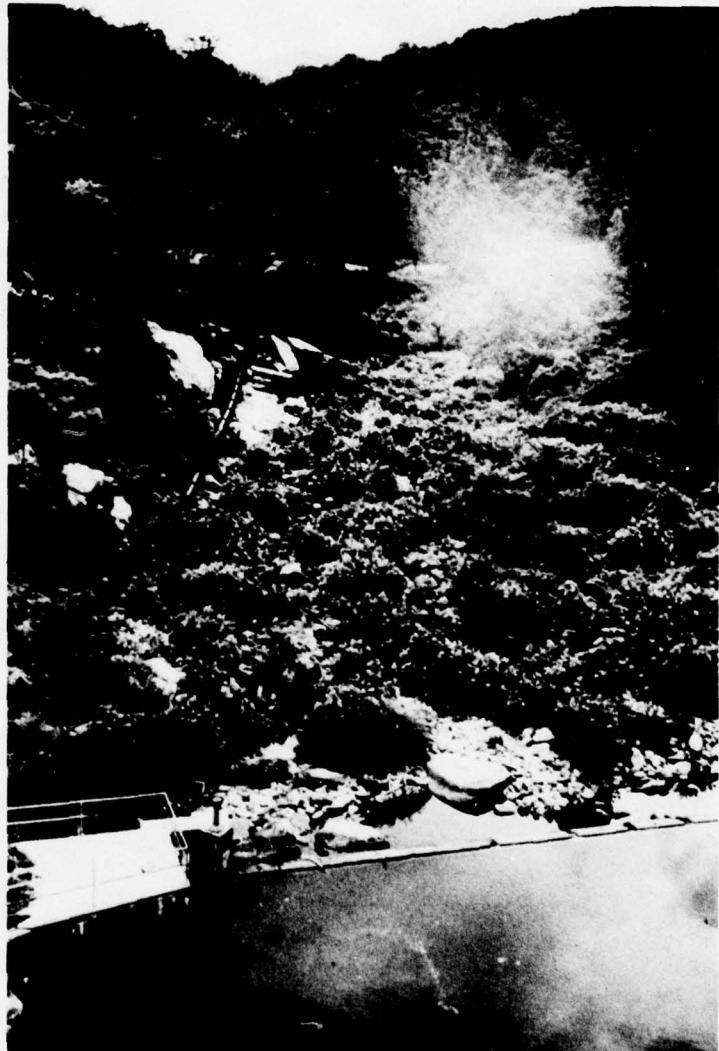
**PHOTO 9. View of Downstream Channel Beyond Stilling Pool**

CONDITION (OBSTRUCTIONS, DEBRIS, ETC.)	REMARKS OR RECOMMENDATIONS
Heavily overgrown with trees and brush in main channel. The streambed consists of boulders and cobbles with sandy gravel. Granite is exposed in some areas primarily near the stilling basin.
